Rhode Island Department of Transportation **Road-Stream Crossing Assessment Handbook**

August 2019

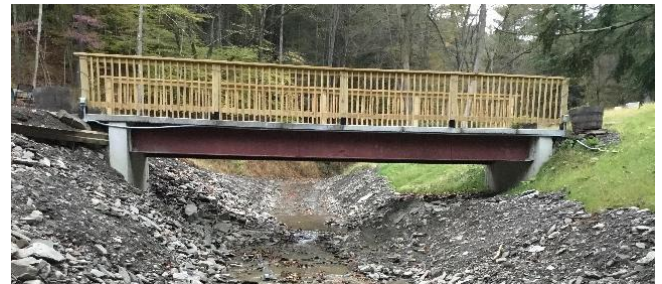
Figure 3-1: Example of a road-stream crossing consisting of a bridge with side slopes and abutments.

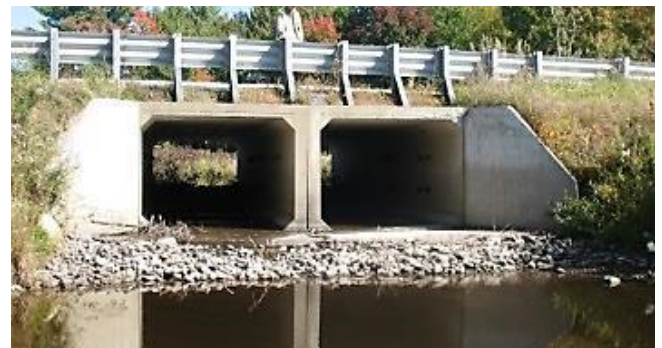
Figure 3-2: Example of a road-stream crossing consisting of multiple box culverts. (Image credit: NAACC)

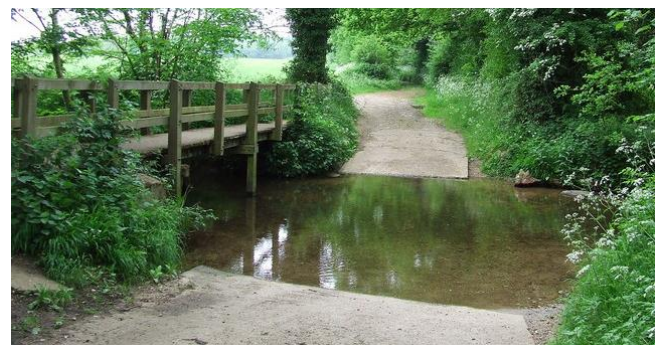
Figure 3-3: Example of a ford. (Image Credit: Keith Evans)

- Ford: A ford is a shallow, open stream crossing, in which vehicles pass through the water. Fords may be armored to decrease erosion, and may include pipes to allow flow through the ford (this is called a *vented ford*).

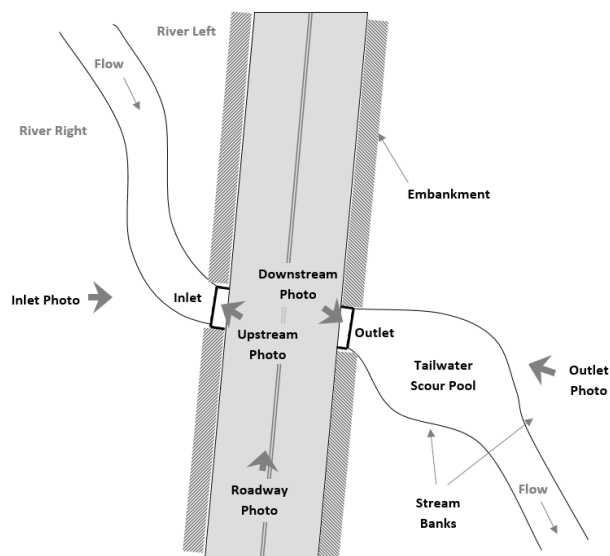
Figure 3-4: Diagram indicating photo locations in relation to a crossing structure. (Image adapted with permission from the NAACC)

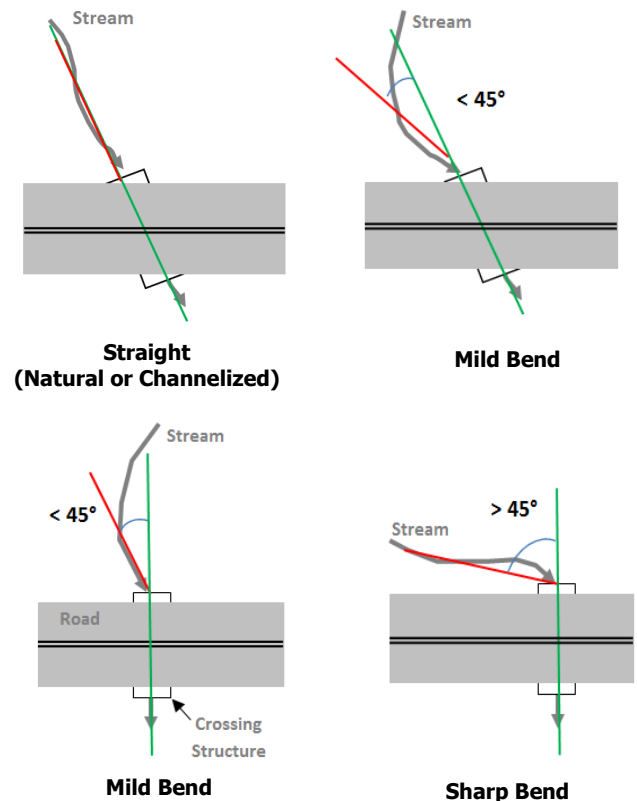
Figure 3-7: Depictions of possible Road-Stream Alignments. (Image adapted with permission from the NAACC)

When determining the alignment of the structure relative to the stream, be careful not to confuse the alignment of low-flow channels through upstream sediment deposits with the alignment of the stream corridor. Assessing the alignment relative to the orientation of flow channels at extremely low flows may cause the field team to assess the alignment as a sharp bend when it should actually be a mild bend or straight. Alignment of the structure should instead be assessed relative to the stream corridor (i.e., the direction of streamflow at moderate and high flows).

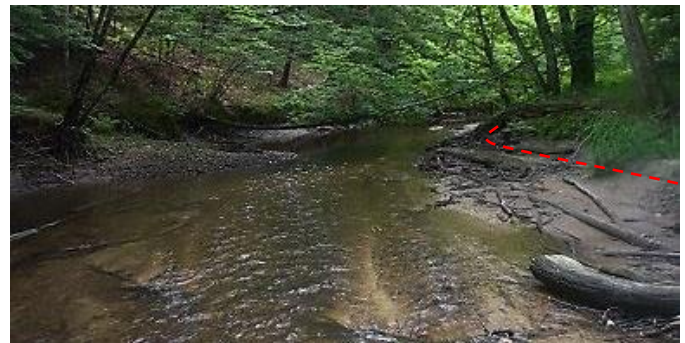
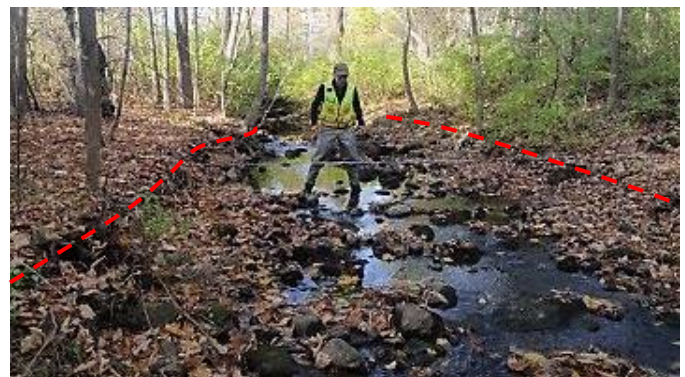
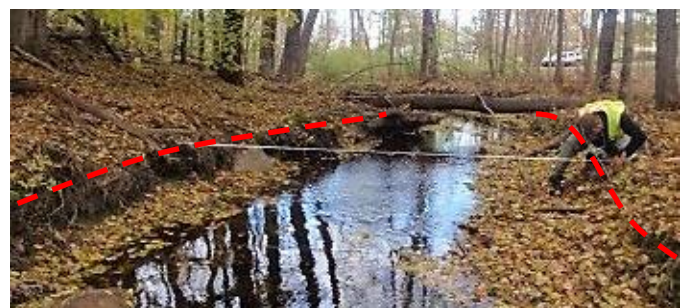
Figure 3-8: Examples of bankfull height indicated by an abrupt transition from bank to floodplain (marked by red lines). (Image adapted with permission from NAACC)

Measure the width from bank to bank at the selected locations. Indicators of bankfull flow (shown in *Figure 3-8* as a red line) include:

- *Abrupt transition from bank to floodplain*: The point of change from a vertical bank to a more horizontal surface is the best identifier of bankfull stage, especially in low-gradient meandering streams.
- *Top of point bars*: The point bar consists of channel material deposited on the inside of meander bends. Set the top elevation of point bars as the lowest possible bankfull.
- *Bank undercuts*: Maximum heights of bank undercuts are useful indicators of bankfull flow in steep channels lacking floodplains.

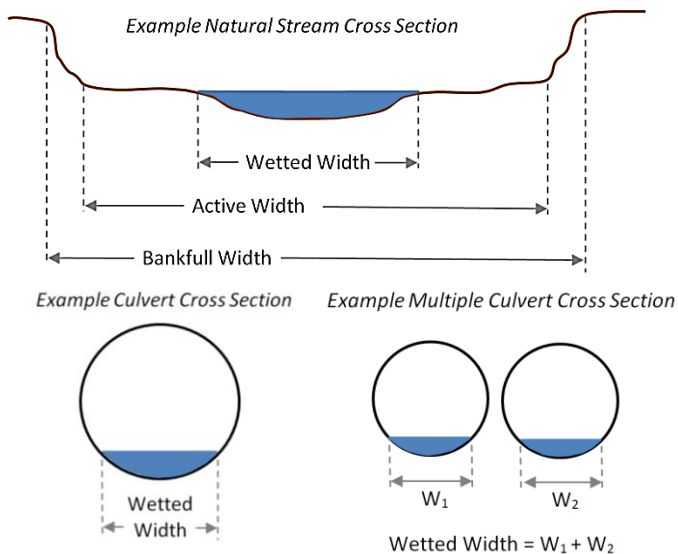
Figure 3-11: Wetted width in natural streams and various culvert configurations. (Image credit: NAACC)

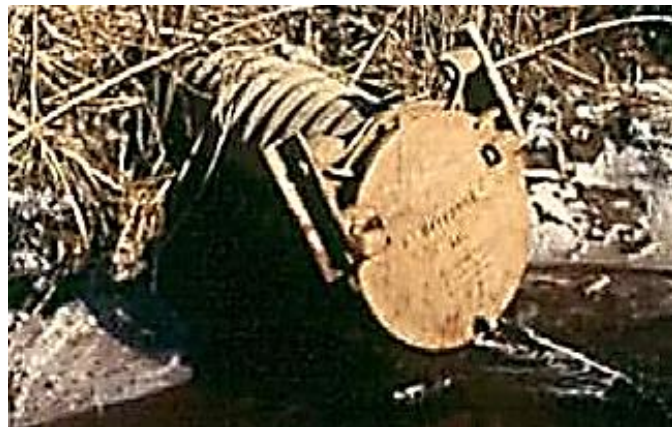
Figure 3-22: Flap tide gate. (Image credit: NAACC)

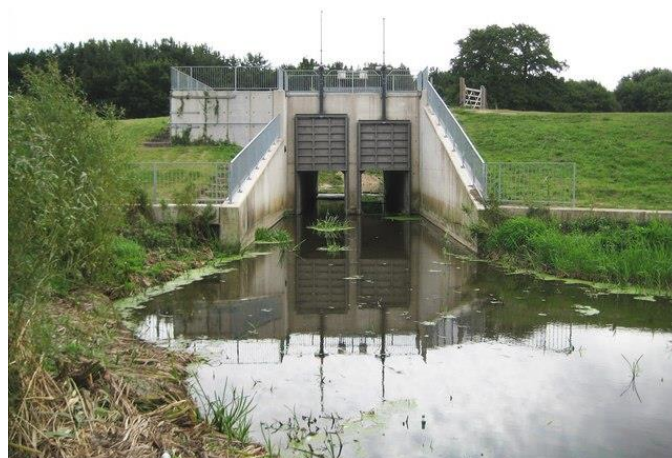
Figure 3-23: Sluice tide gate. (Image credit: Nigel Cox)

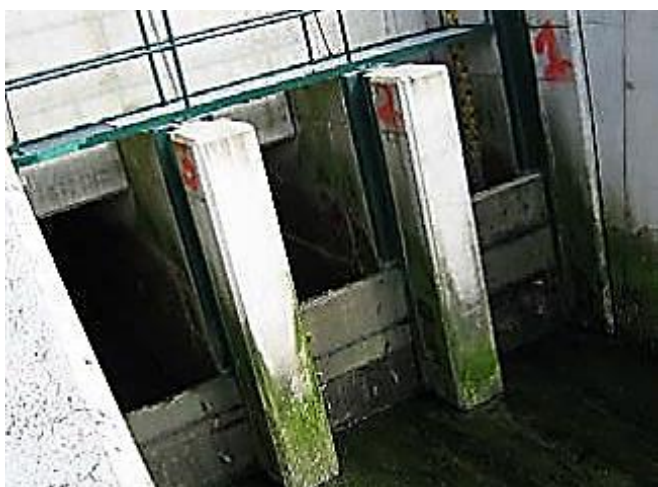
Figure 3-21: Stop log tide gate. (Image credit: NAACC)

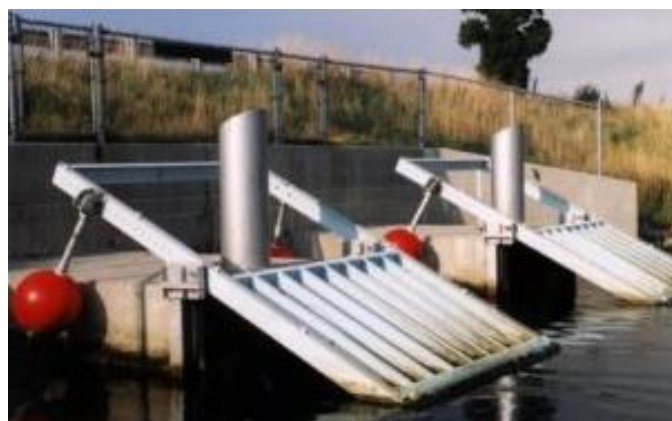
Figure 3-24: Self-regulating tide gate. (Image credit: URI)

- Self-regulating Tide Gate: Self-regulating tide gates are fixed with floats or some other mechanism that allows unregulated flow at times, but restricts high flows to prevent upstream flooding.

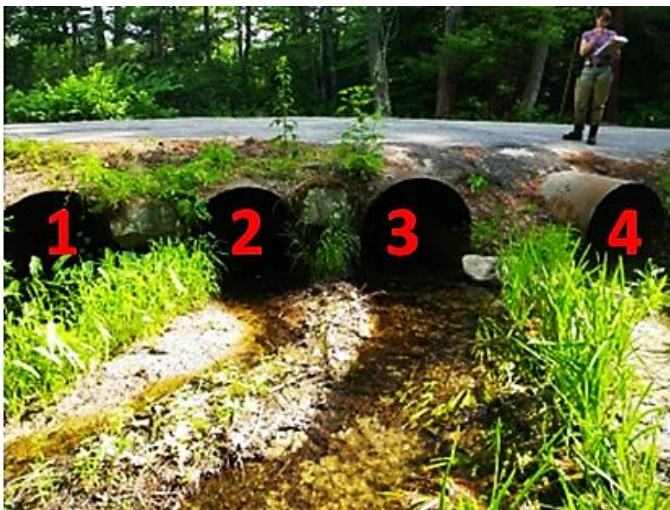
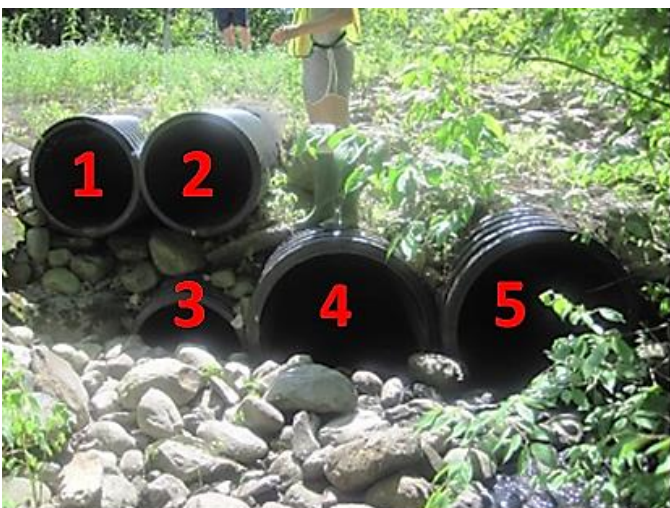
Figure 3-25: Examples of numbered structures. (Image credit: NAACC)

When there are multiple culverts and/or bridge cells, number them from left to right, **while looking downstream toward the culvert inlet**. The left-most structure is Structure 1, and structure numbers increase to the right. See examples below.

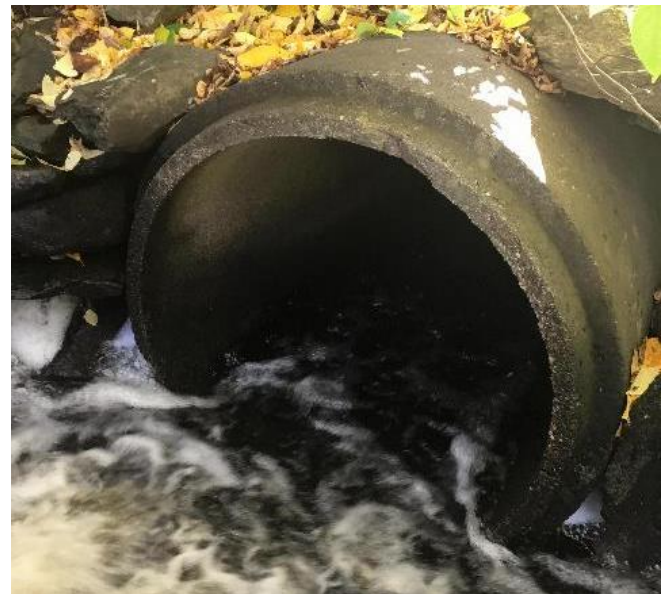
Figure 3-26: Material - Concrete.

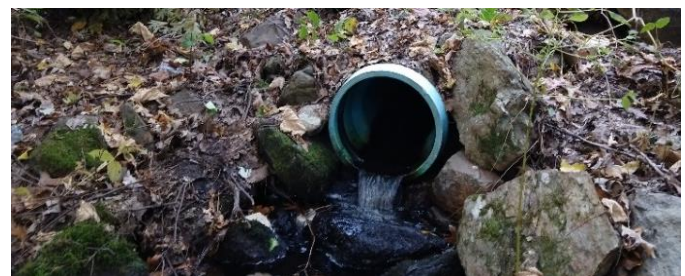
Figure 3-27: Material – Fiberglass.

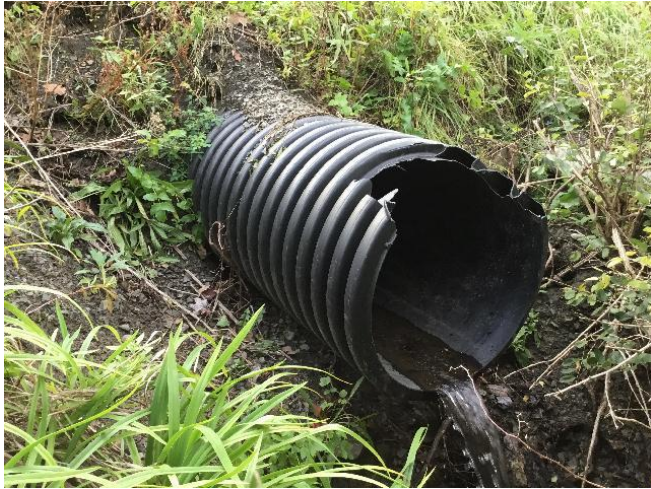
Figure 3-28: Material – Corrugated plastic (internal surface as well as external). (Image credit: NAACC)

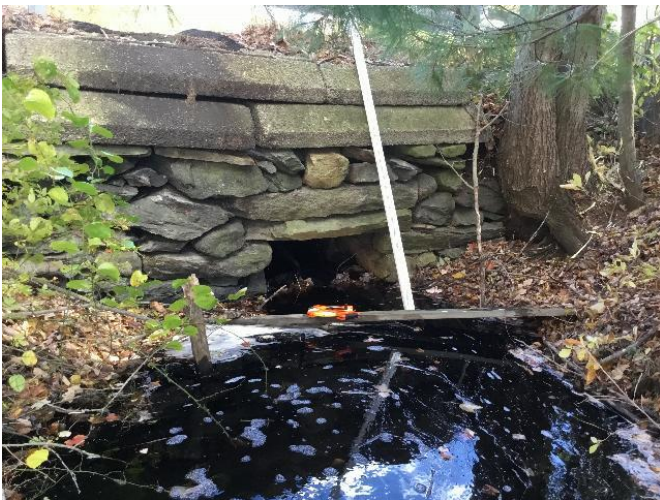
Figure 3-29: Material – Stone (Image credit: NAACC)

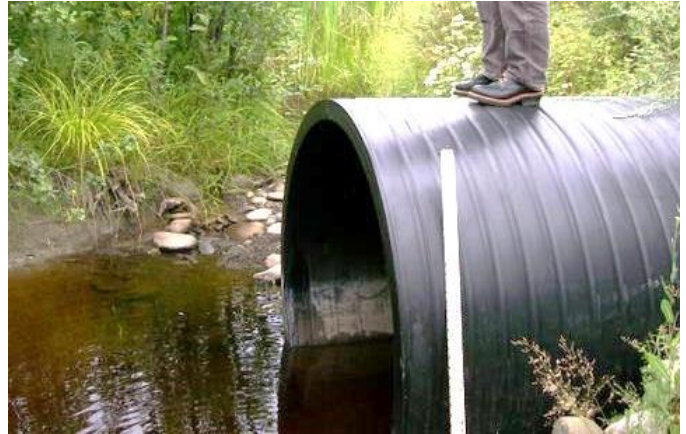
Figure 3-31: Material – Smooth plastic. (Image credit: NAACC)

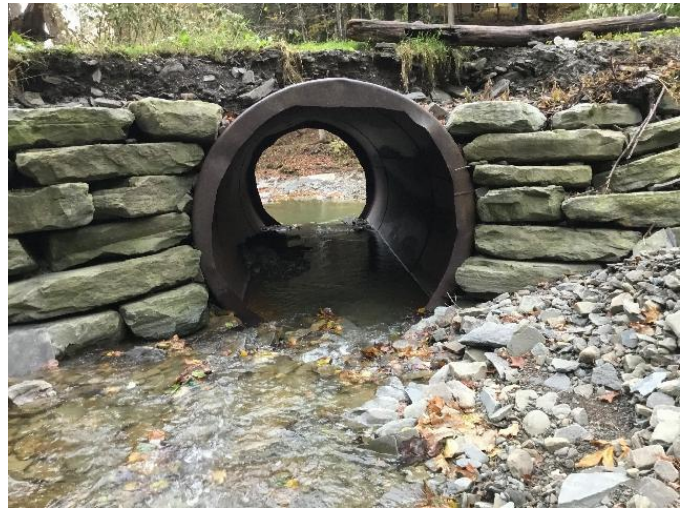
Figure 3-32: Material – Smooth metal.

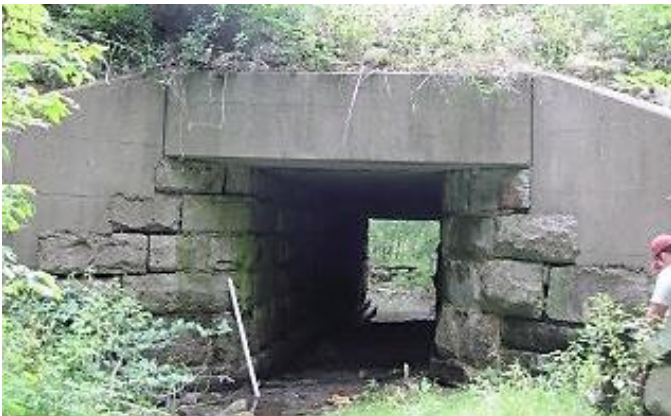
Figure 3-30: Material – Combination of stone and concrete. (Image credit: NAACC)

If a structure is made of two materials, such as a bridge with concrete abutments and a steel deck structure, a metal culvert that has been lined along its entire bottom with concrete, or a crossing with different types of structures at inlet and outlet, you may select two options. **In this case, or if *Combination* is selected, describe the configuration of the structure materials in *Structure Comments*.**

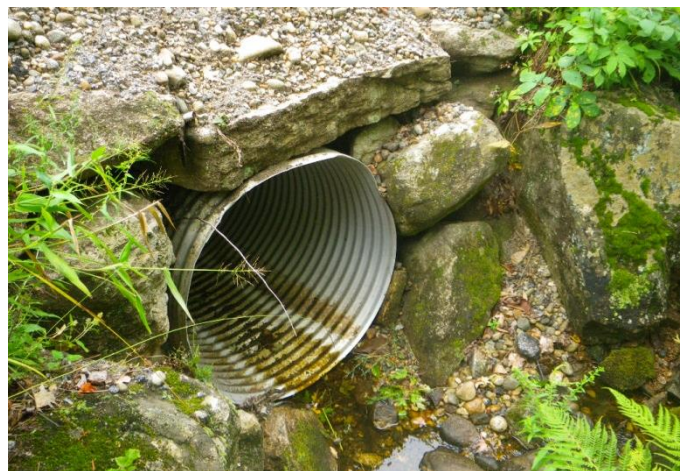
Figure 3-33: Material – Corrugated metal. (Image credit: NAACC)

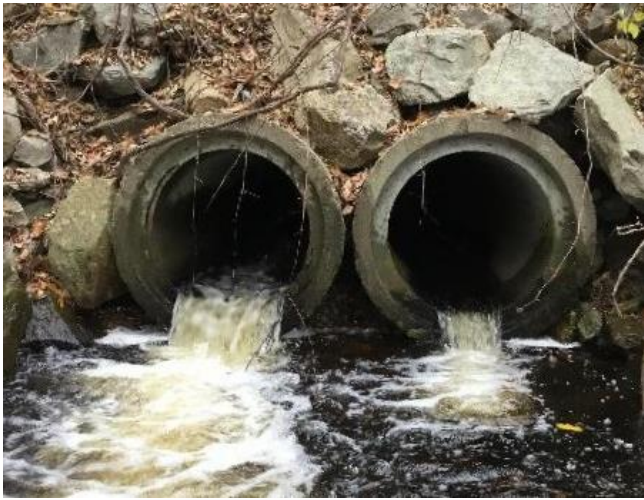
Figure 3-36: Outlet shape – Round.

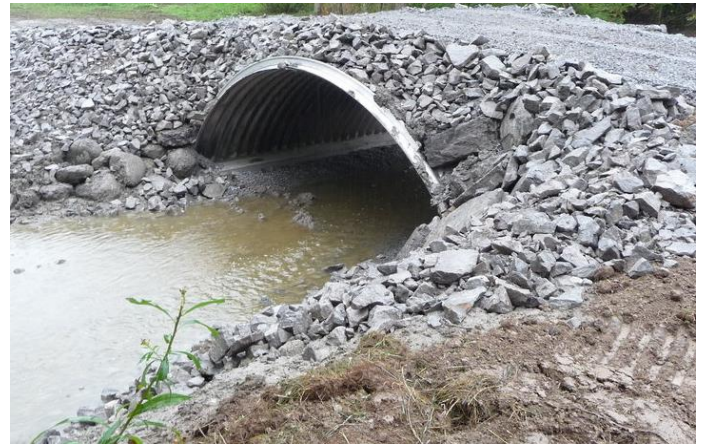
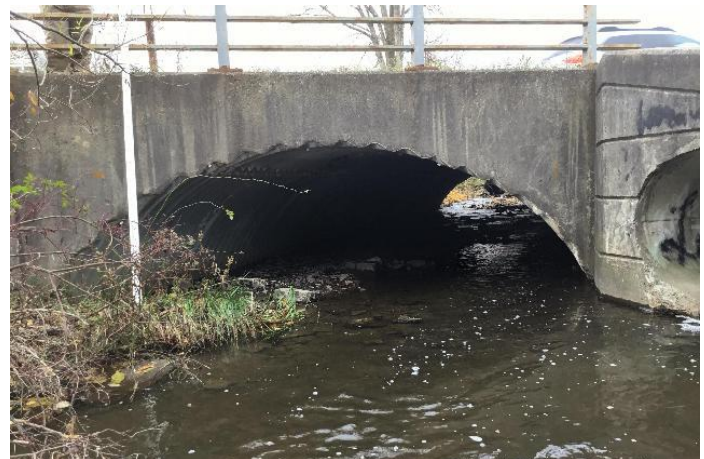
Figure 3-38: Outlet shape – Open-bottomed arch culvert and bridge. (Image credit: US Fish & Wildlife Service)

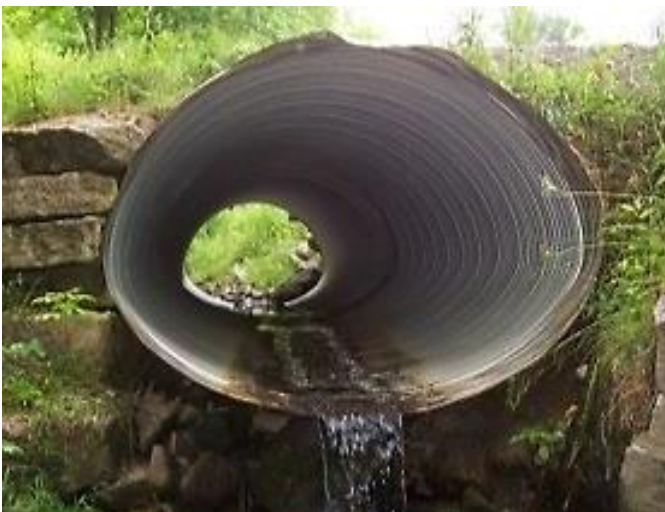
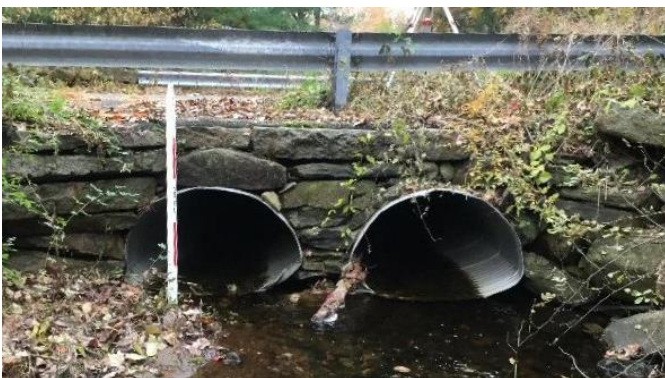
Figure 3-37: Outlet shape –Pipe arch/elliptical. (Image credit: NAACC)

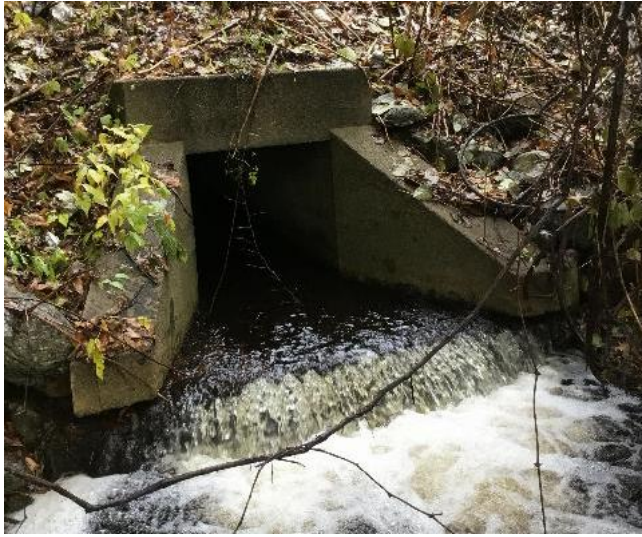
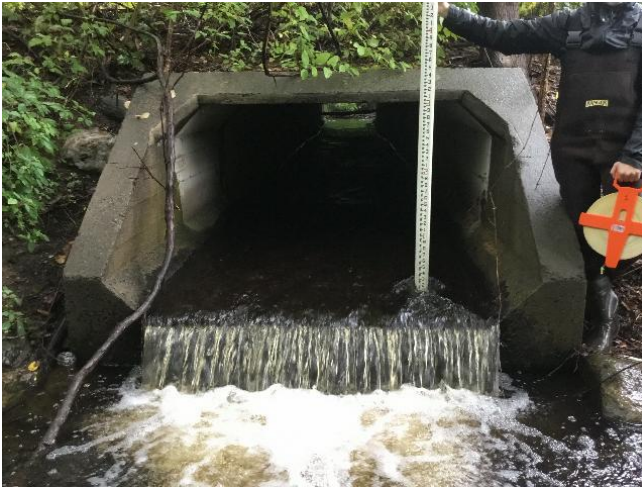
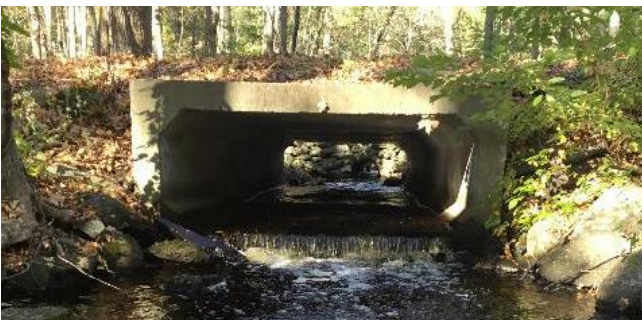
Figure 3-39: Outlet shape – Box culverts.

4. Box Culvert: These structures are usually made of concrete or stone, but sometimes of corrugated metal with a slightly arched top. Typically, they have a top, two sides, and a bottom. A box culvert **without** a bottom, called a bottomless box culvert, should be classified as a *Box/Bridge with Abutments (Shape 6)*. If you cannot tell if the structure has a bottom, classify it as a *Box/Bridge with Abutments (Shape 6)*. *Figure 3-39 shows Box Culverts (Shape 4)*.

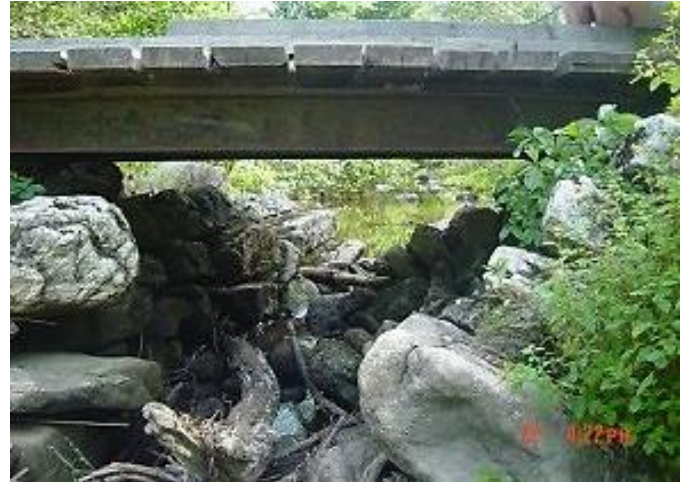
Figure 3-40: Example of a bridge with side slopes. (Image credit: NAACC)

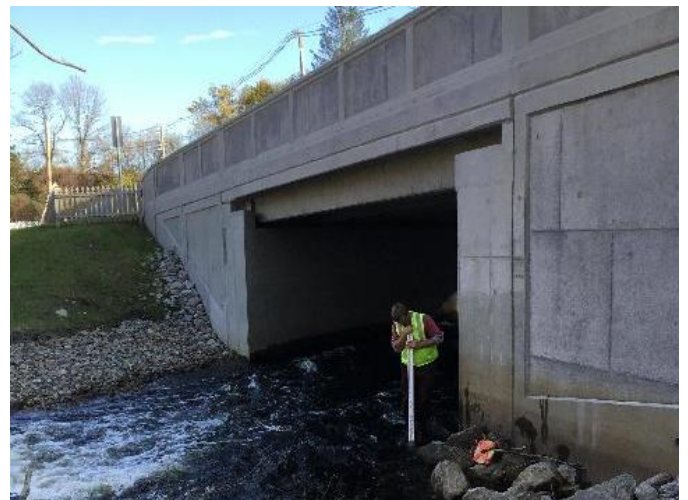
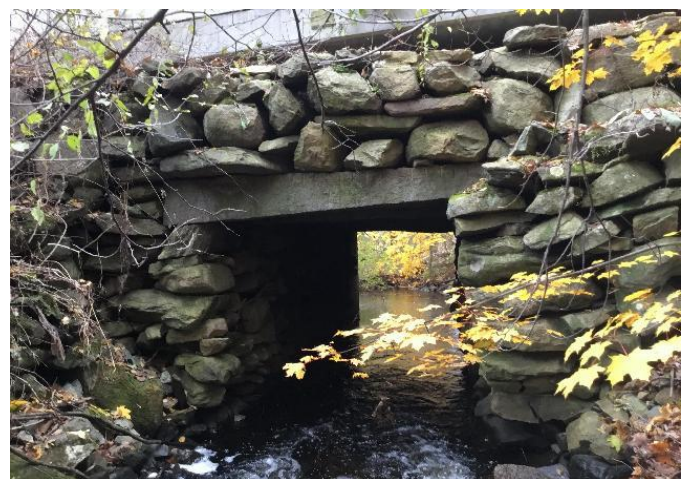
Figure 3-41: Examples of a box culvert and bridge with abutments. (Image credit: NAACC)

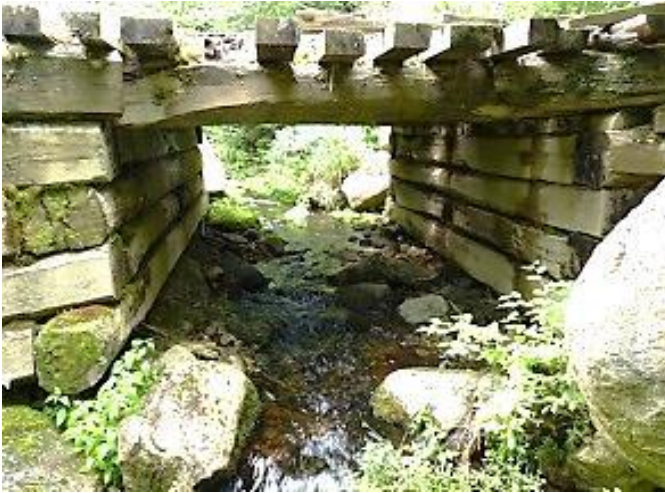
Figure 3-42: Example of a bridge with abutments. (Image credit: NAACC)

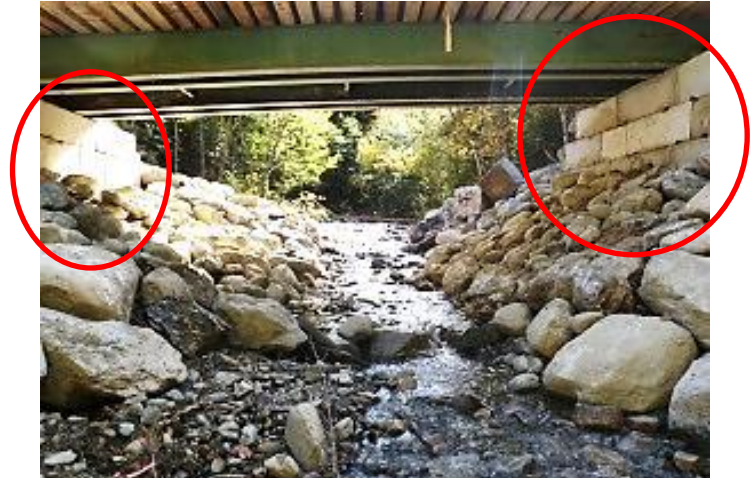
Figure 3-44: Examples of bridges with abutments and side slopes. The abutments are indicated by the red circles. (Image credit: NAACC)

6. Box/Bridge with Abutments: This is a bridge or bottomless box culvert with vertical sides.
7. Bridge with Side Slopes and Abutments: This is a bridge with sloping banks and vertical abutments (typically short) that support the bridge deck. (Circles in *Figure 3-43* and *Figure 3-44* indicate the abutments.)

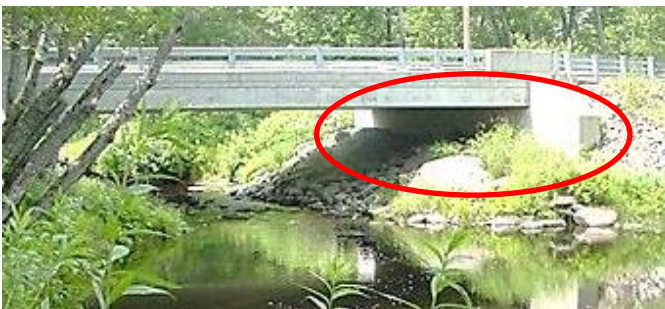
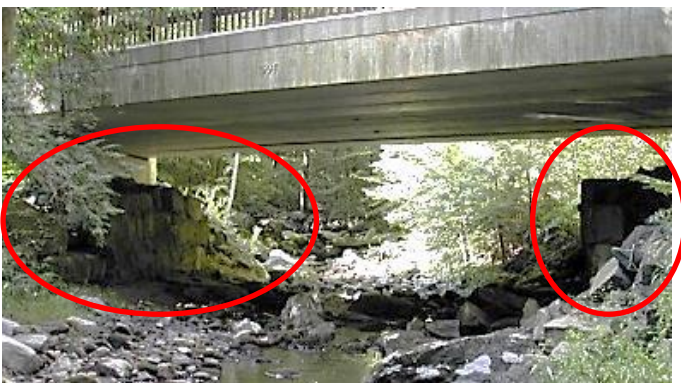
Figure 3-43: Examples of bridges with abutments and side slopes. The abutments are indicated by the red circles. (Image credit: NAACC)

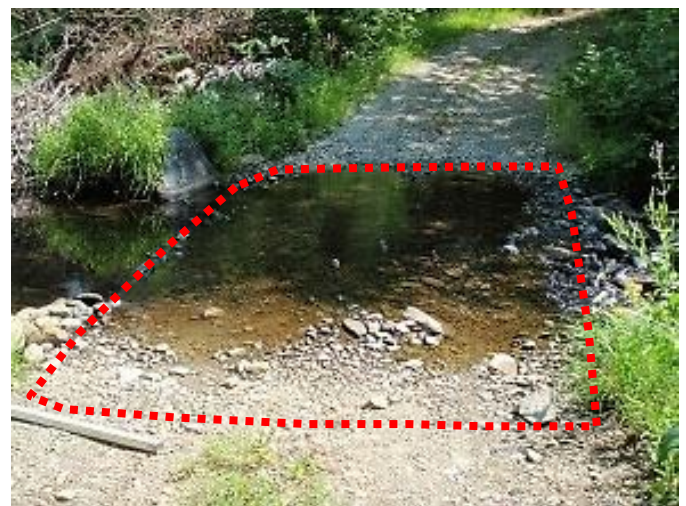
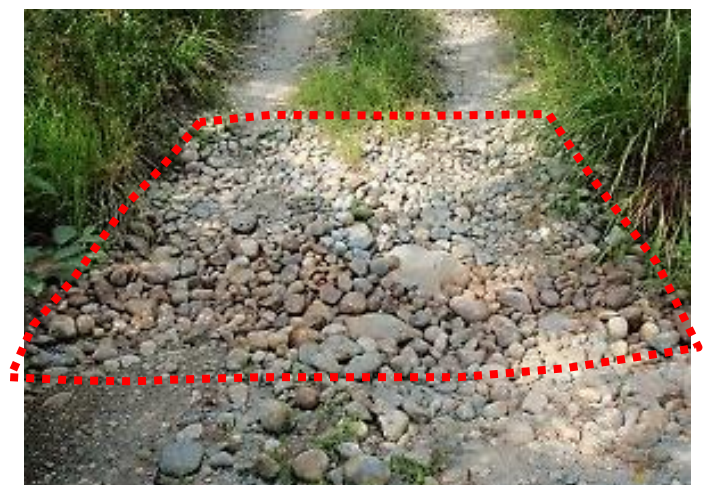
Figure 3-45: Examples of fords. (Image credit: NAACC)

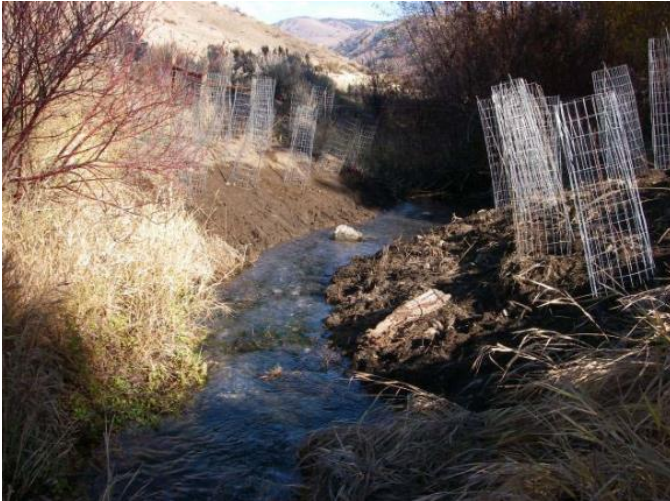
Figure 3-46: Example of a removed crossing. (Image credit: Washington Department of Fish and Wildlife)

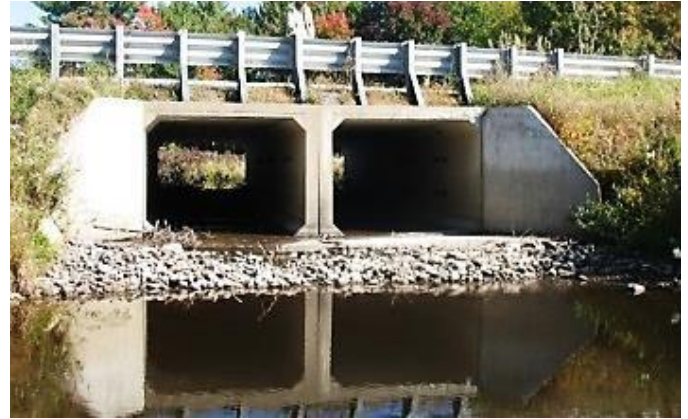
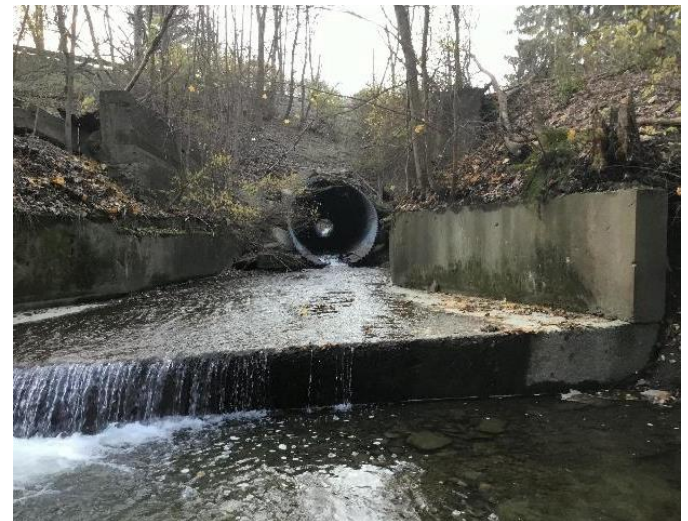
Figure 3-47: Examples of crossings with an extensive outlet apron. (Image Credit: NAACC and Fuss & O'Neill)

Outlet Apron: Select from the options to indicate the presence and extent of material placed **in the streambed** below the outlet for the purpose of diffusing flow and minimizing scour. The most common forms of apron are a layer of riprap (angular rock) placed below the outlet or concrete poured in the streambed extending from the outlet. A few pieces of rock that may have fallen into the stream near the structure's outlet do not constitute outlet armoring. **Armoring of the road embankment and stream banks should not be confused with an apron covering the stream bottom at the outlet.** Choose only one option. Refer to the images in Figure 3-47 through Figure 3-49 for examples of each option.

- **Extensive:** Select this option only if you observe an extensive layer of material covering an area more than 50% of the stream width, which was put in place specifically to minimize scour at the outlet.
- **Not Extensive:** There is a layer of material covering less than 50% of the stream width placed purposefully below the outlet specifically to minimize the effects of scour.
- **None:** This situation represents the majority of crossing structures. You may observe rocks that have fallen from the embankment or that are natural to the stream. Most cascades do not

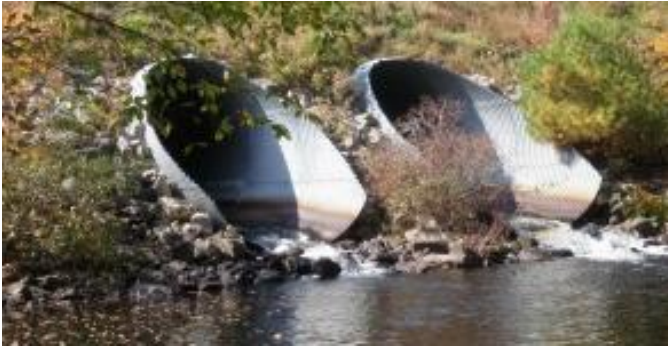
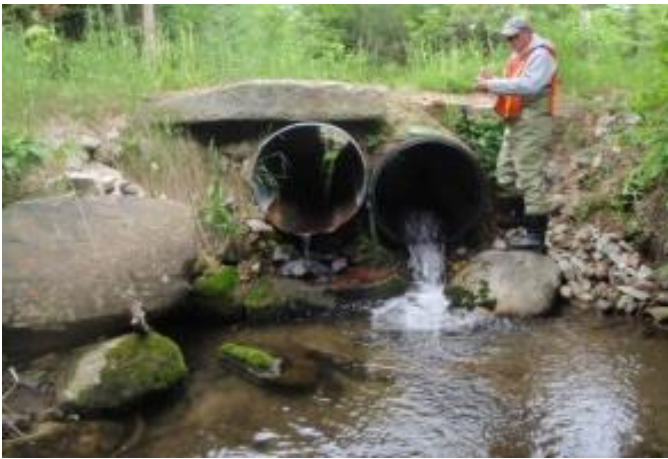
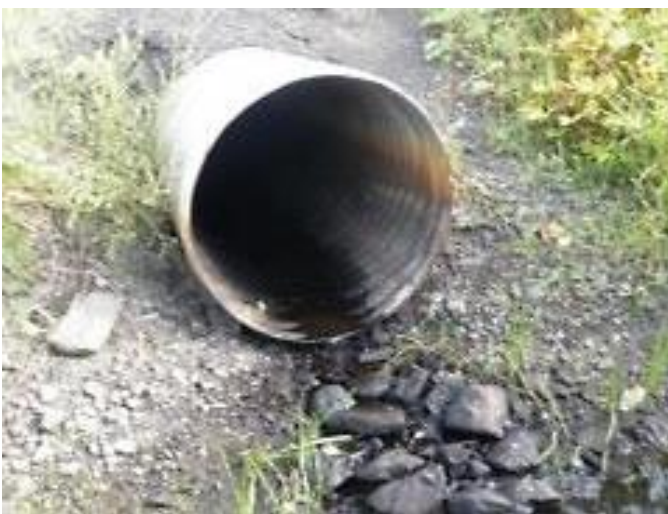
Figure 3-48: Examples of crossings with an outlet apron that is not extensive. (Image credit: NAACC)

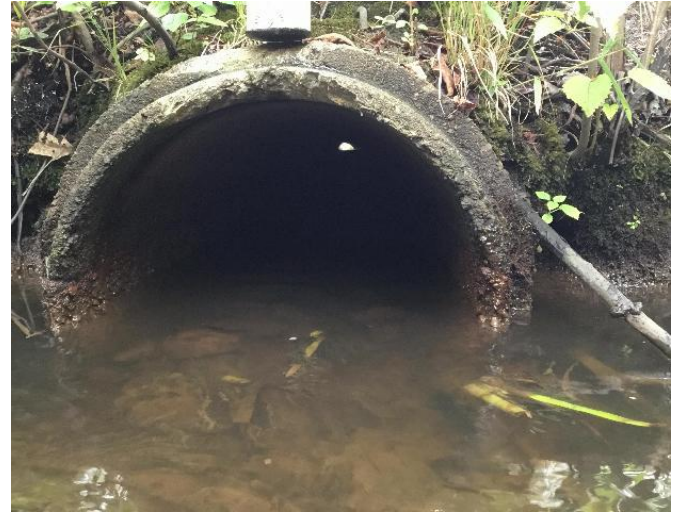
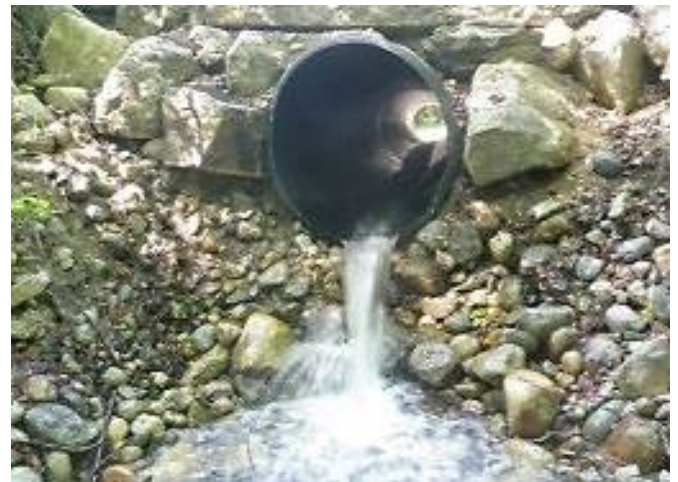
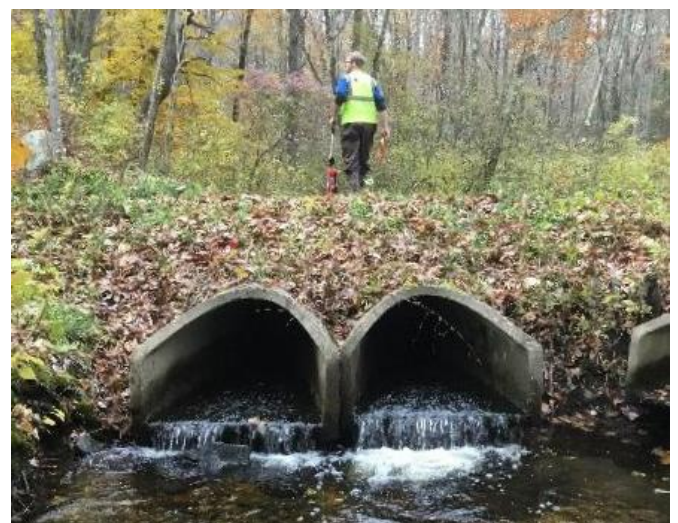
Figure 3-49: Examples of crossings with no outlet apron. (Image credit: NAACC)

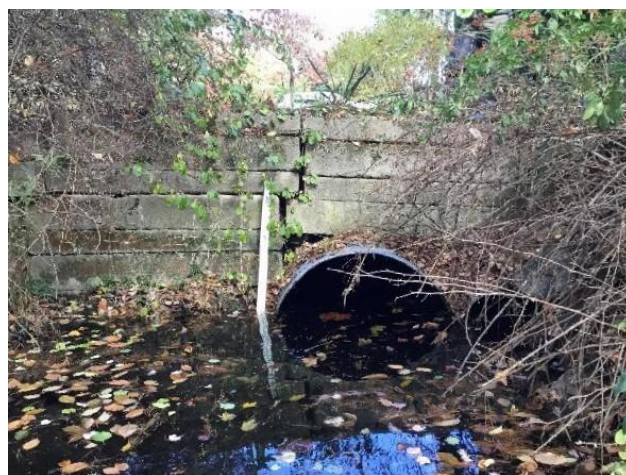
Figure 3-54: Example of a culverts with outlet at stream grade. (Image credit: NAACC)

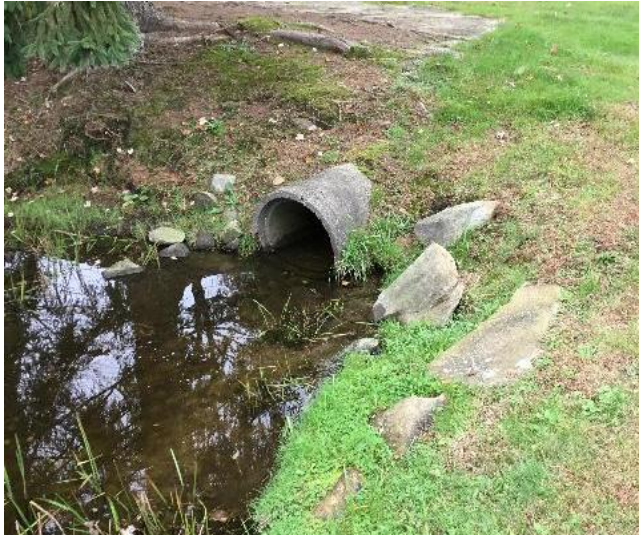
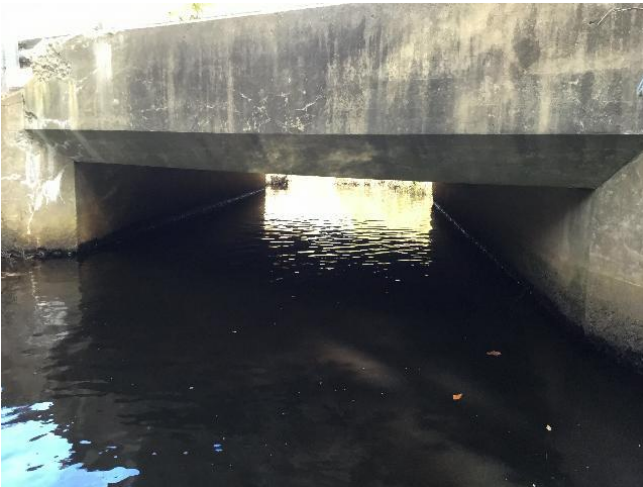
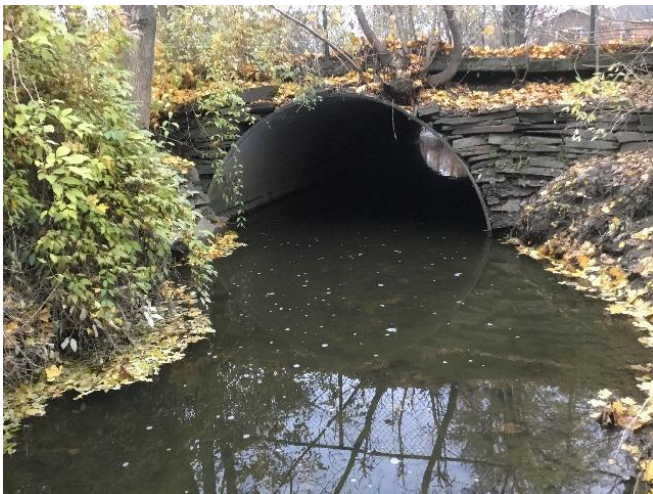
Figure 3-55: Examples of culverts with outlets at stream grade.
(Image credit: NAACC)

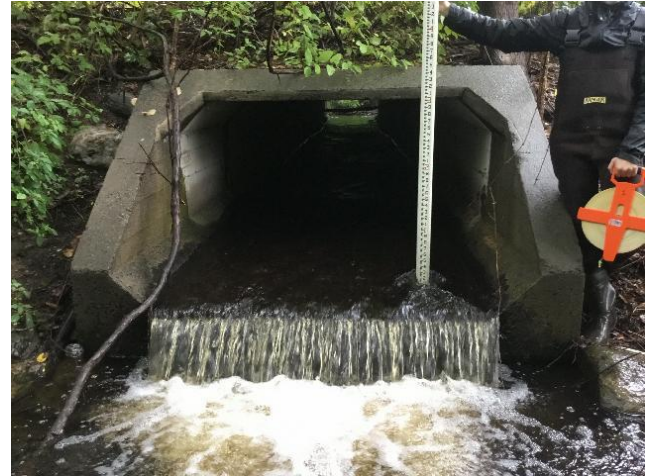
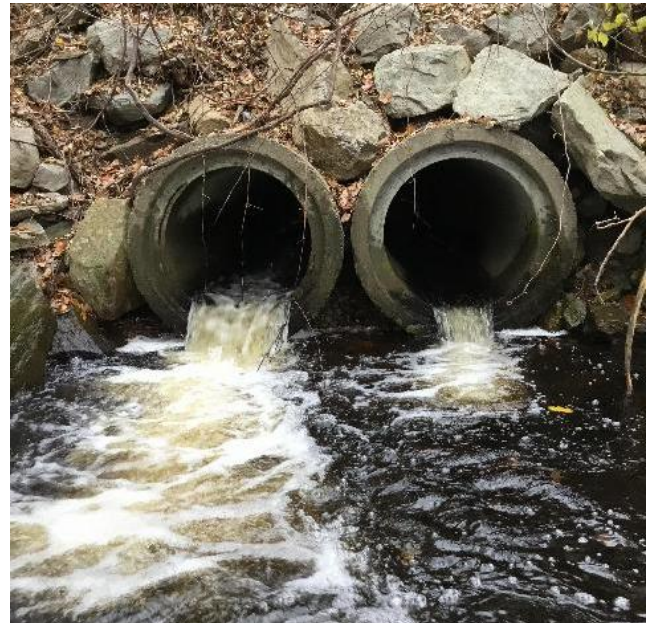
Figure 3-56: Examples of culverts with a free fall at the outlet.
(Image credit: NAACC)

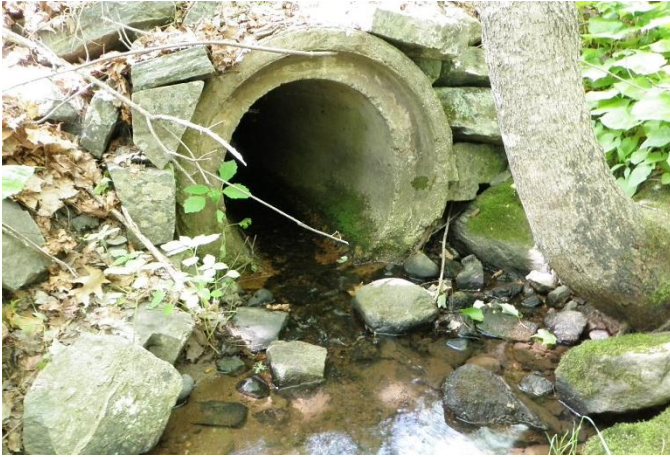
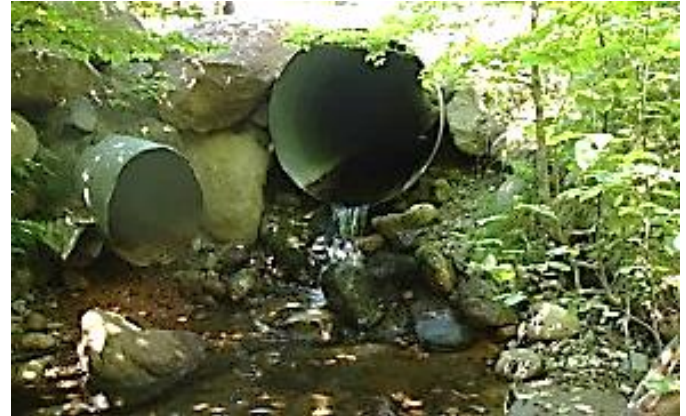
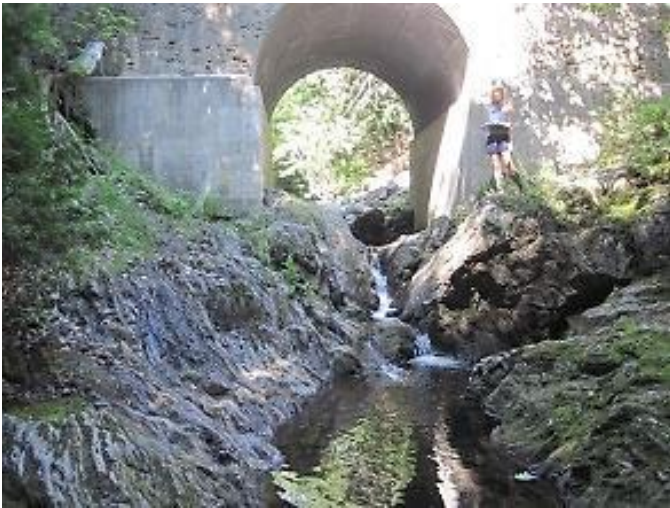
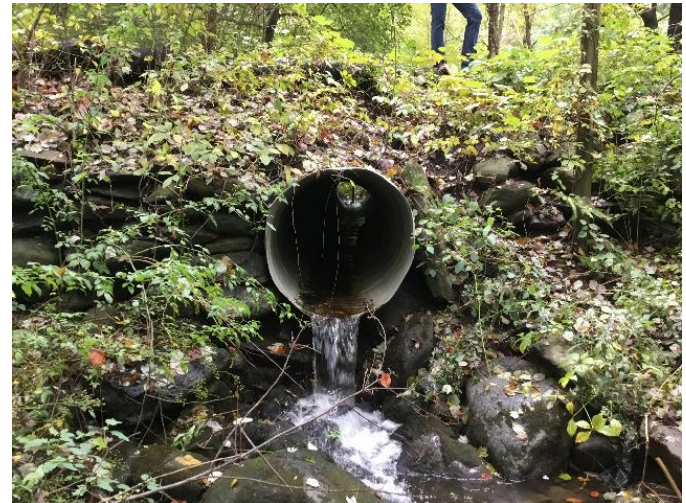
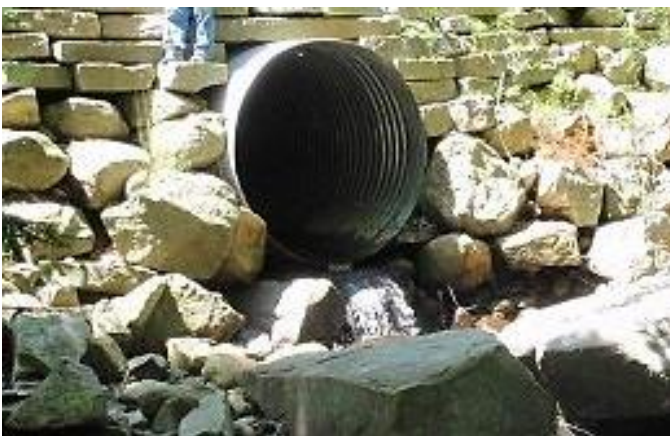
Figure 3-57: Examples of culverts with cascades at the outlet.
(Image credit: NAACC)

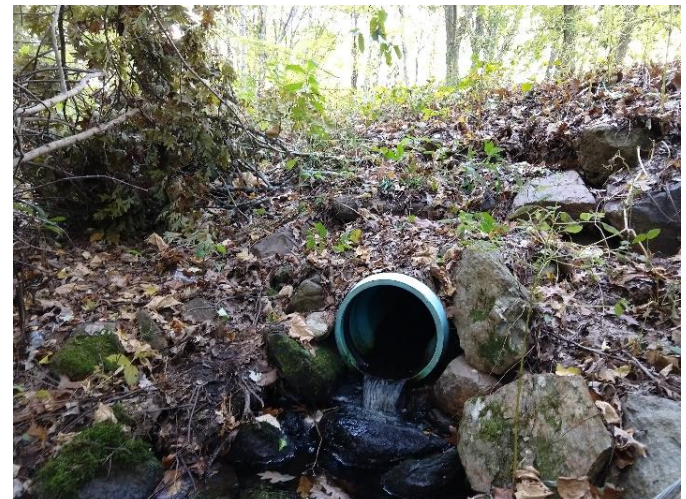
Figure 3-58: Examples of culverts with free falls onto cascades at the outlet. (Image credit: NAACC)

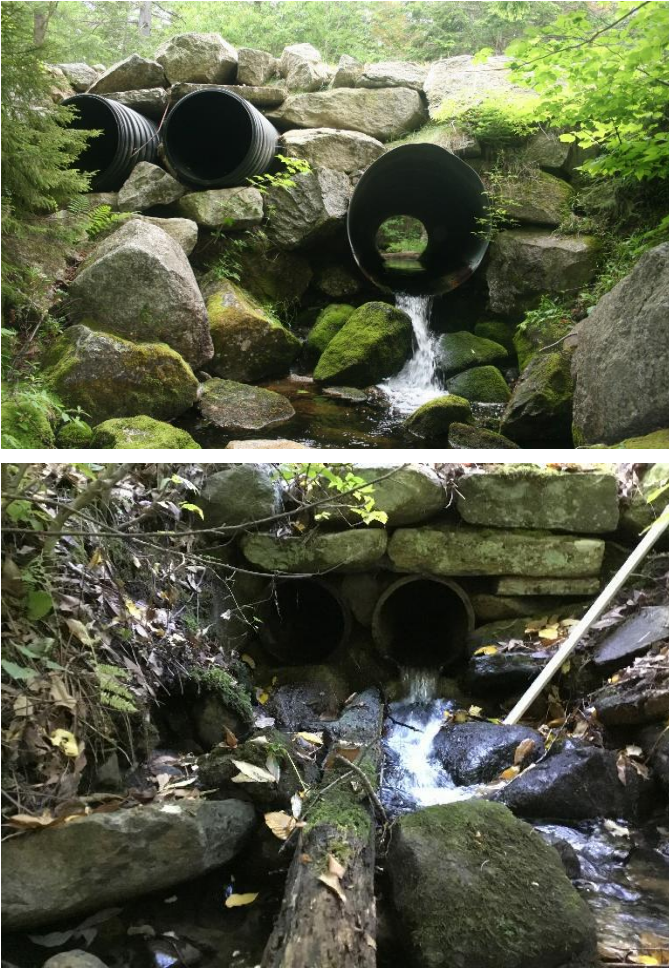
Figure 3-59: Examples of culverts with a free fall onto cascades at the outlet. (Image credit: U.S. Fish and Wildlife Service, NAACC)

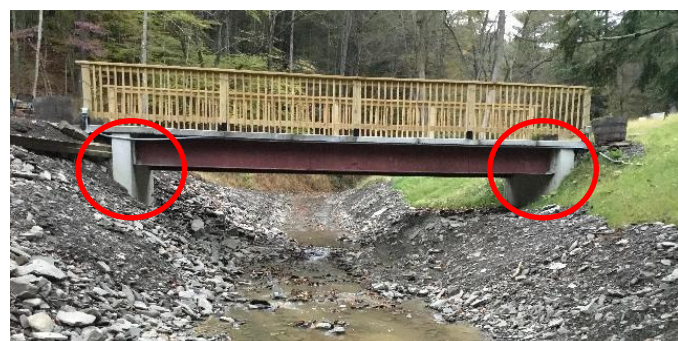
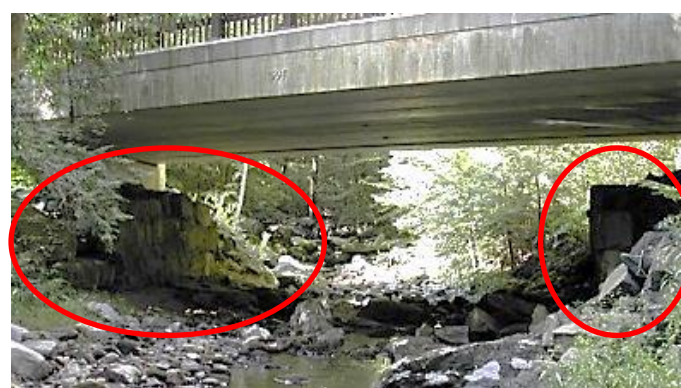
Figure 3-62: Examples of bridges with side slopes and abutments. The red circles indicate the abutments. (Image credit: NAACC)

Abutment Height: Dimension E: This measurement is only taken when for a *Bridge with Side Slopes and Abutments (Shape 7)*. To the nearest foot, measure the height of the vertical abutments from the top of the side slopes up to the bottom of the bridge deck structure.
