Rhode Island Department of Transportation **Road-Stream Crossing Assessment Handbook**

August 2019

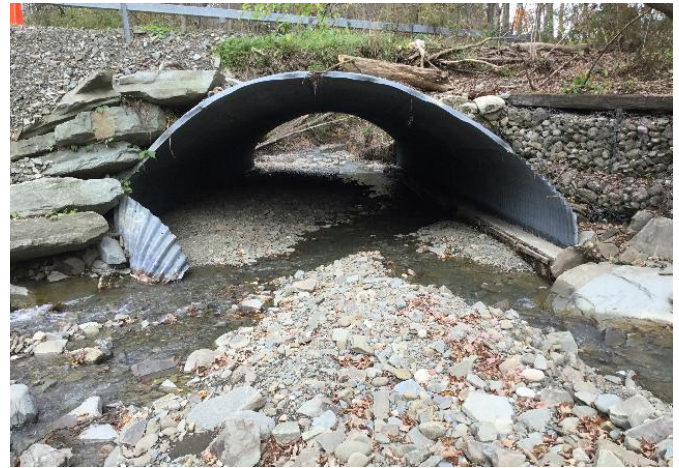
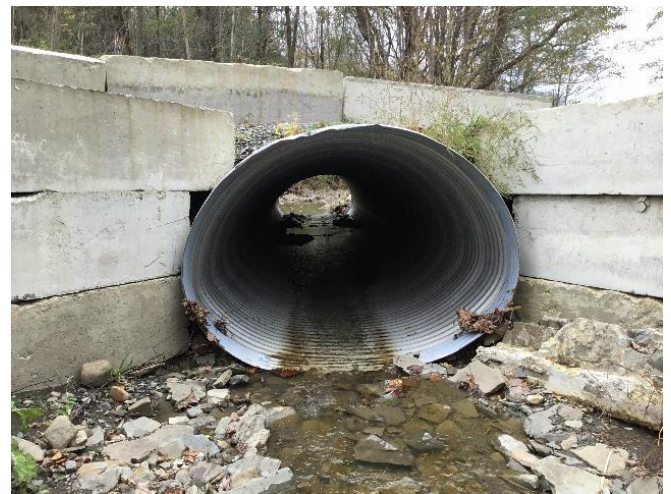
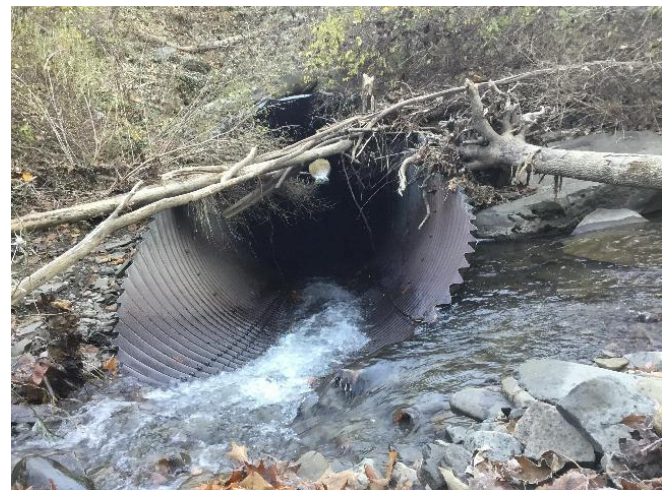
Figure 3-64: Examples of crossings with projecting inlets.

Inlet Type: Choose only one option for the style of a culvert inlet, which affects how water flows into the crossing, particularly at higher flows. The drawings in *Figure 3-63* are meant as general guides, but refer to *Figure 3-64* through *Figure 3-74* for more specific images of each type.

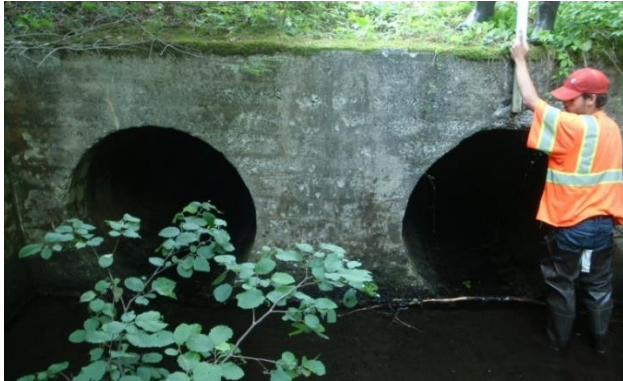
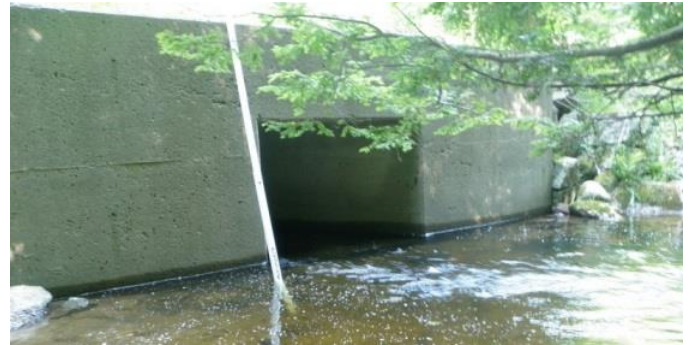
Figure 3-66: Example of a crossing with headwall with square edges. (Image credit: NAACC)

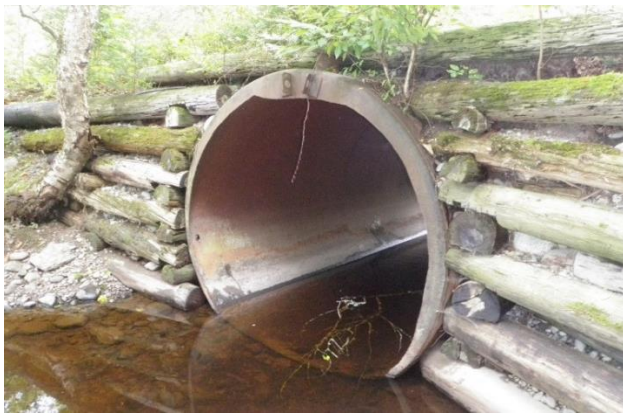
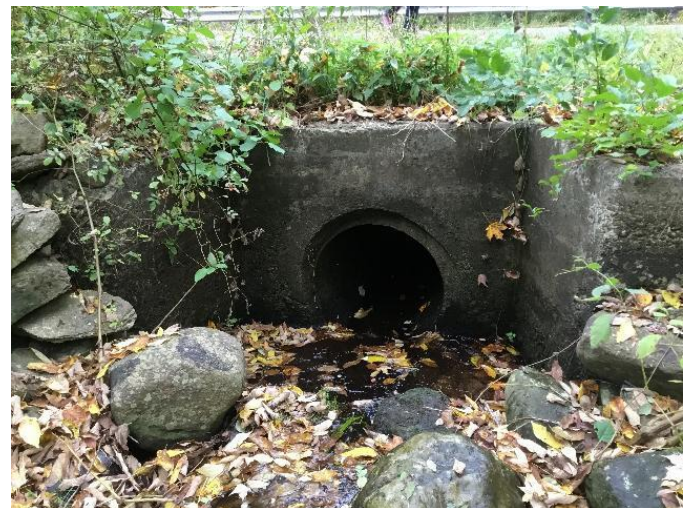
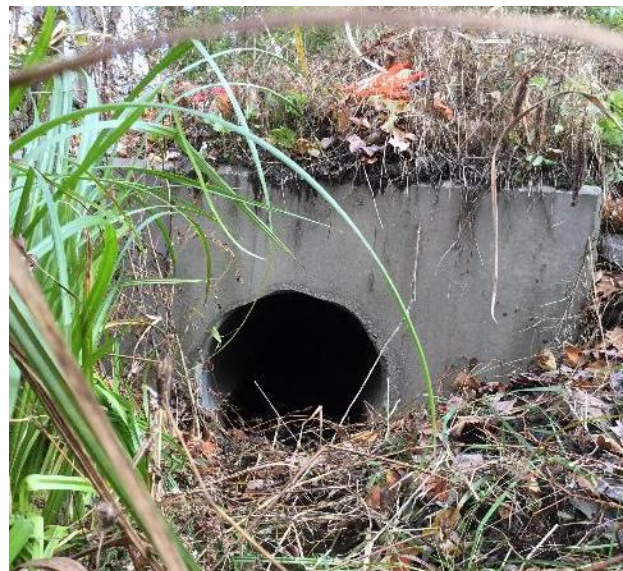
Figure 3-65: Examples of crossings with headwalls with square edges. (Image credit: NAACC)

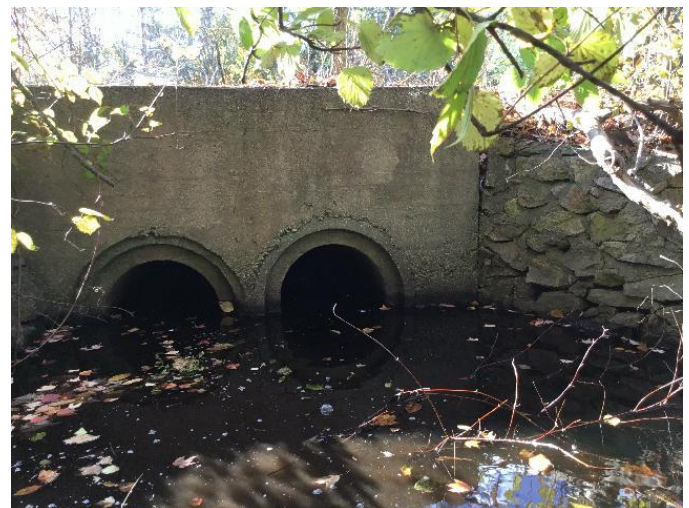
Figure 3-67: Example of crossings with headwalls with a chamfered or beveled edge.

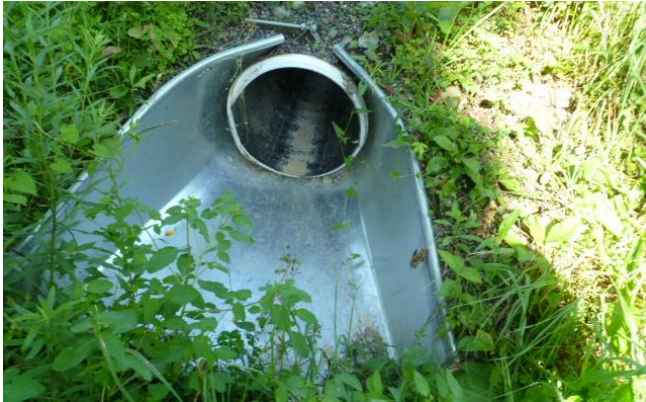
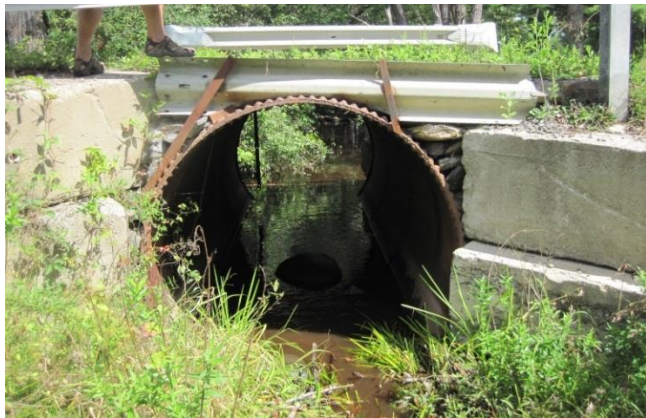
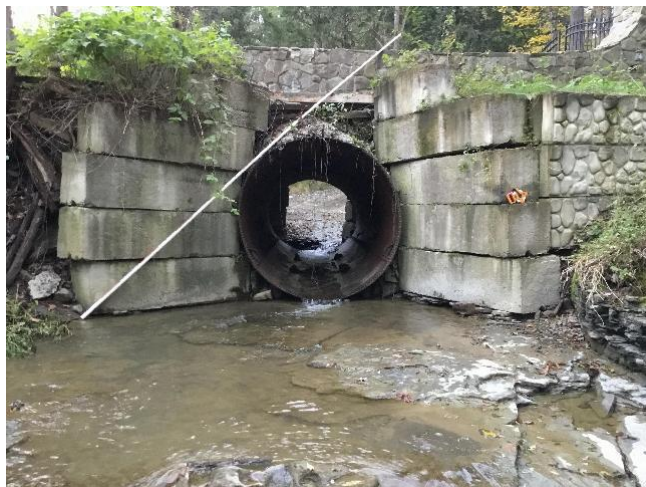
Figure 3-68: Examples of crossings with wingwalls. (Image credit: NAACC)

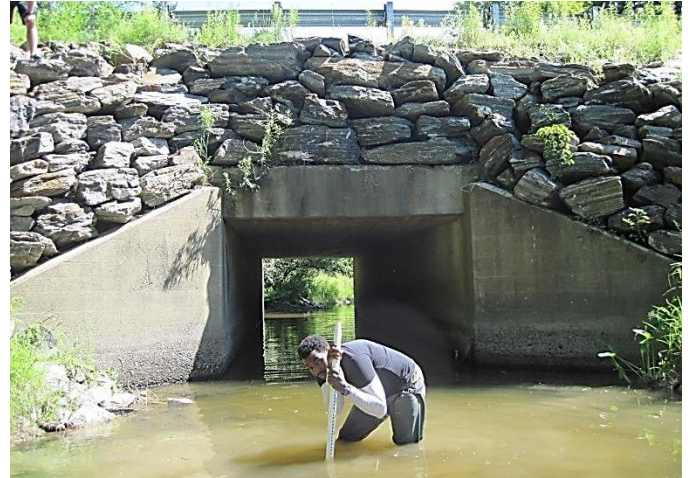
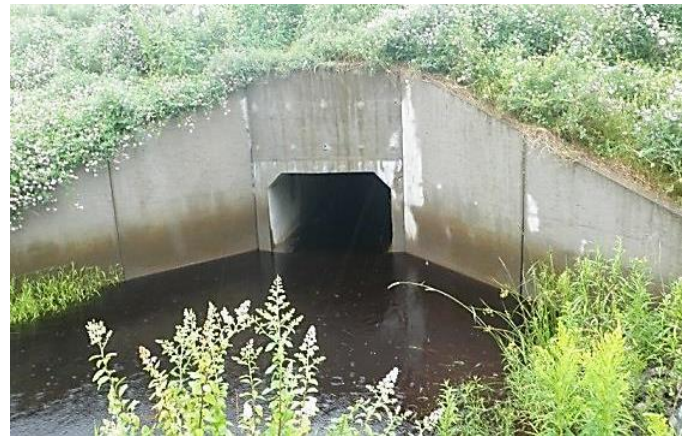
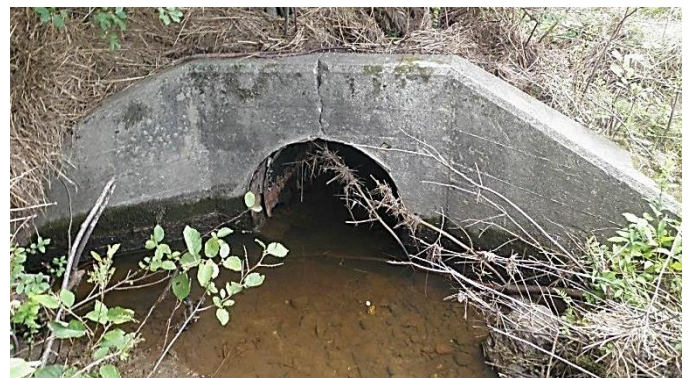
Figure 3-69: Examples of crossings with wingwalls and headwalls with square edges. (Image credit: NAACC)

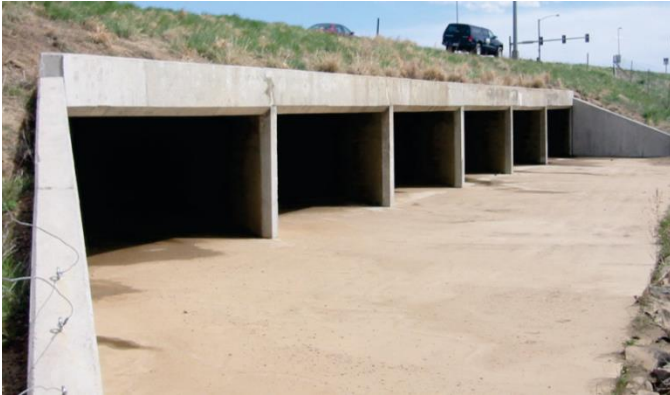
Figure 3-70: Example of a headwall with beveled or chamfered edge and wingwalls (Image credit: Schall et al., 2012).

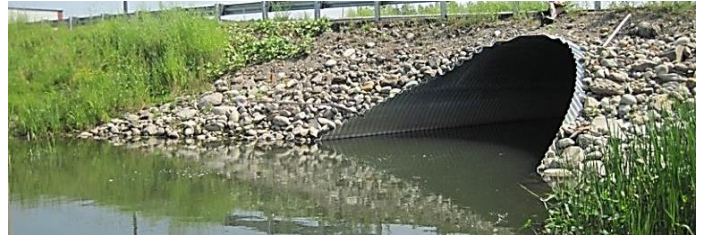
Figure 3-72: Example of a crossing with inlet that is mitered to the slope. (Image credit: NAACC)

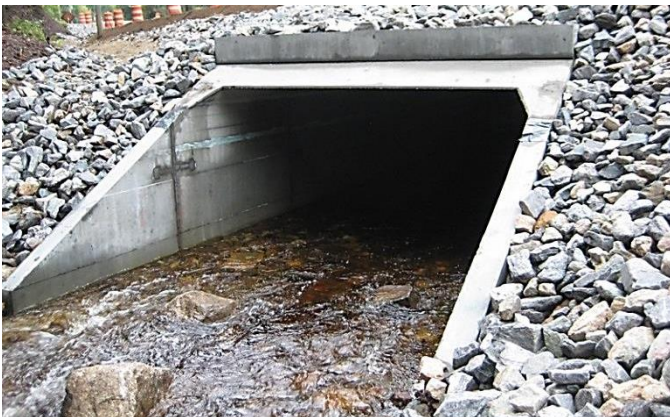
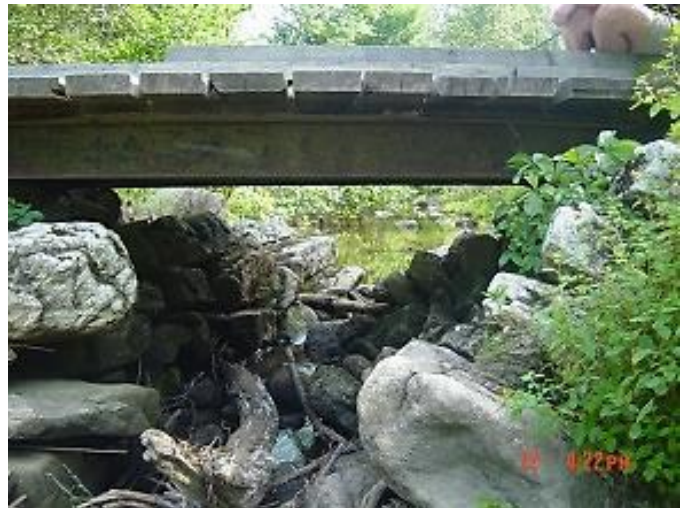
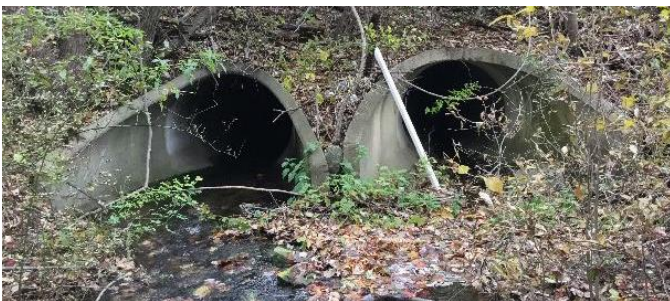
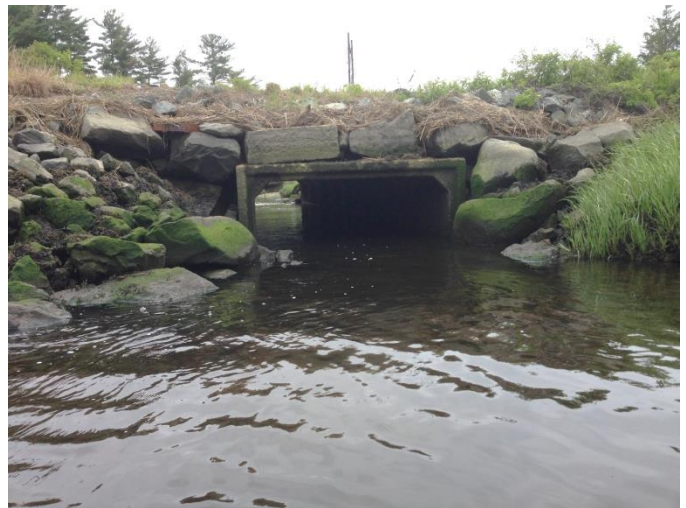
Figure 3-73: Examples of bridges where none of the above characteristics occur (Image credit: Steckler Tidal Module)

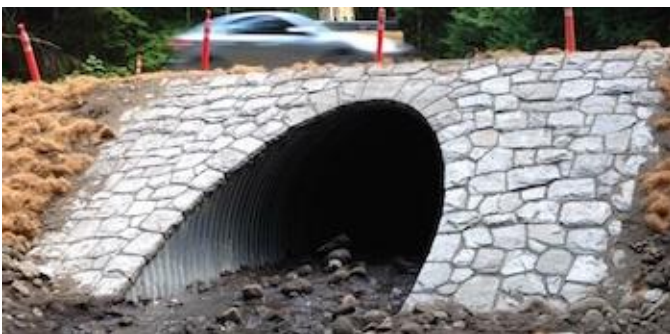
Figure 3-71: Examples of crossings with inlets that are mitered to the slope. (Image credit: NAACC, National Park Service)

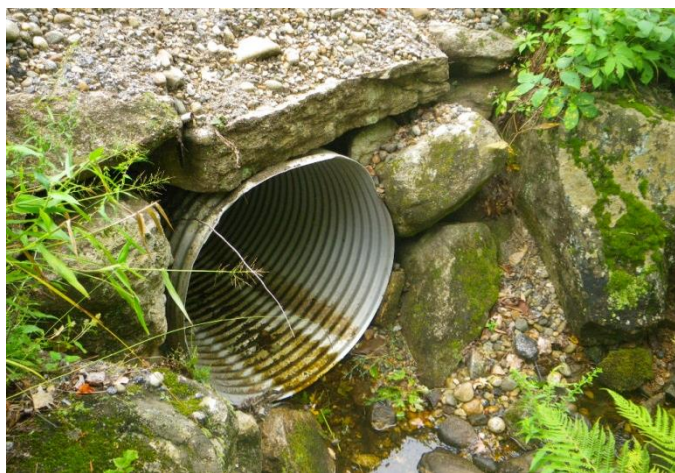
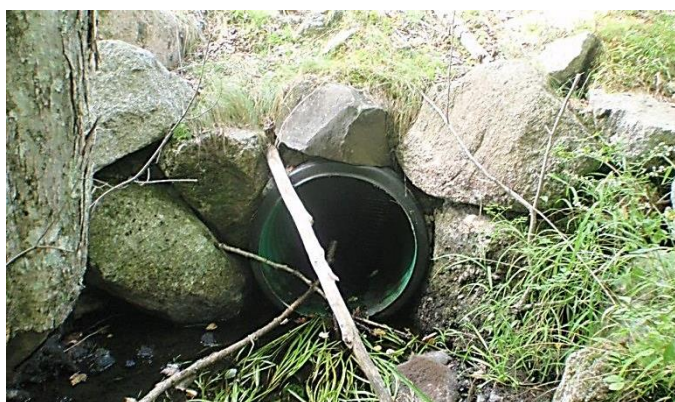
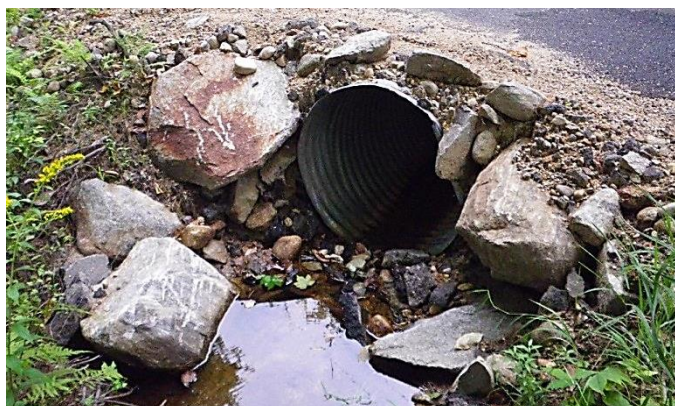
Figure 3-74: Examples of culverts where none of the above characteristics occur. (Image credit: NAACC)

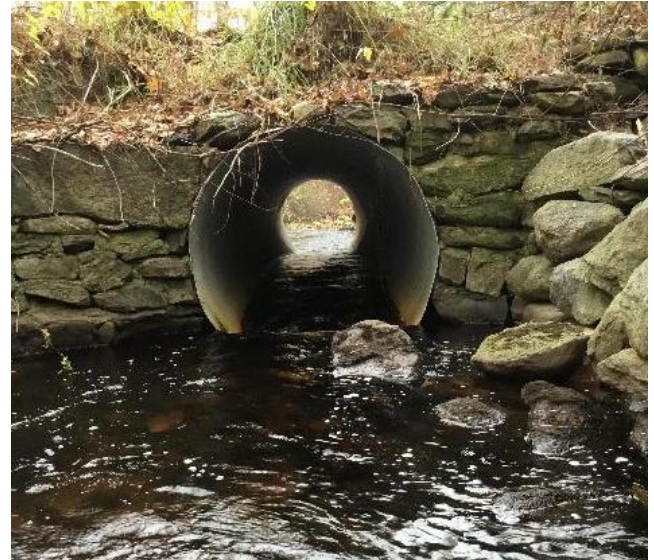
Figure 3-79: Examples of crossings with the inlet at stream grade. (Image credit: NAACC)

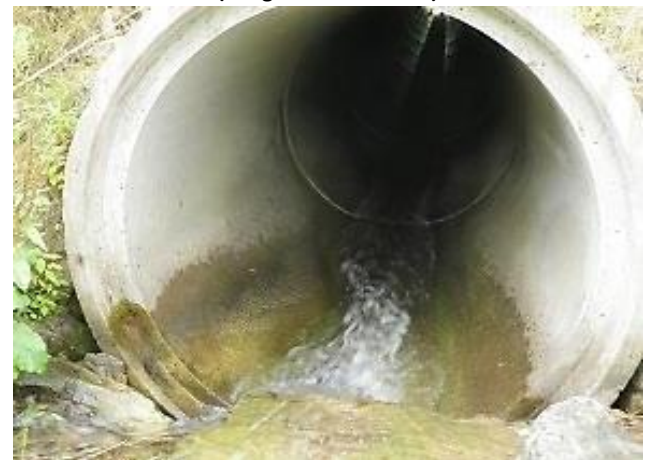
Figure 3-80: Example of a crossings with an inlet drop. (Image credit: NAACC)

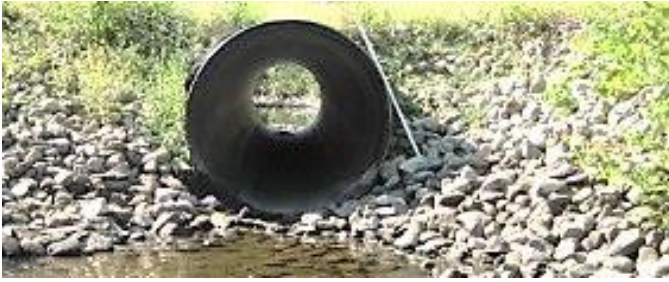
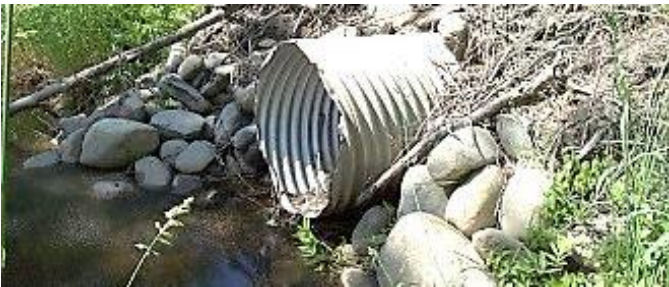
Figure 3-81: Examples of crossings with perched inlets. (Image credit: NAACC)

- **Perched:** The structure inlet is above the surface of water in the stream. Little water passes through the structure during normal low summer flows, though the stream has water upstream and downstream of the crossing. Water can enter the structure only at higher flows. This is a relatively rare condition, found mostly on very small streams. At such sites, there is generally water backed up above the inlet. In some cases water may be seeping underneath the structure and emerging below the structure outlet at the downstream end of the structure.

If you observe a perched inlet, measure the distance (in decimal feet) from the invert to the water surface in the pool or channel above the crossing.
- **Clogged/Collapsed/Submerged:** The structure inlet is either full of debris, collapsed, or completely underwater (not usually all three), making inlet measurements impossible. This may be found in places where beavers or debris have plugged a structure inlet so completely that water has backed up and covered the inlet, or

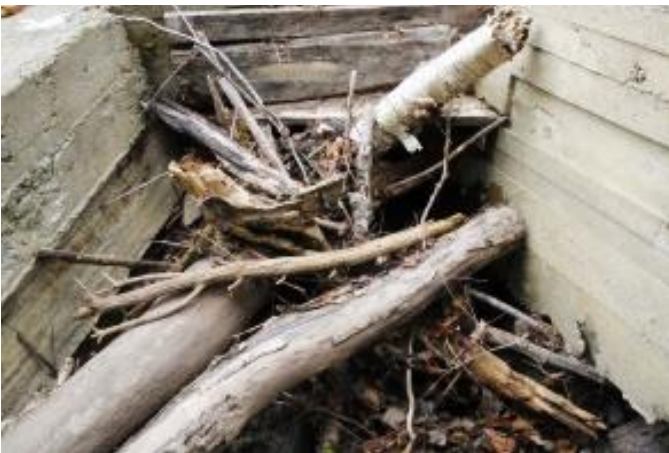
Figure 3-82: Example of a crossing with a clogged inlet. (Image credit: NAACC)

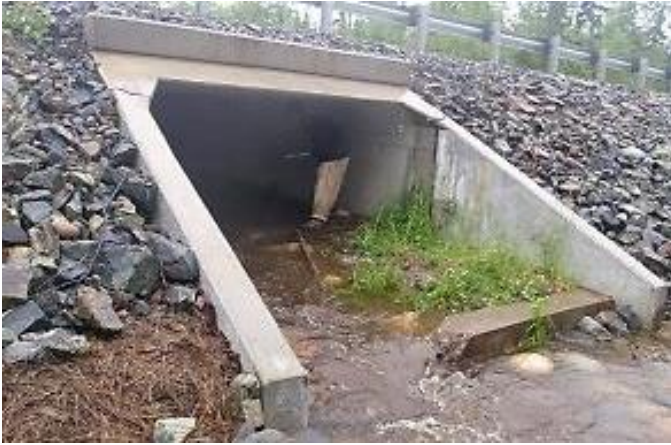
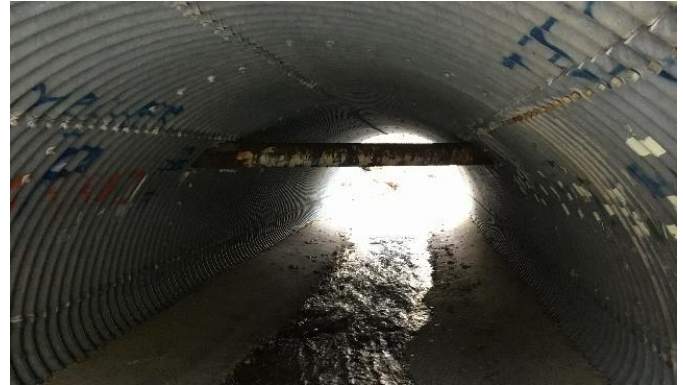
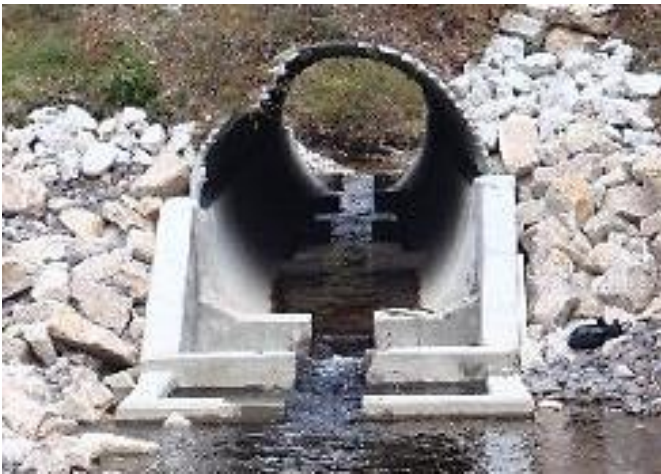
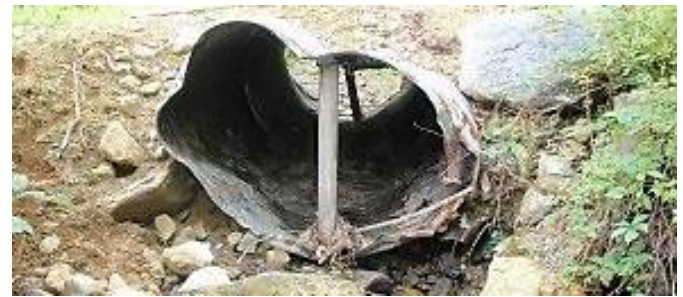
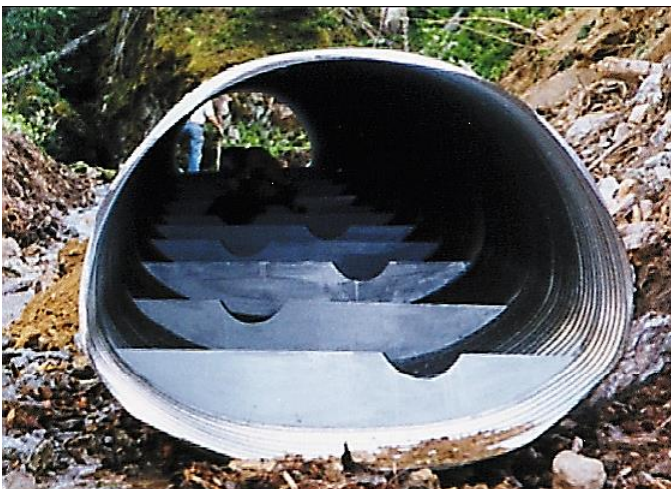
Figure 3-83: Examples of crossings with baffles and weirs. (Image credit: NAACC)

Figure 3-83 and Figure 3-84 are examples of internal structures. Choose any option(s) that apply.

- **None:** There are no apparent structures inside the crossing structure.
- **Baffles/Weirs:** Baffles (partial width) or weirs (full width, notched or not) are incorporated into the structure, either inside or at its outlet, to help aquatic organisms move through the structure.
- **Supports:** Some type of structural supports, such as bridge piers, vertical or horizontal beams, or rods apparently meant to support the structure, are observed inside the crossing structure.
- **Other:** Structure(s) other than the categories above are present inside the crossing structure. Provide a very brief description of those structures here, or more fully describe them under *Structure Comments*. **Do not** include here items such as bedrock, material blockages, structural deformation, or inlet fencing to exclude beavers, which will be recorded below as *Physical Barriers*.

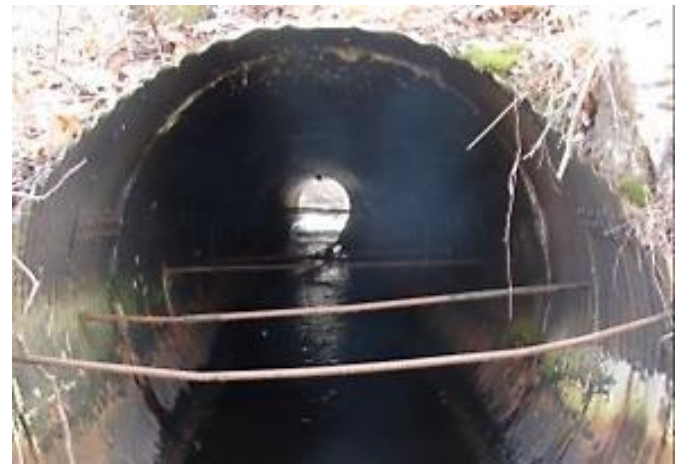
Figure 3-84: Examples of supports inside of road stream crossings. (Image credit: NAACC)

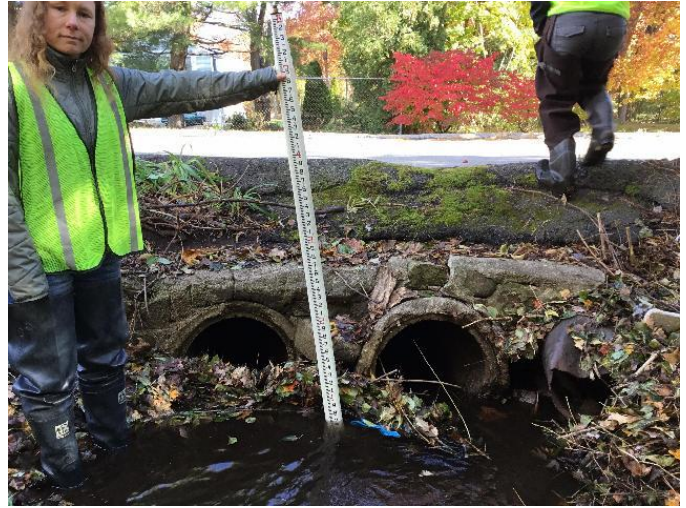
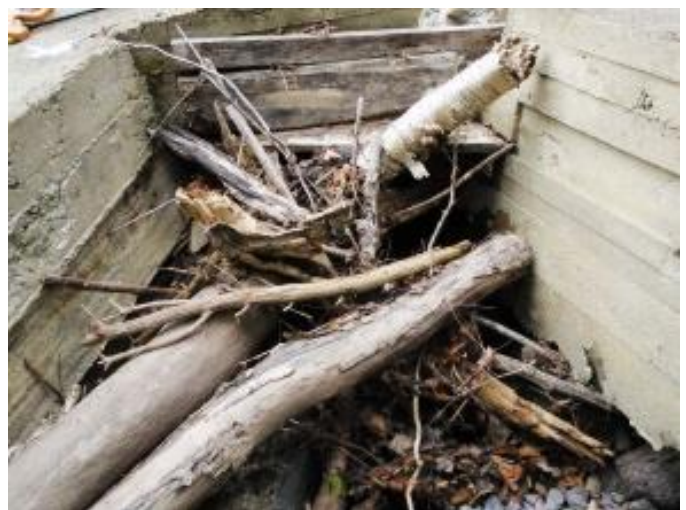
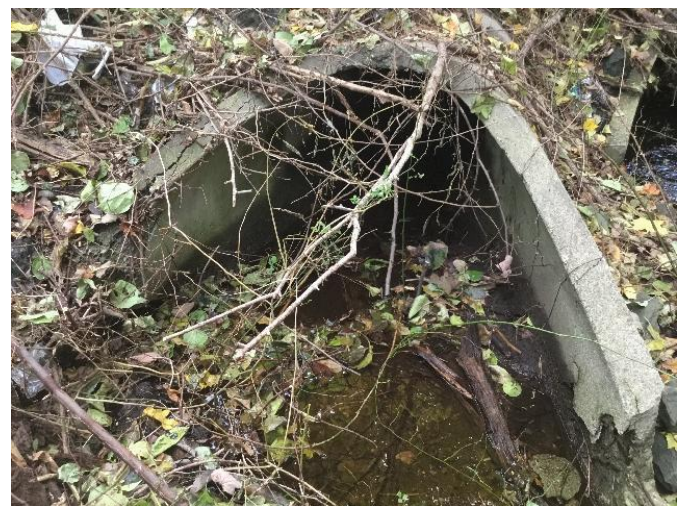
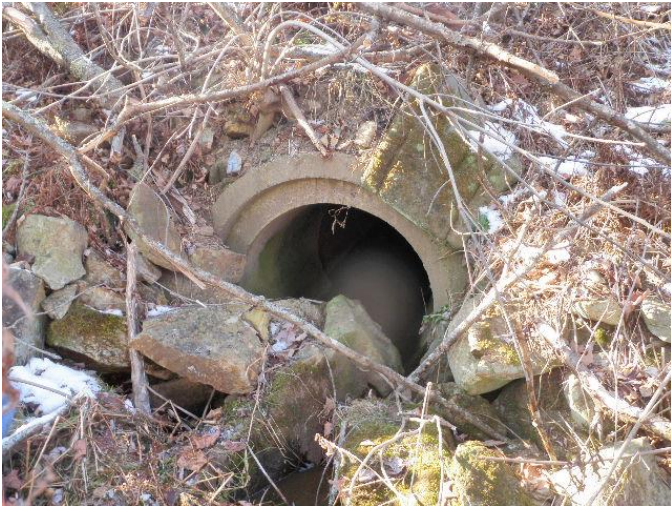
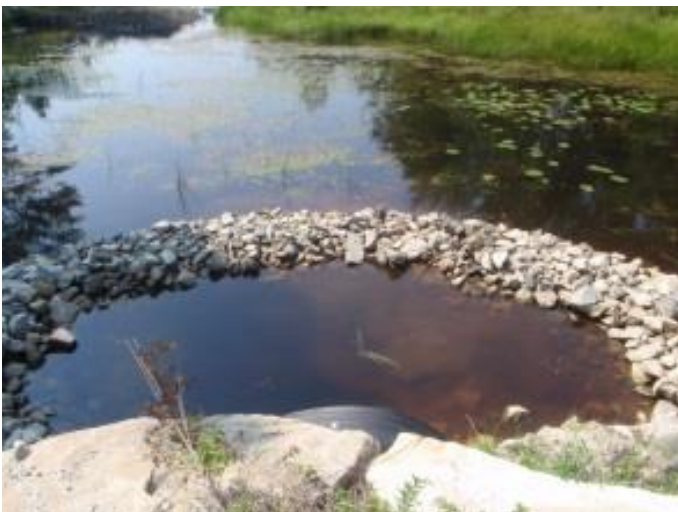
Figure 3-85: Stone acting as a physical barrier. (Image credit: NAACC)

Figure 3-86: Debris acting as physical barriers. (Image credit: NAACC)

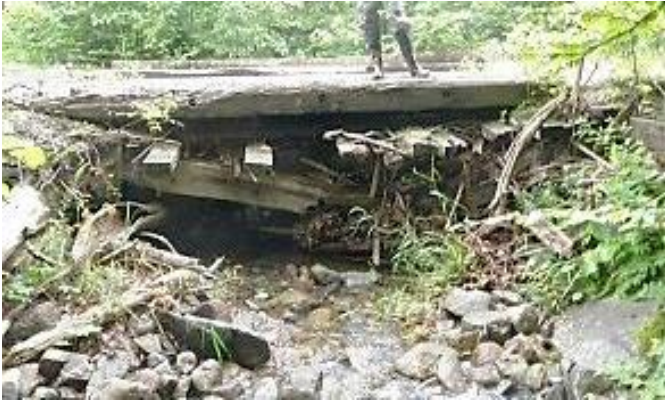
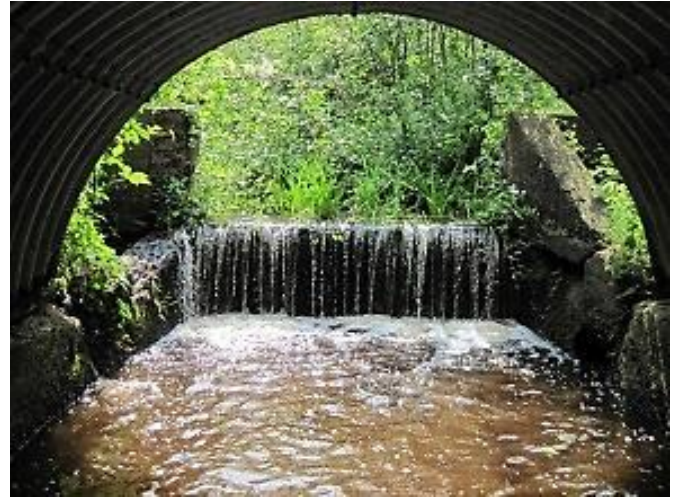
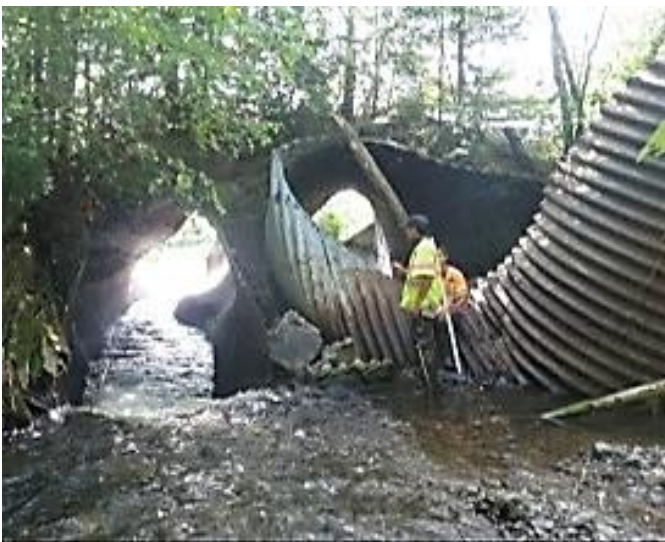
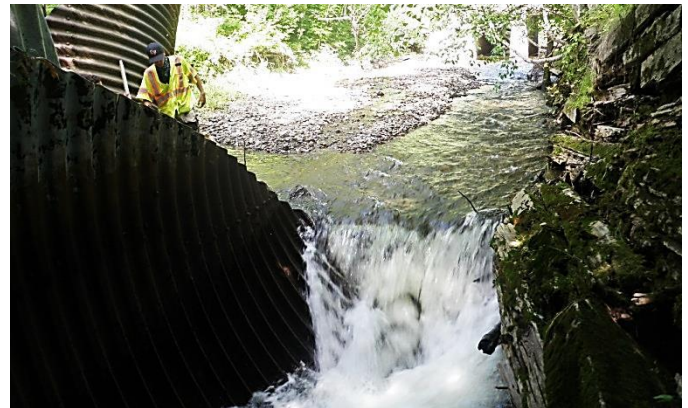
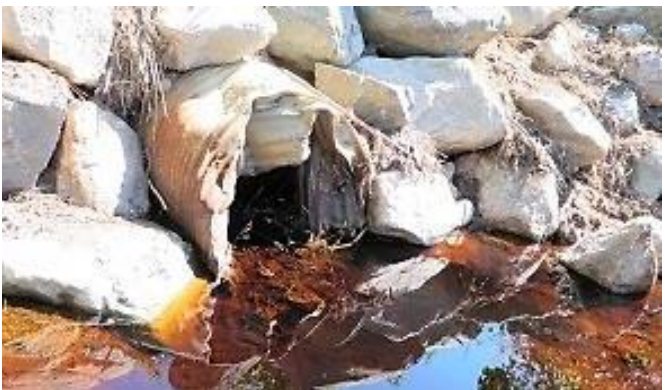
Figure 3-87: Deformation acting as physical barriers. (Image credit: NAACC)

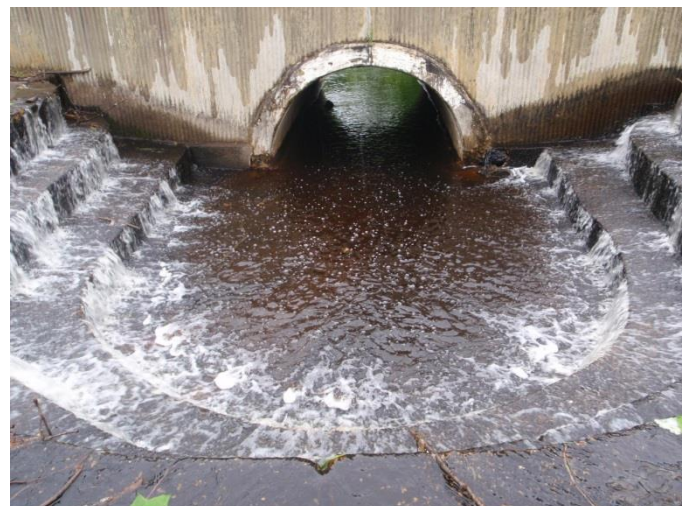
Figure 3-88: Free falls acting as physical barriers. (Image credit: NAACC)

- **Free Fall:** In addition to its *Outlet Grade*, which may include a *Free Fall*, the structure has one or more **additional** vertical drops associated with it. These may include a dam at the inlet, a vertical drop over bedrock inside the structure, or some other feature likely to inhibit passage of aquatic organisms. Note that a *Free Fall* inside a structure is often more limiting than similar size drops found in an undisturbed natural reach of the same stream which occurs where there may be multiple paths for organisms to follow. A *Free Fall* can exist because of a debris blockage; in this case **both** physical barriers would be recorded.

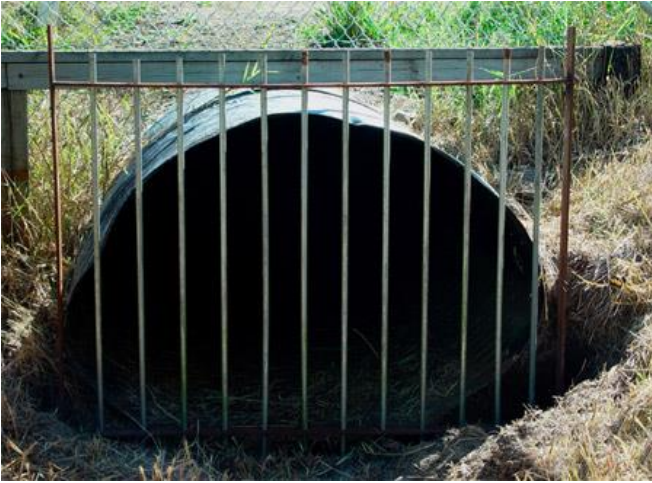
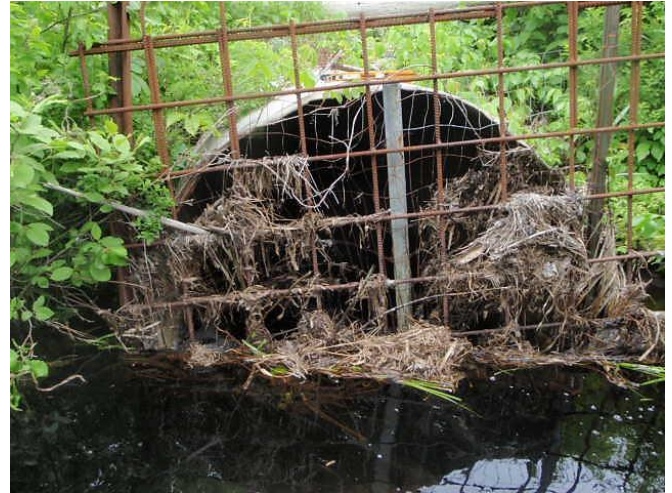
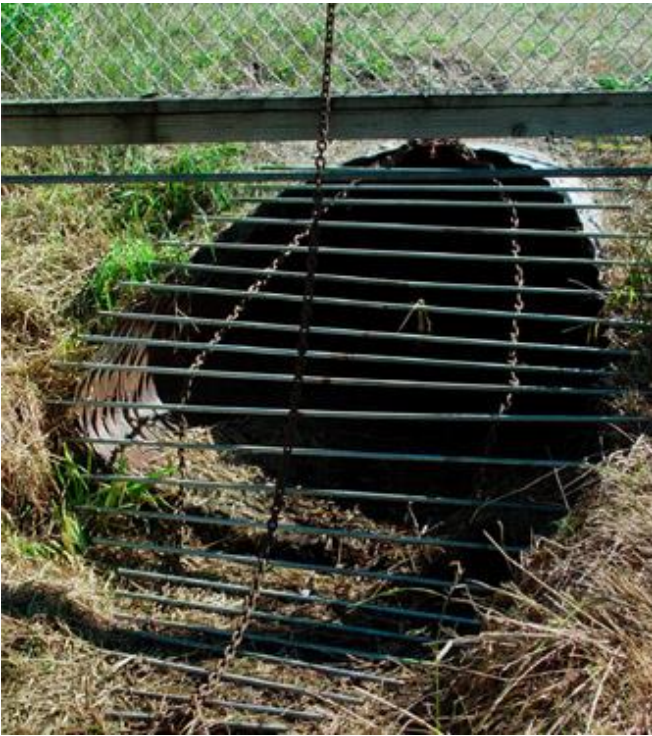
Figure 3-89: Fencing acting as physical barriers. (Image credit: USDA)

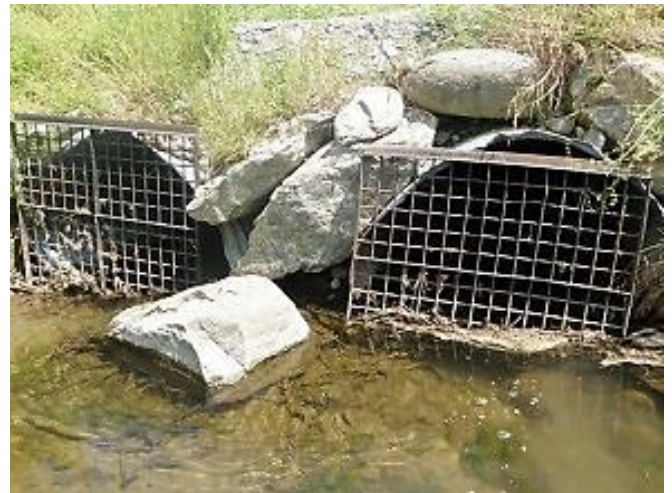
Figure 3-90: Fencing acting as physical barriers. (Image credit: NAACC)

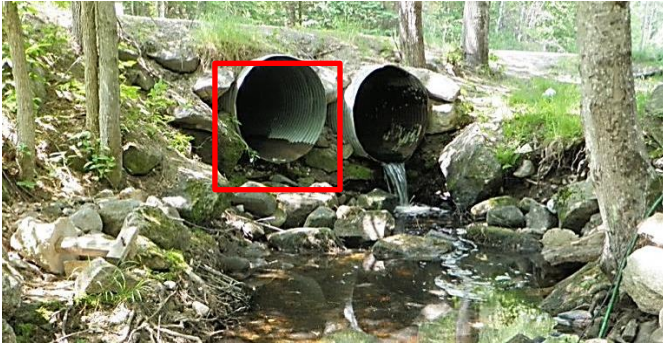
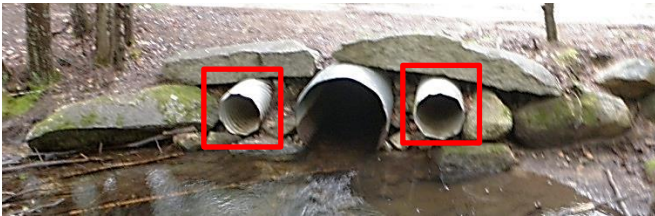
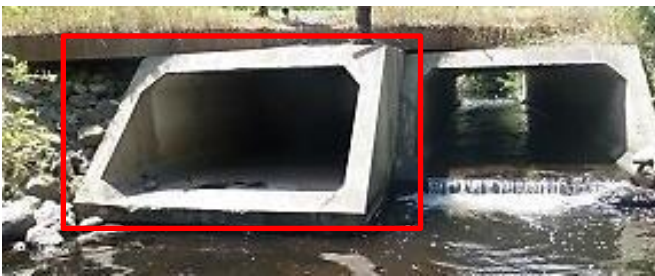
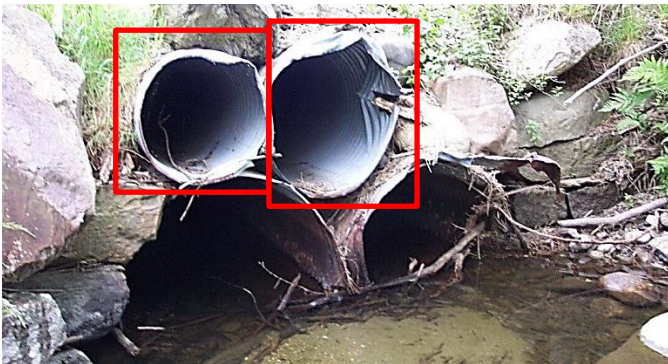
Figure 3-91: Dry culverts (indicated by the red boxes) acting as physical barriers. (Image credit: NAACC)

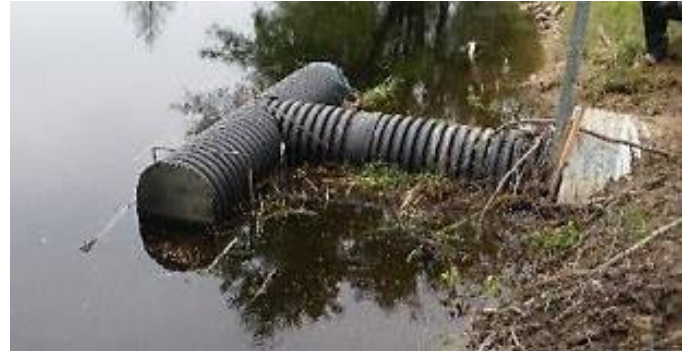
Figure 3-92: An anti-beaver attached to a crossing inlet acting as a physical barrier at a crossing. This physical barrier would be classified as "Other." (Image credit: NAACC)

physical barriers to aquatic organism passage. Examples include tide gates and beaver exclusion devices. Use this option to capture such situations, and add relevant information in *Structure Comments*. Figure 3-92 and Figure 3-93 are examples of some unusual physical barriers which may not fit under Physical Barrier categories listed above.

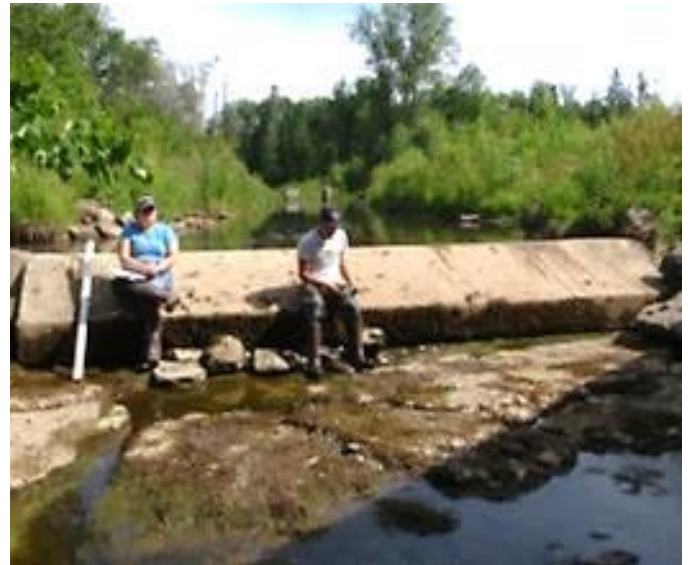
Figure 3-93: A dam with no free fall acting as a physical barrier at a crossing. This physical barrier would be classified as "Other." (Image credit: NAACC)

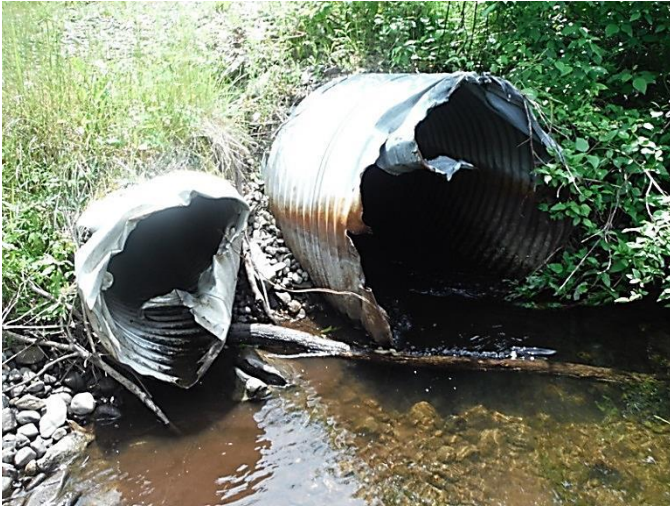
Figure 3-94: An example of a structure with multiple barriers. The culvert on the left is deformed and dry. (Image credit: NAACC)

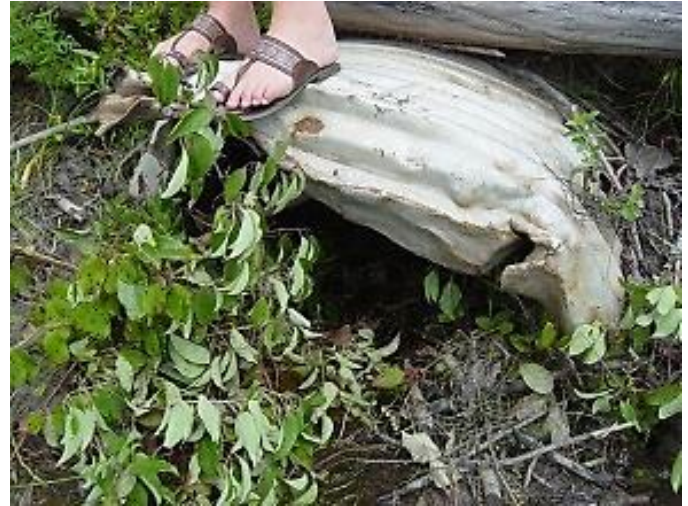
Figure 3-96: An example of a crossing structure with multiple barriers. The culvert is deformed and blocked by debris. (Image credit: NAACC)

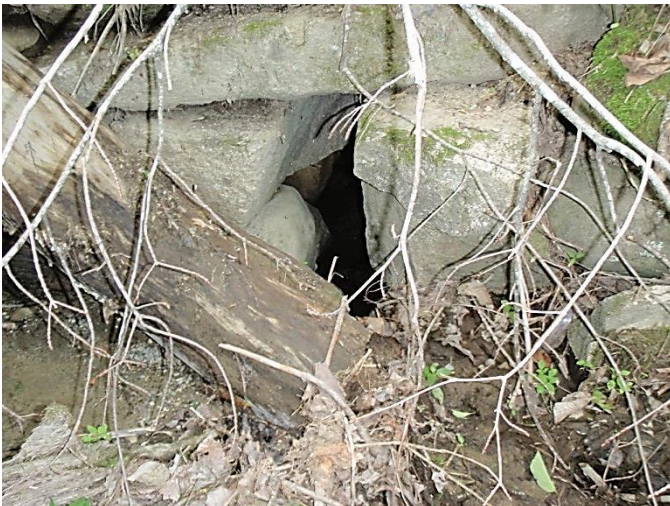
Figure 3-95: An example of a crossing structure with multiple barriers. The culvert is deformed by displaced stones, blocked by debris, and dry. (Image credit: NAACC)

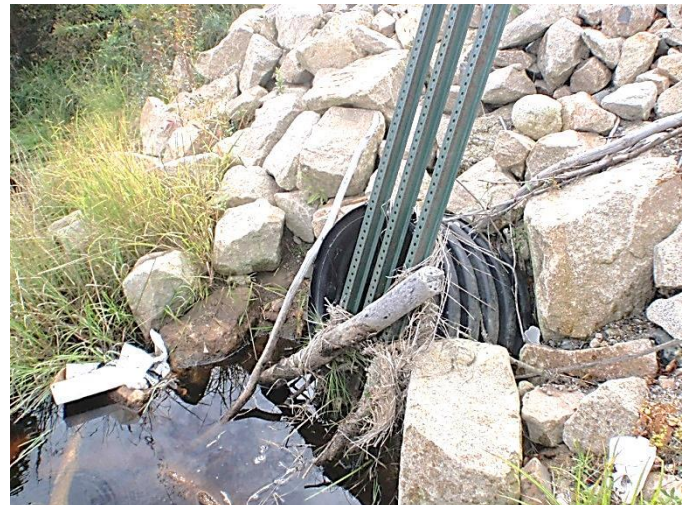
Figure 3-97: An example of a structure with multiple barriers. The culvert on the left is deformed (bent upward) and blocked by debris. (Image credit: NAACC)

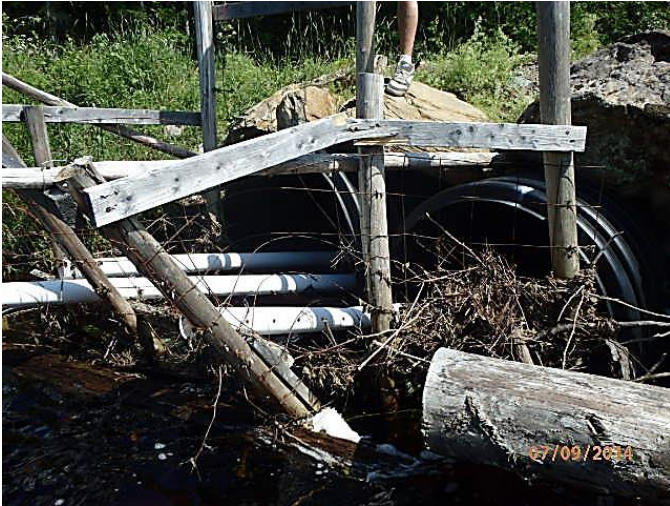
Figure 3-98: An example of a crossing structure with multiple barriers: the culvert is blocked by debris and fencing. (Image credit: NAACC)

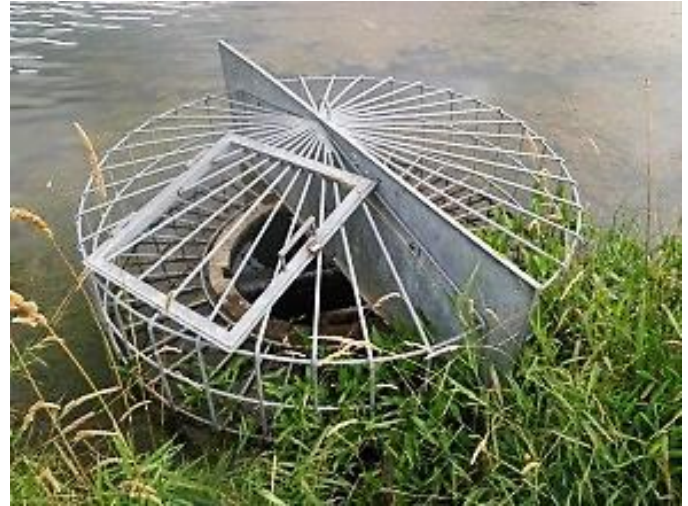
Figure 3-100: An example of multiple barriers, including fencing and a vertical drop. (Image credit: NAACC)

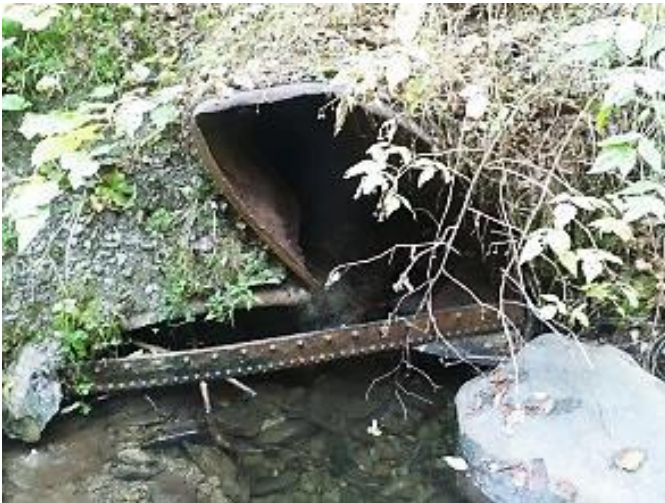
Figure 3-99: An example of a crossing structure with multiple barriers: the culvert is deformed, blocked by debris, and dry. (Image credit: NAACC)

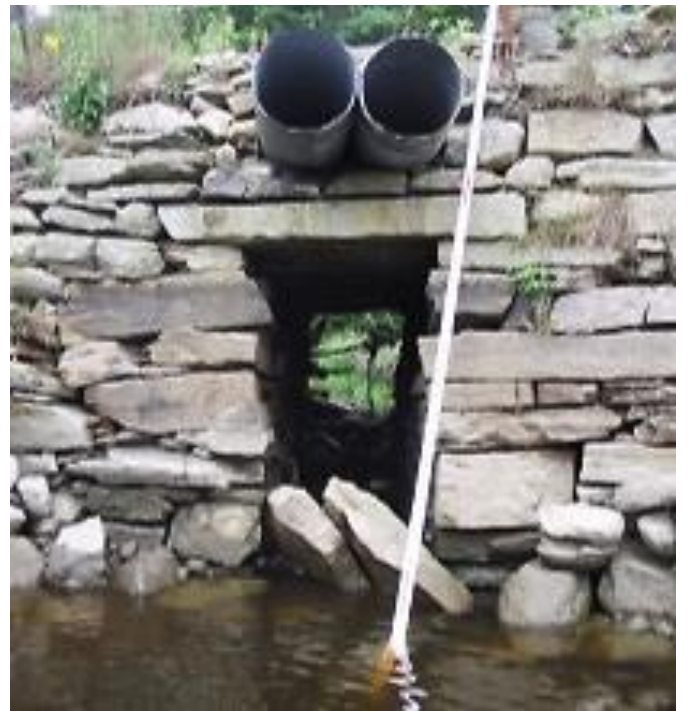
Figure 3-101: An example of multiple structures at a crossing, each with a physical barrier. The lower, rectangular stone culvert is blocked by fallen stones. The two metal culverts above are dry. (Image credit: NAACC)

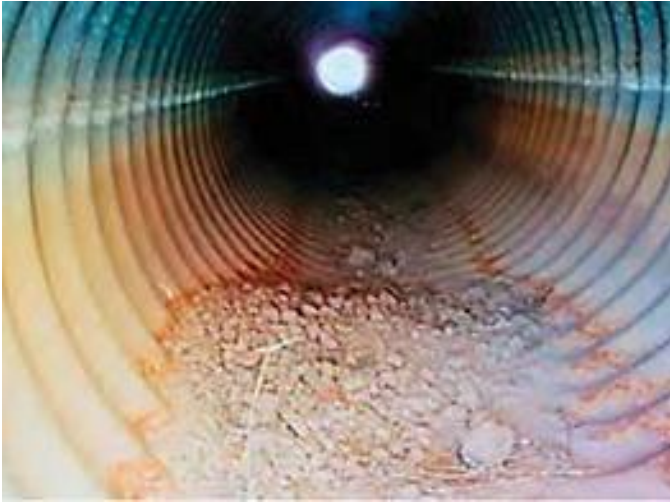
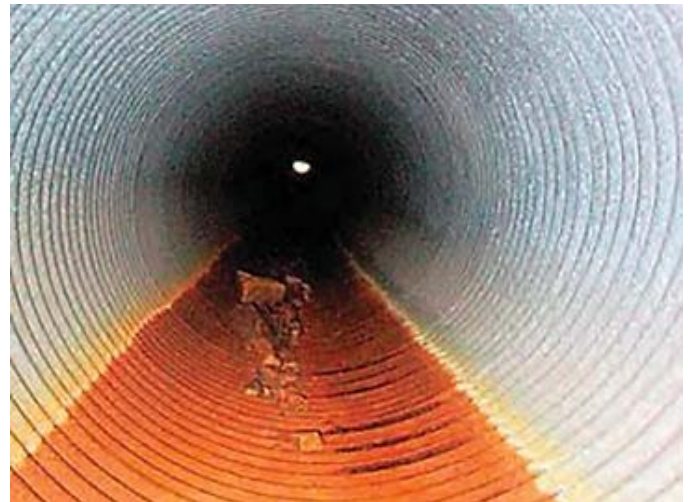
Adequate: Minor corrosion and pitting occurring. No holes or distortion. Cannot penetrate metal with sharp point of chipping hammer (metal). Minor isolated spalls (concrete). (Image credit: NAACC)

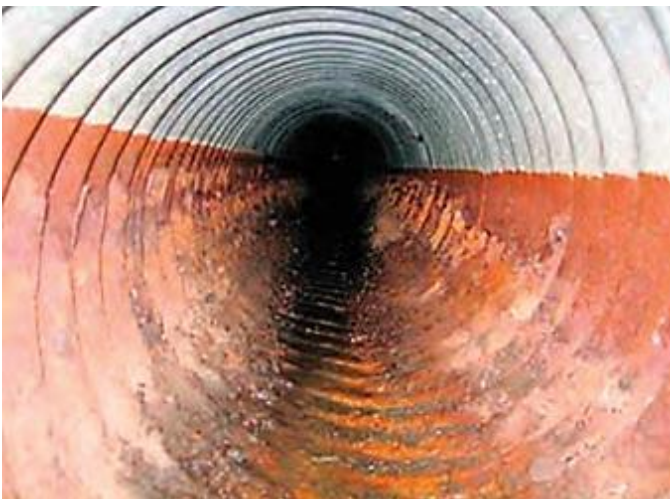
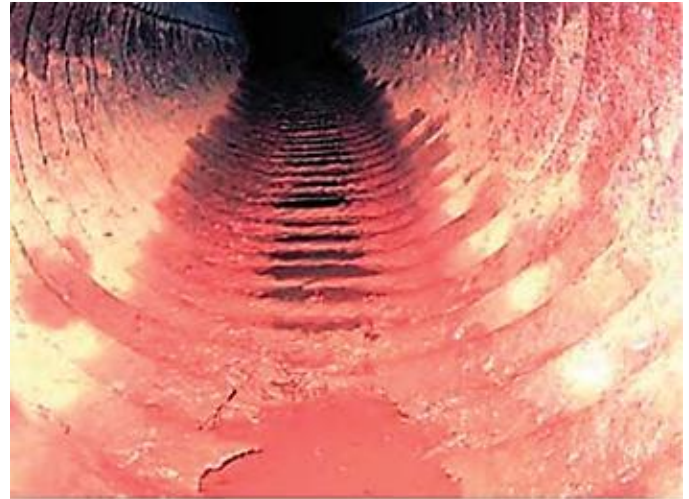
Poor: Perforations visible and/or connection hardware is failing (metal). Heavy abrasion and scaling with exposed steel reinforcement (concrete). Heavy abrasion or scour damage (plastic). Displaced mortar and/or blocks, holes in invert area (masonry). (Image credit: NAACC)
