Rhode Island Department of Transportation **Road-Stream Crossing Assessment Handbook**

August 2019

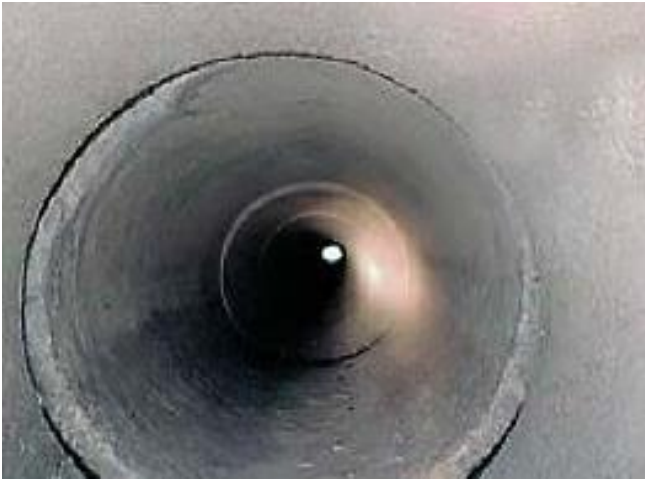
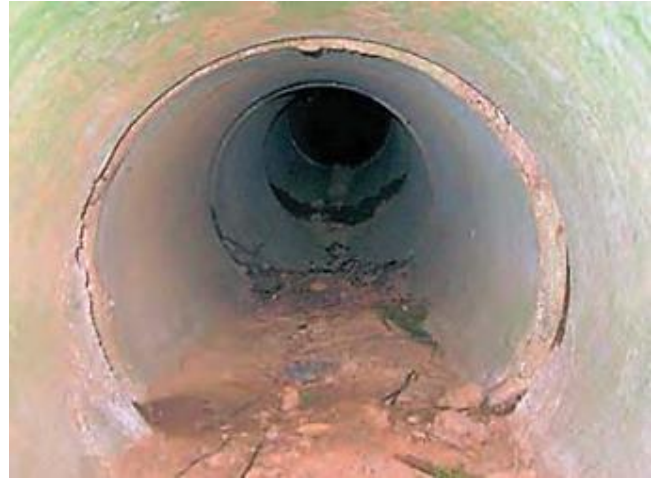
Adequate: Minor separation of joints and seams up to 1". Minor backfill infiltration. (Image credit: NAACC)

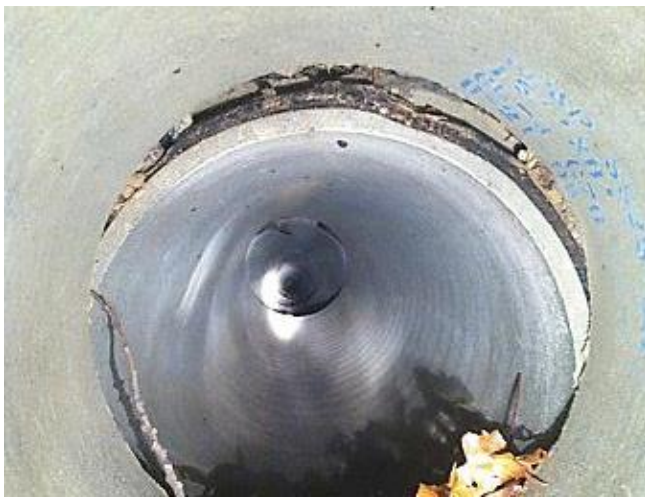
Poor: Significant separation of joints and seams between 1" to 3". Infiltration of backfill into culverts. Voids visible in fill through offset joints. Missing mortar or displace blocks (masonry). (Image credit: NAACC)

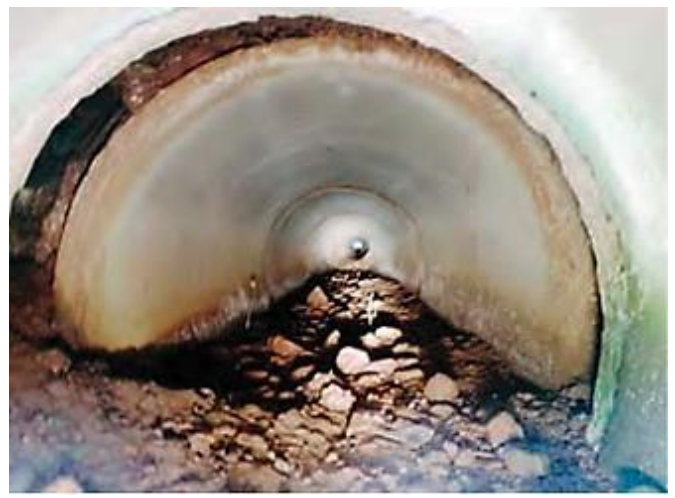
Critical: Severe separation of joints and seams greater than 3". Significant infiltration of soil backfill into culvert and accompanying embankment or roadway damage. Large voids in fill visible through offset joints. (Image credit: NAACC)

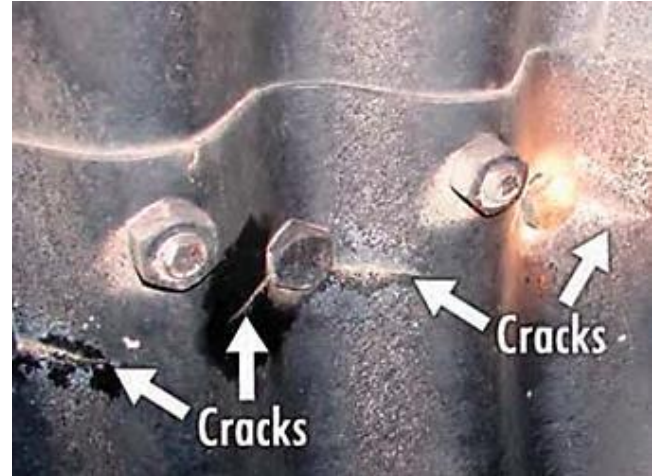
Adequate: Minor cracking around bolt holes or seams at isolated sections. (Image credit: NAACC)

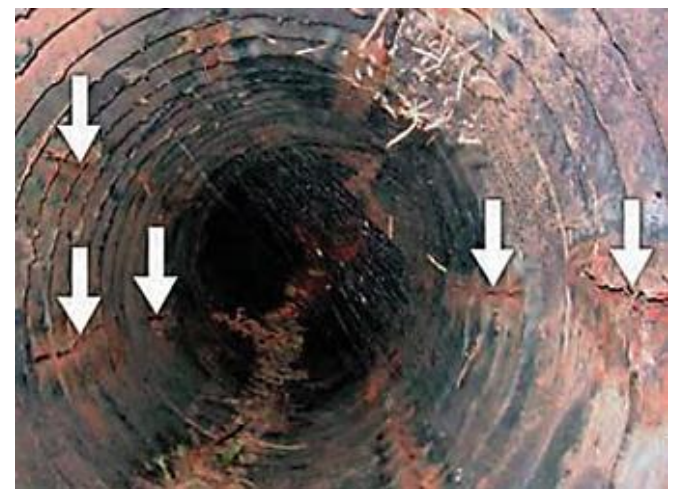
Poor: Significant cracking and/or deterioration along bolt holes and isolated seams of plates. (Image credit: NAACC)

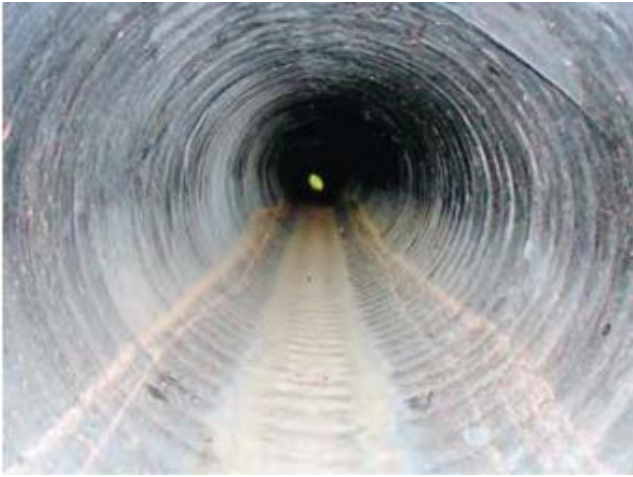
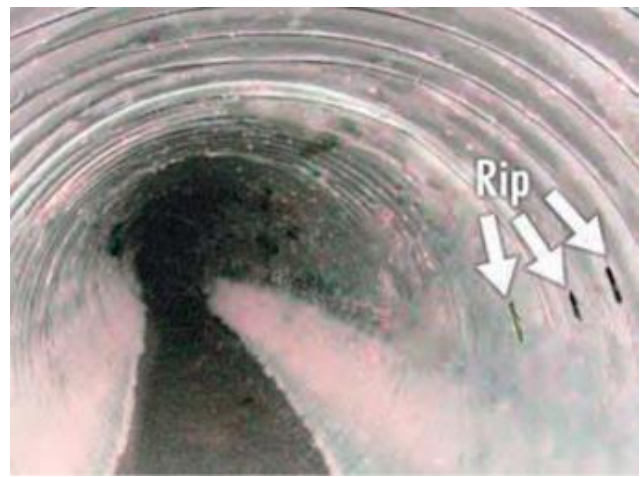
Adequate: Minor isolated rip or tear caused by debris less than 6" in length and $\frac{1}{2}$ " in width. Minor cuts or gouges to end sections from maintenance or construction activities. (Image credit: NAACC)

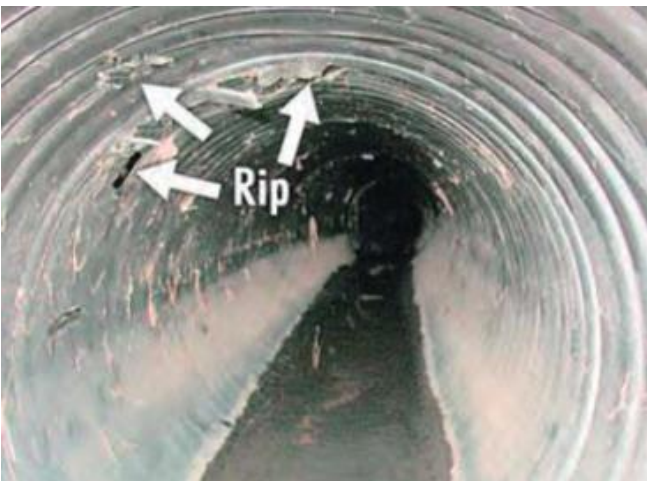
Poor: Cracking, splits or tears over 6" in length and up to $\frac{3}{4}$ " in width. Openings in pipe causing loss of backfill material. (Image credit: NAACC)

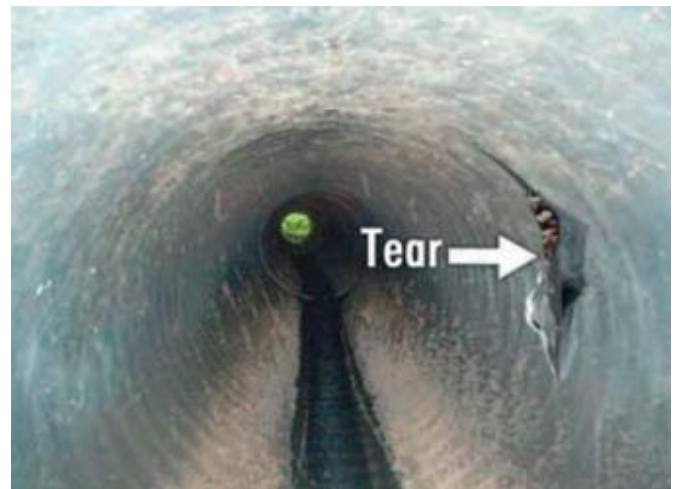
Critical: Cracking, splits, punctures, or tears over 6" in length and over 1" in width. Openings in pipe causing loss of backfill material. (Image credit: NAACC)

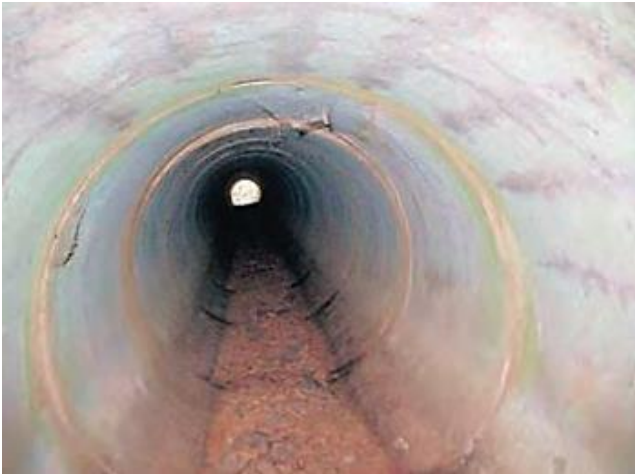
Adequate: Longitudinal cracks less than 1/8" in width. Spalls up to 1/4" deep. (Image credit: NAACC)

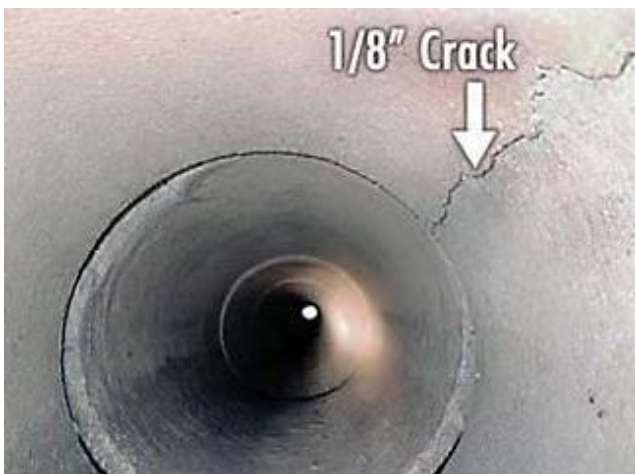
Poor: Longitudinal cracks between 1/8" - 1/4" in width. Significant infiltration of soil and/or leakage of water. Heavy rust staining. Spalls larger than 1/2" deep. Exposed steel reinforcement in sides and top of barrel. (Image credit: NAACC)

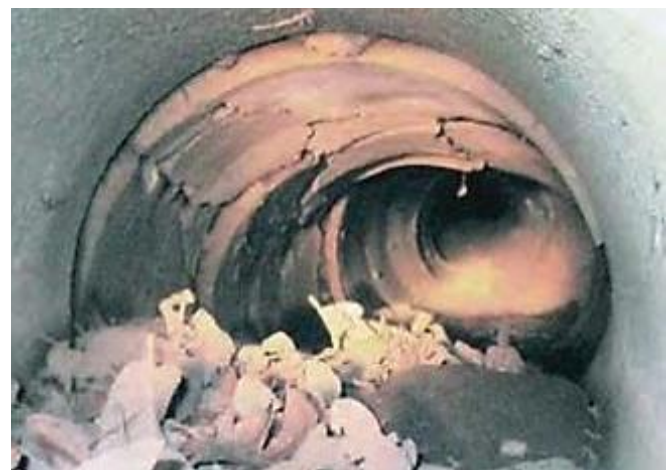
Critical: Severe cracking and spalls greater than 1/2" on culvert walls (concrete). Cracks, tears, splits, bulges, holes or section loss have led to extensive infiltration of soil, structural failure, voids, and embankment/roadway damage. Sections of culvert are partially collapsed, major corrosion of rebar. (Image credit: NAACC)

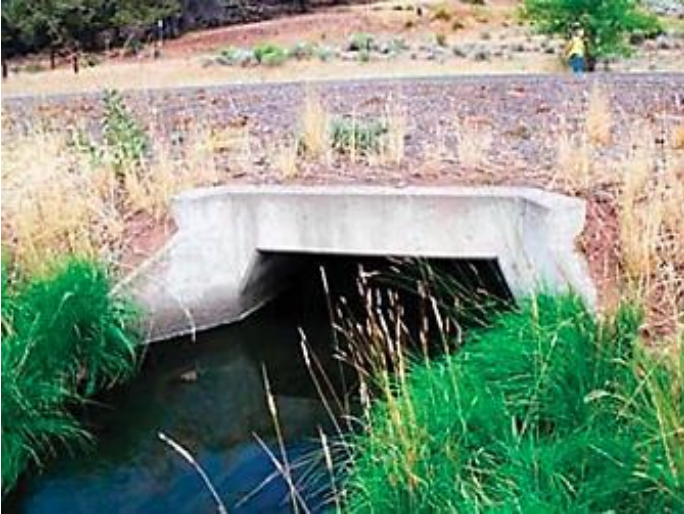
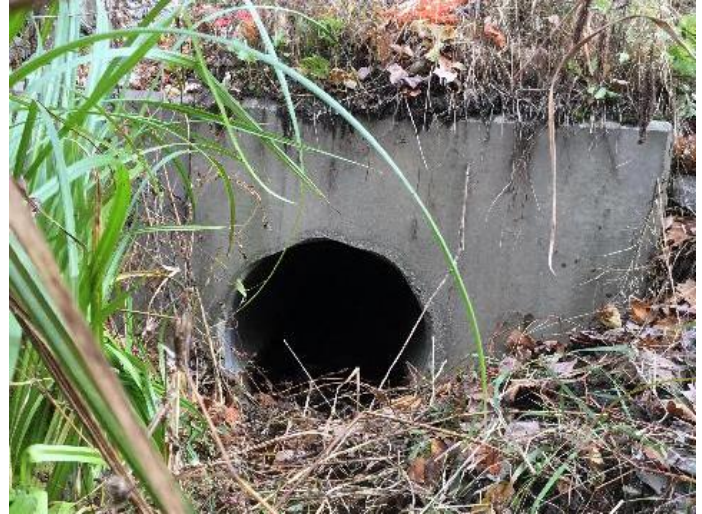
Adequate: Minor spalls and cracks less than 1/8" in width. No exposed rebar or surface evidence of rebar corrosion. Minor settlement of the wall. (Image credit: NAACC)

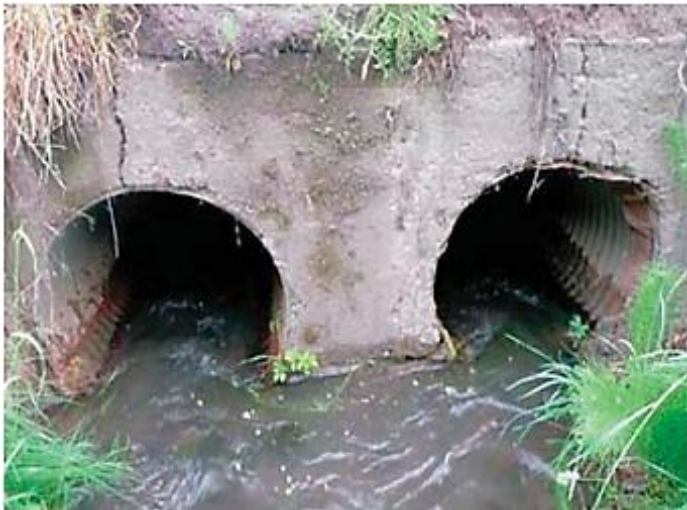
Poor: Significant spalls and cracks between 1/8" to 1/4" in width. Cracking or breaking off of flakes or chips affecting >50% of area. Exposed rebar with corrosion. Significant settlement of the wall. (Image credit: NAACC)

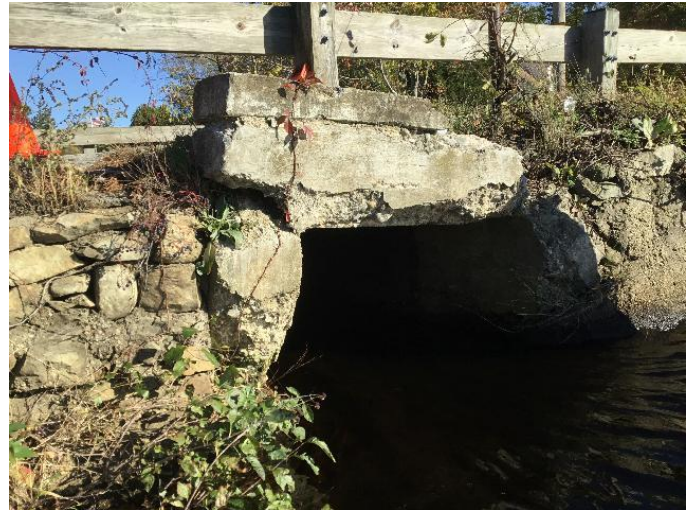
Critical: Extensive deterioration with loss of concrete. Corrosion of rebar and extensive section loss. Extensive settlement of the wall. Partially or totally collapsed with damage to embankment/roadway. (Image credit: NAACC)

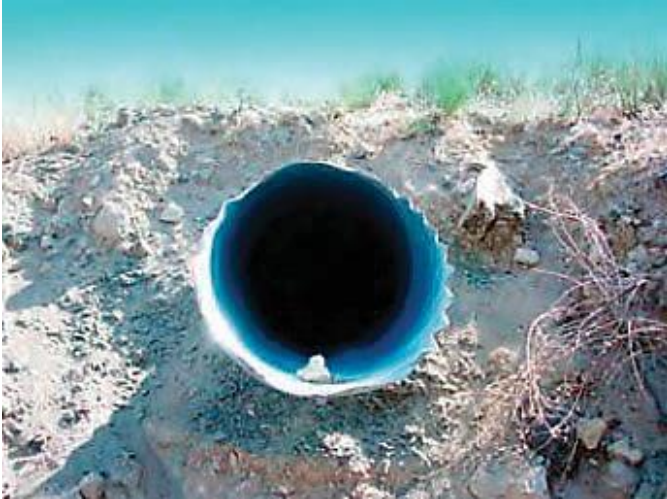
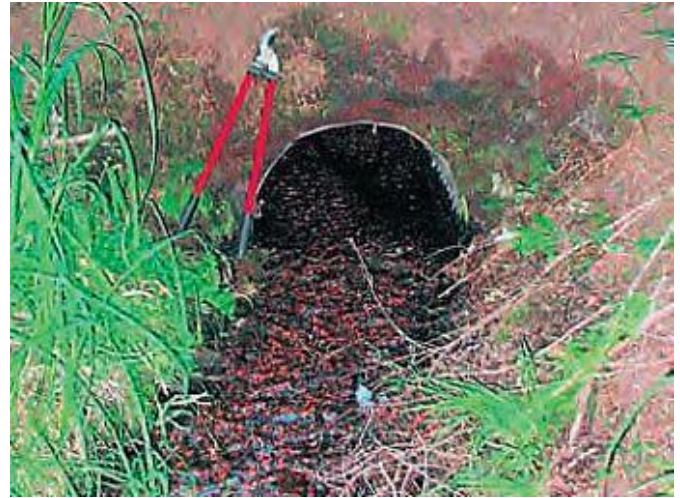
Adequate: Embankment moist only in areas surrounding culvert barrel. No evidence of flow or sediment transport observed. (Image credit: NAACC)

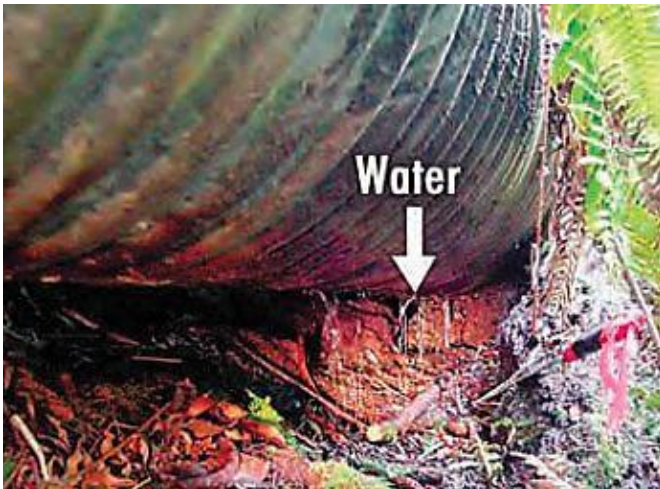
Poor: Evidence of seepage through the embankment along the outside of the culvert barrel. Sediment transport not observed. (Image credit: NAACC)

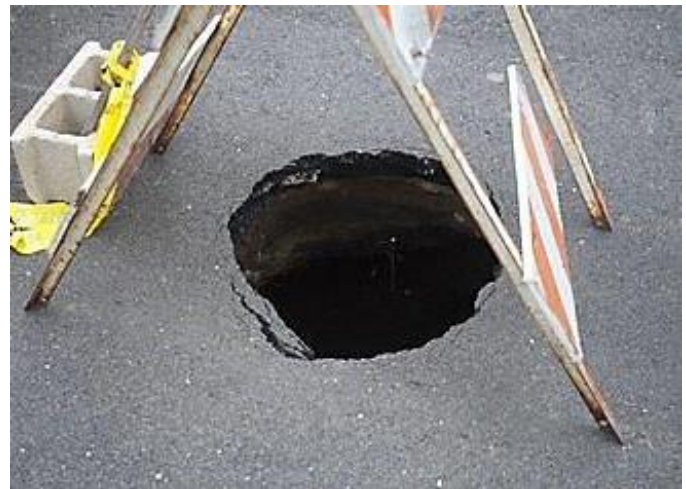
Critical: Evidence of flow through embankment along the outside of culvert barrel. Evidence of sediment transport, voids, or sink holes observed. (Image credit: NAACC)

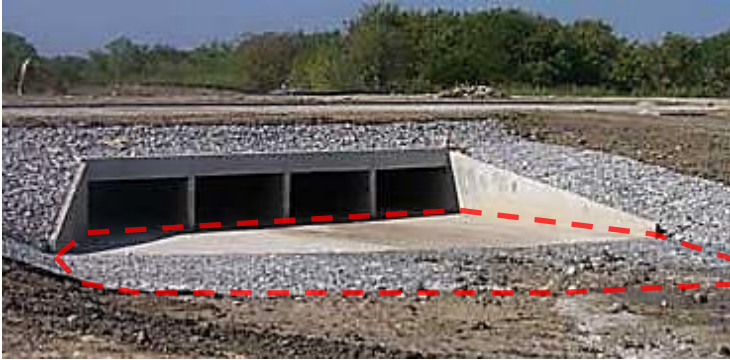
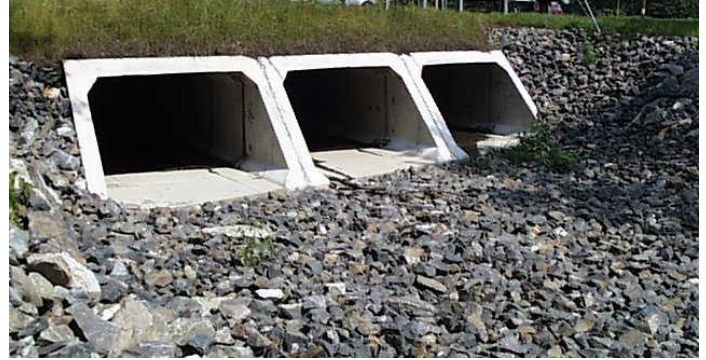
Adequate: Some minor undermining of culvert and small scour hole. Some deterioration of joint between apron and headwall. (Image credit: NAACC)

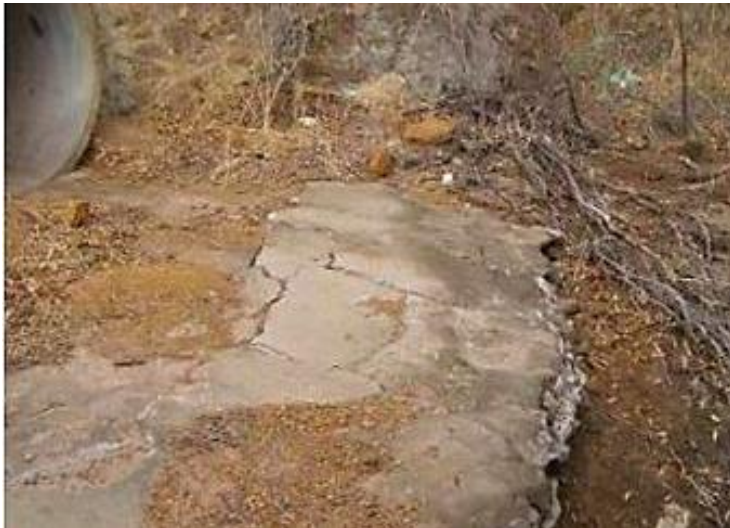
Poor: Significant undermining of culvert and evidence of scour hole. Significant deterioration of joint between apron and headwall. (Image credit: NAACC)

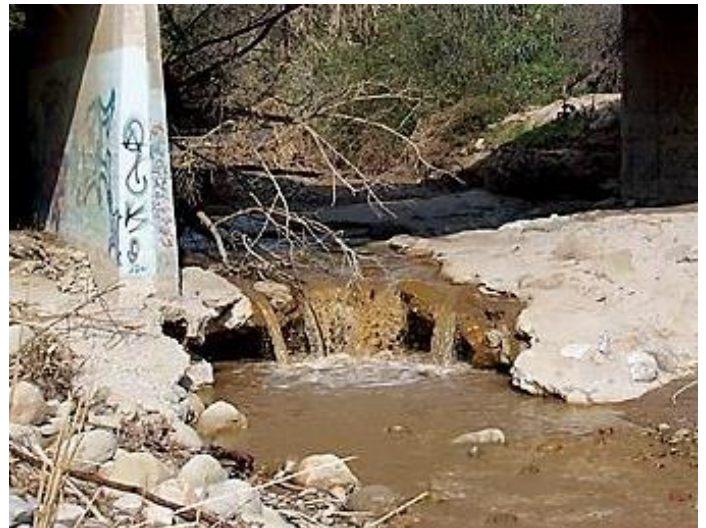
Critical: Extensive undermining of culvert and development of a large hole under structural element of the culvert. Substantial deterioration of joint between apron and headwall. (Image credit: NAACC)

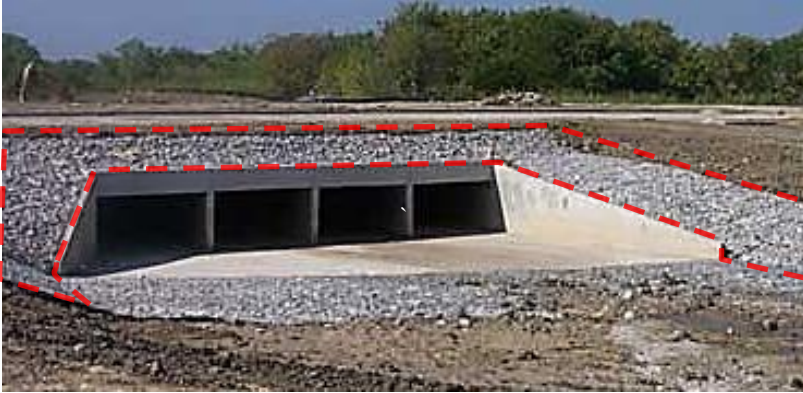
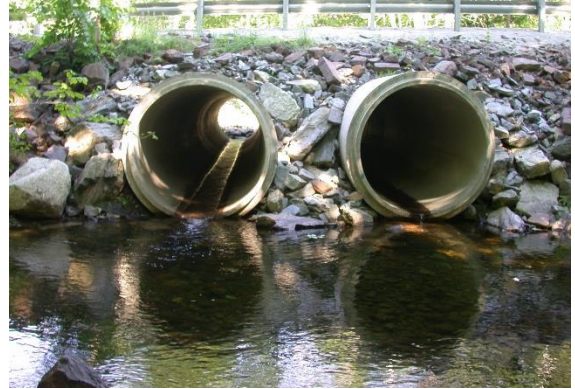
Adequate: Minor displacements of armor. No significant erosion of embankment where armor has been displaced. (Image credit: NAACC)

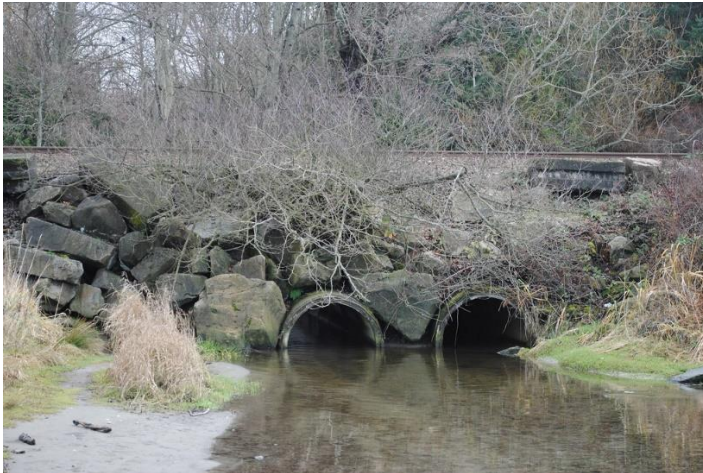
Poor: Significant displacements, undermining, or deterioration of armor leading to some erosion of embankment. (Image credit: Scott O'Dell)

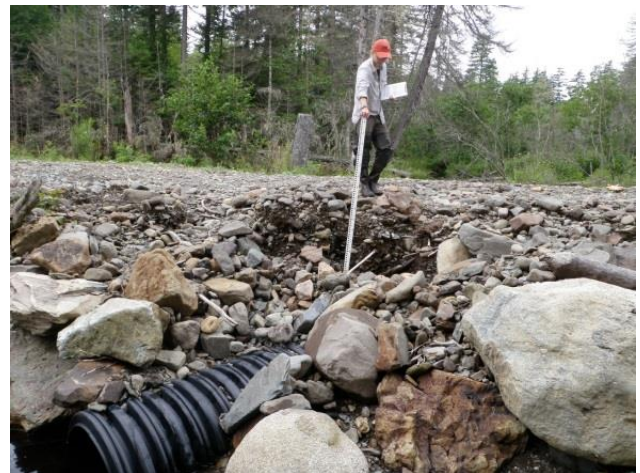
Critical: Armor Partially or totally failed, causing embankment or roadway damage, or undermining of the culvert barrel or footings. Armor displaced from streambanks and culvert embankment may have been deposited in streambed. (Image credit: NAACC)

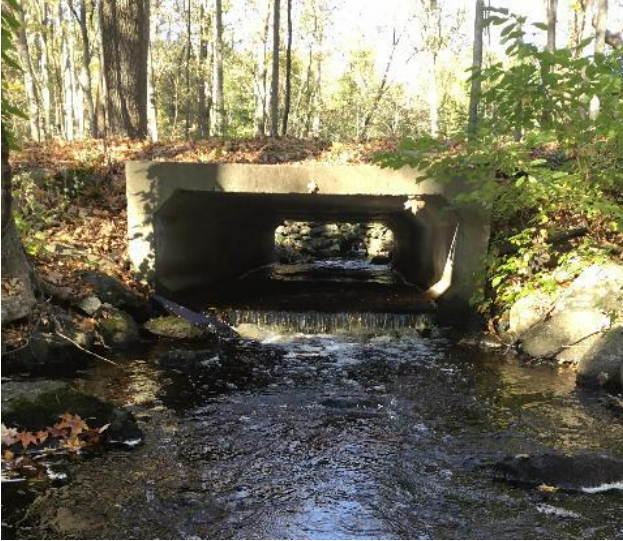
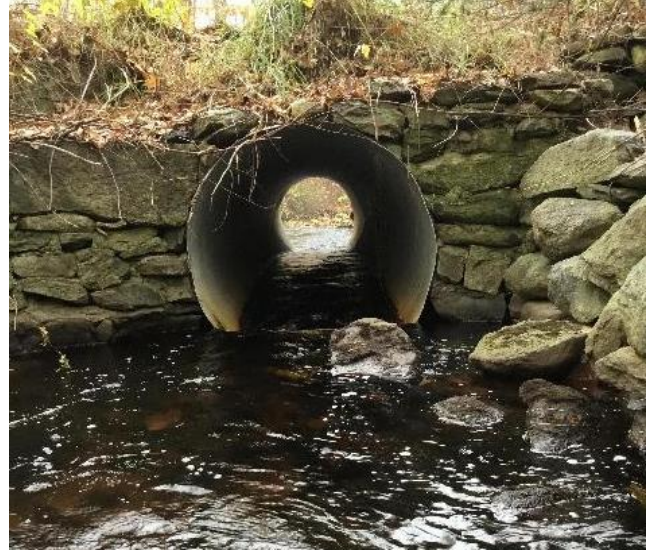
Adequate: No significant misalignment of pipe.

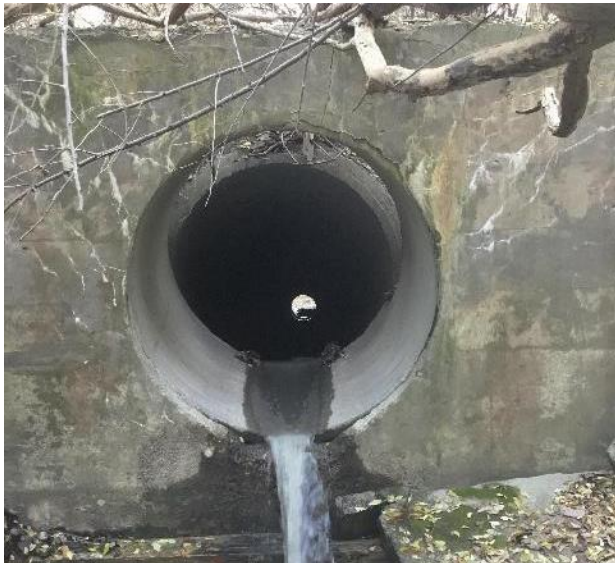
Poor: Significant horizontal or vertical misalignment of the pipe. (Note: Do not confuse this with constructed pipe bends.)

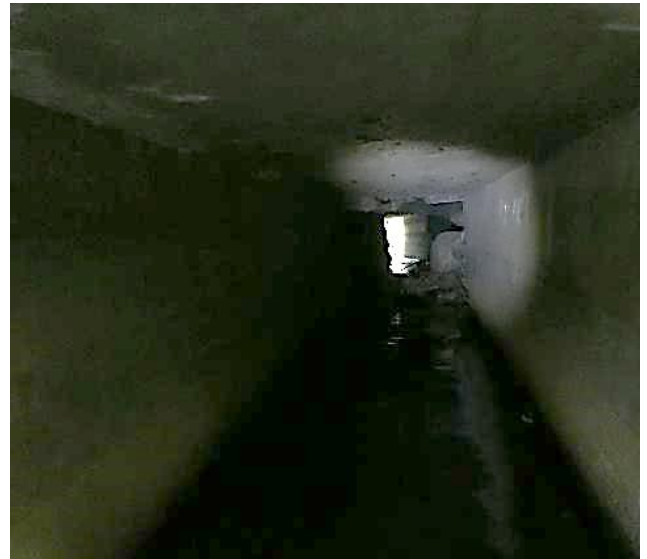
Critical: Significant misalignment of the pipe resulting in deformation of the pipe or embankment/roadway damage. Significant bend or jogs in the culvert resulting in gaps filled with stone that are vulnerable to collapse (concrete/masonry).

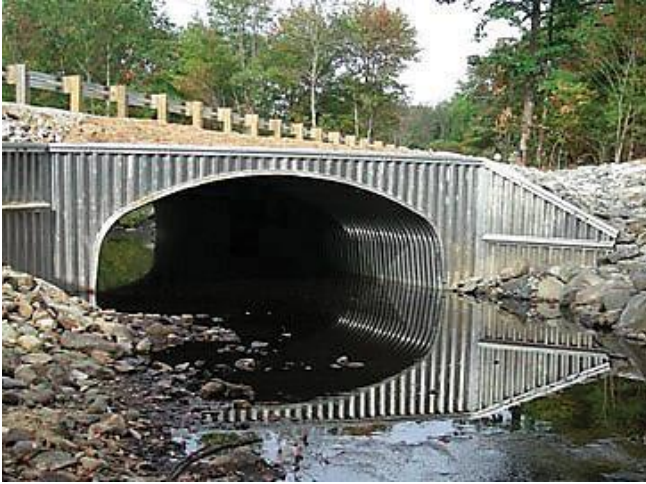
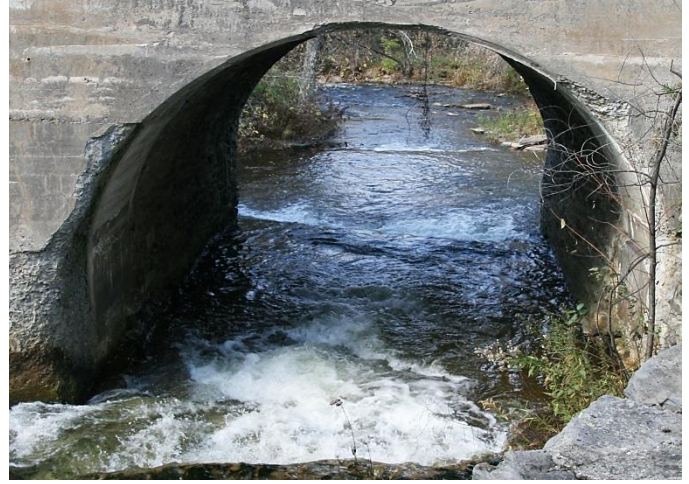
Adequate: Minor to moderate deterioration. Moderate cracking, scaling or leaching; minor delamination or spalling (concrete). Moderate weathering; minor joint deterioration (masonry). Slight settlement or undermining. Minor footing exposure. (Image credit: NAACC)

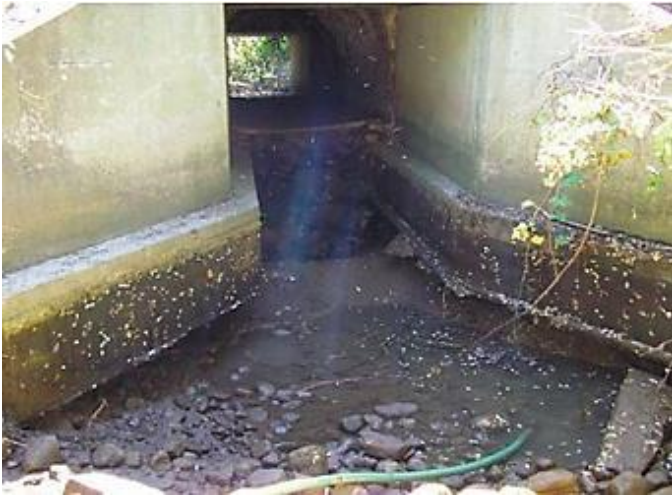
Poor: Extensive deterioration. Extensive cracking, scaling or leaching; delamination or spalling may be present (concrete). Extensive weathering; significant joint deterioration (masonry). Significant settlement or undermining. Footing exposed and undermined. (Image credit: NAACC)

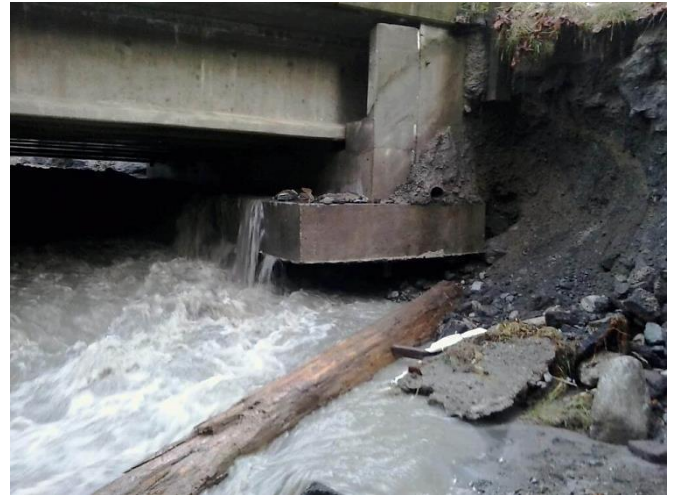
Critical: Severe or critical deterioration. Function or structural capacity of the structure has been severely impacted; immediate repairs or structural analysis may be required. Severe cracking, scaling, delamination or spalling (concrete). Severe weathering, failed joints or displaced masonry blocks (masonry). Severe settlement or undermining. (Image credit: NAACC)

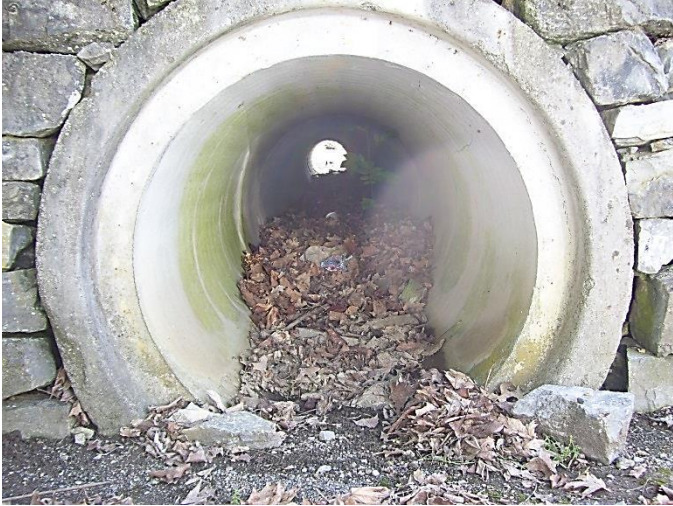
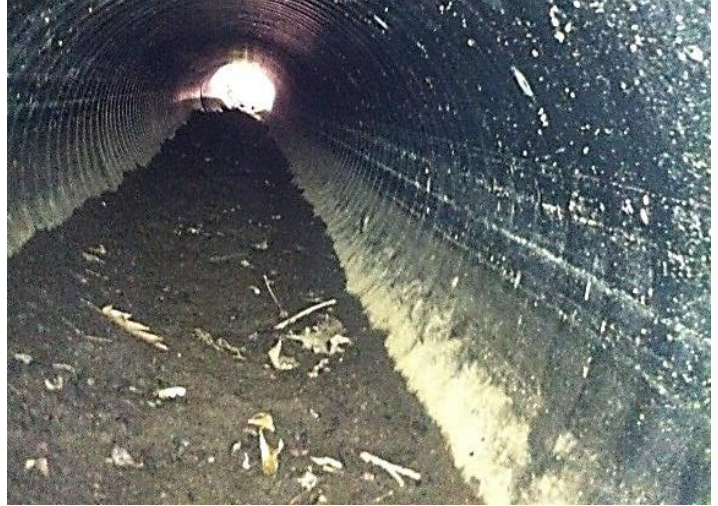
Adequate: Blockage is 0-30% of opening.

Note that very small amounts of debris that are likely to be washed away during the next rain event should not be considered a blockage. Leaves or other debris that are less than 30% of the opening and could be easily washed away should be marked as adequate. Any blockage (leaves or otherwise) that is not easily cleared should be considered poor or critical. (Image credit: NAACC)

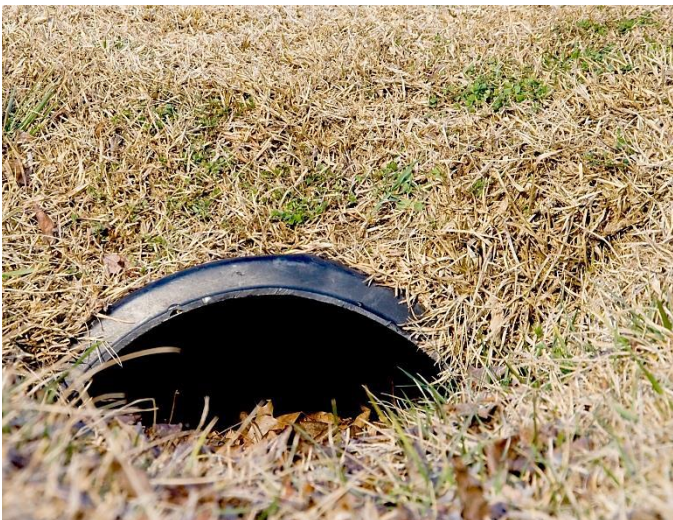
Poor: Blockage is 30-75% of opening. (Image credit: NAACC)

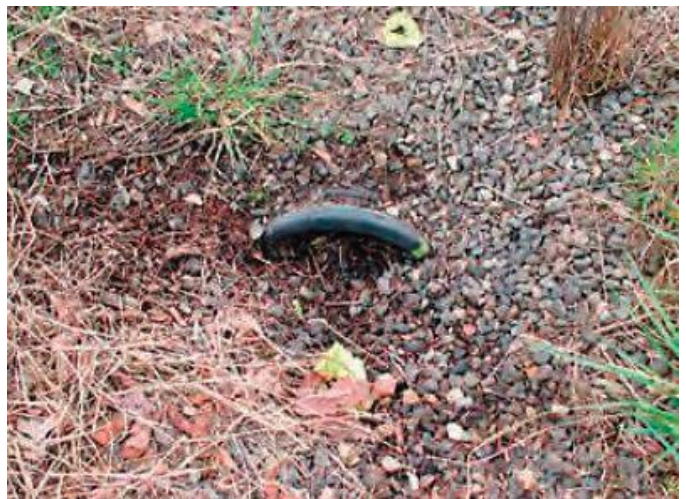
Critical: Blockage is >75% of opening. (Image credit: NAACC)

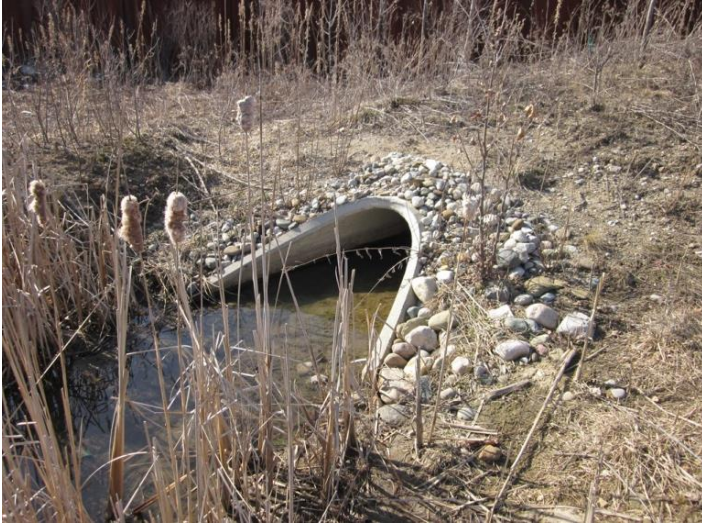
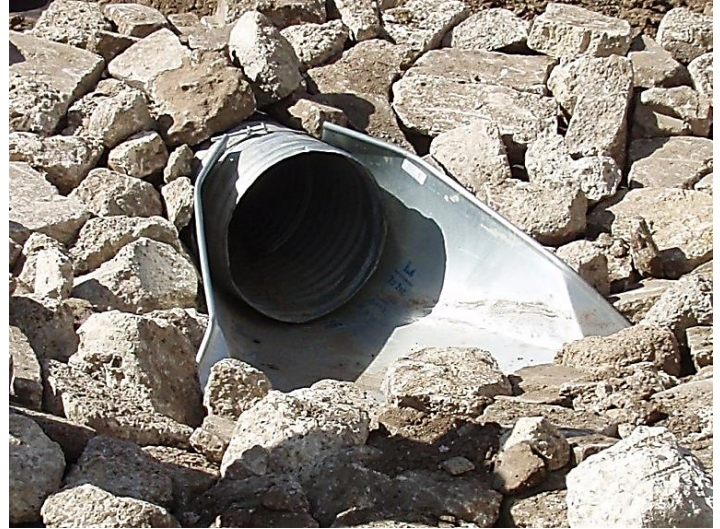
Adequate: Minor cracking, deterioration or deformation. Minor undermining. (Image credit: NAACC)

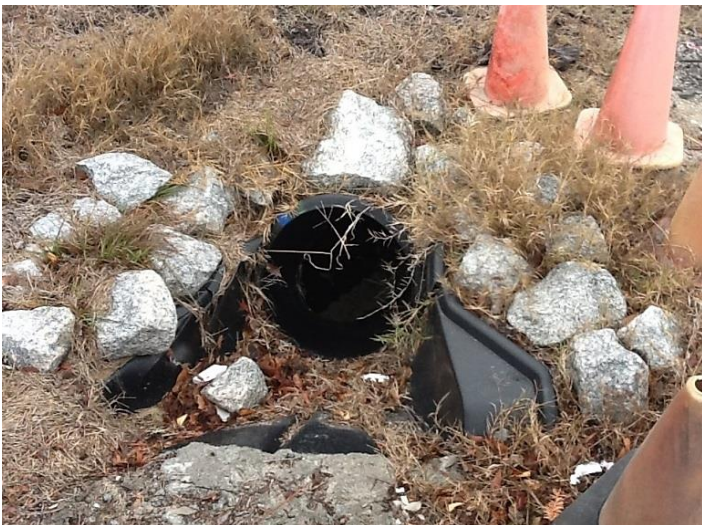
Poor: Significant cracks, piping or undermining affects >50% of appurtenance. End crushed or separated from barrel. (Image credit: NAACC)

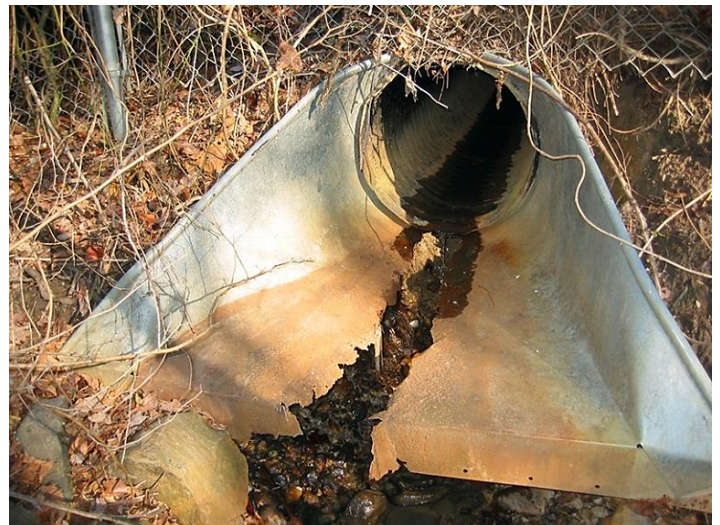
Critical: Deterioration is significantly affecting performance, and/or causing embankment and/or roadway damage. (Image credit: NAACC)

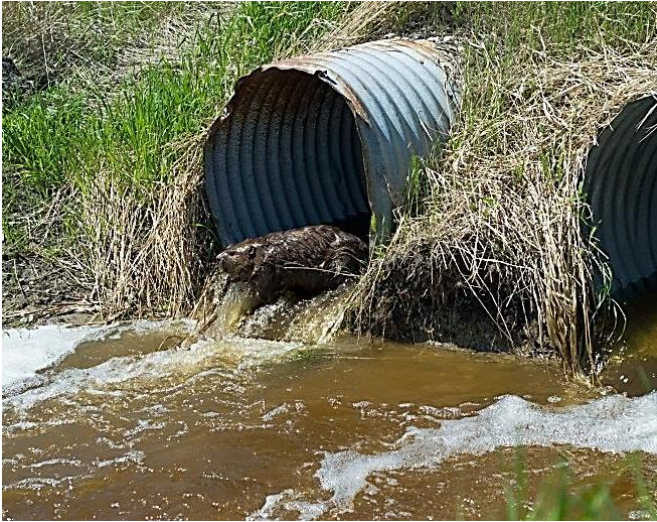
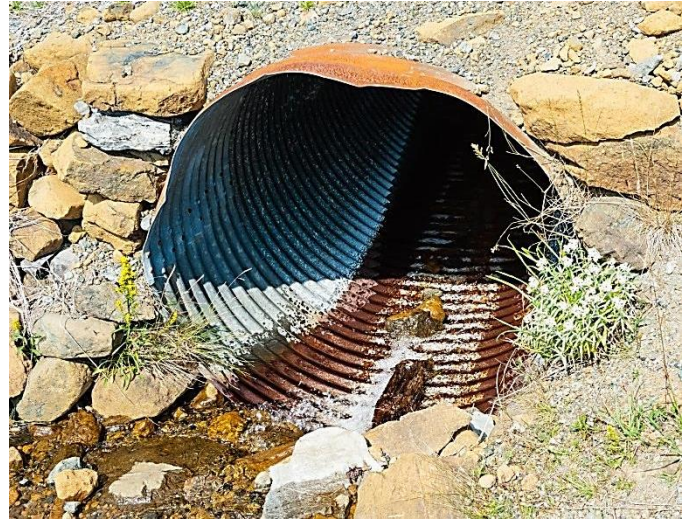
Adequate: Hydraulic uplift and deformation not apparent. Hydraulic uplift overcome by a combination of the weight of the pipe, weight of the fill material over the pipe, and the weight of the water in the pipe. (Image credit: NAACC)

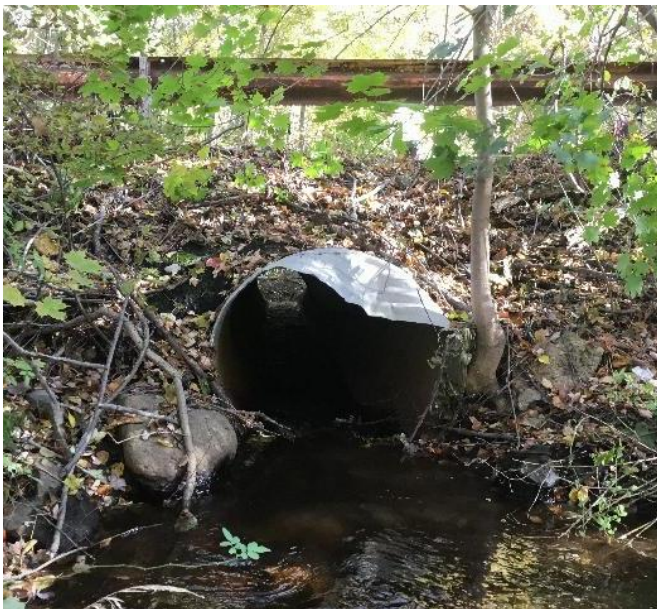
Poor: Light to moderate denting or deformation of inlet and/or outlet of flexible pipe culverts. The invert of the inlet is at the streambed elevation (no uplift). (Image credit: NAACC)

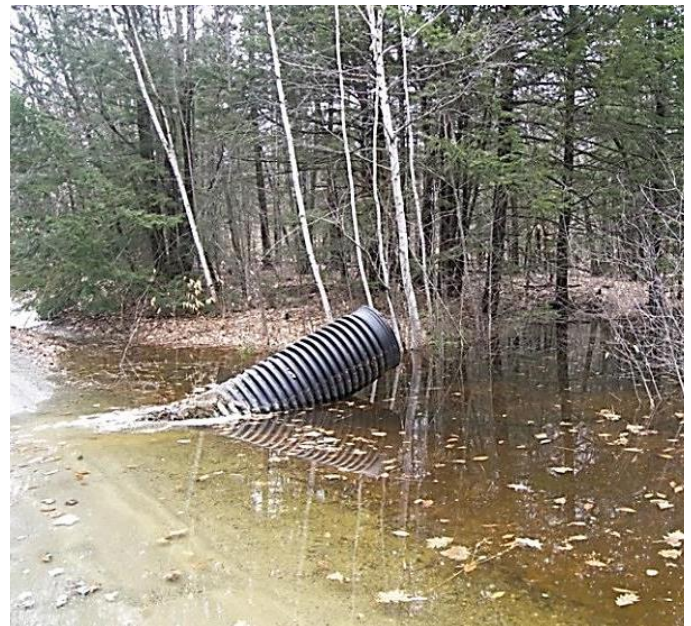
Critical: Invert of inlet bent upward above stream bed or mitered edges crumpled inward. (Image credit: NAACC)

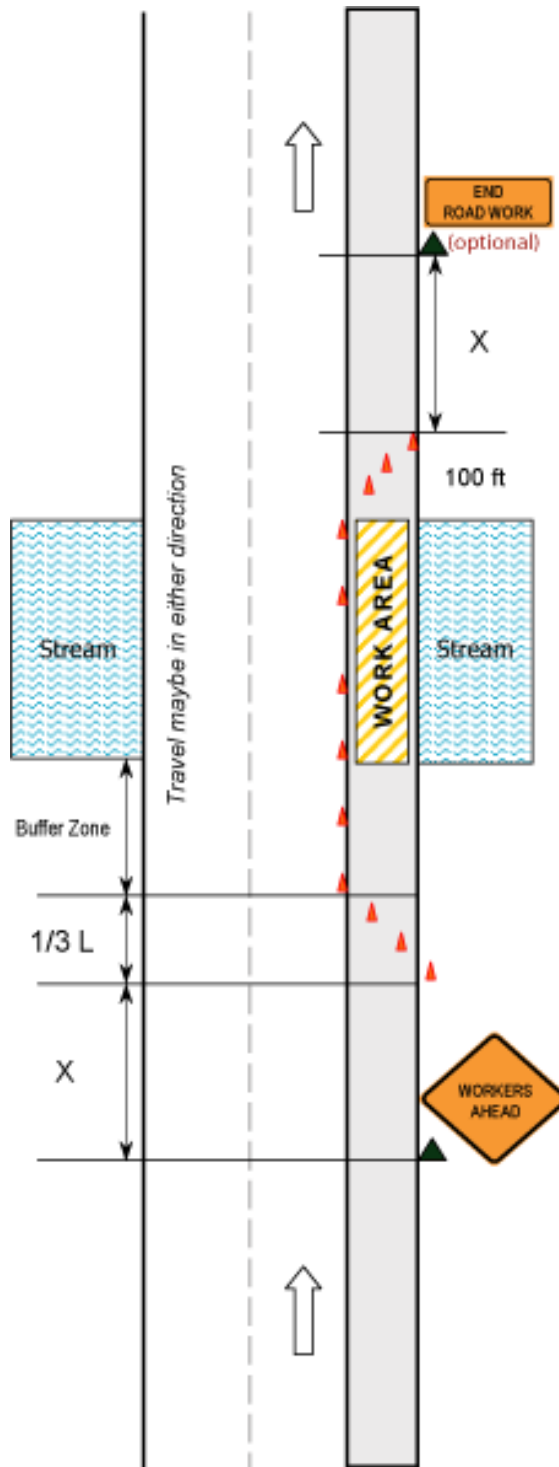
Figure 1. Diagram of a traffic control plan for short term, greater than one hour. From U.S. Department of Transportation, Federal Highway Administration, 2009).

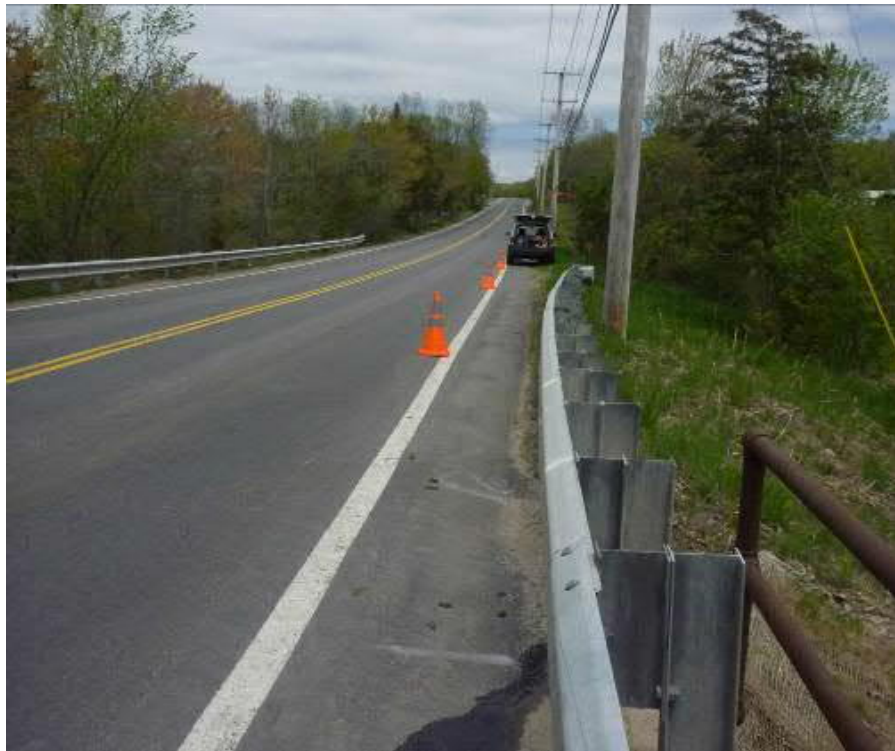
Figure 2. Cones set up on relatively high speed state route. Travel lanes are not blocked, and work will be less than one hour.

Some sites will require the use of traffic cones. Supervisors will provide employees guidance on which sites require cones. A sample diagram of a traffic control plan has been provided (Figure 1). Examples of different work site set-ups are shown in Figures 2-4.

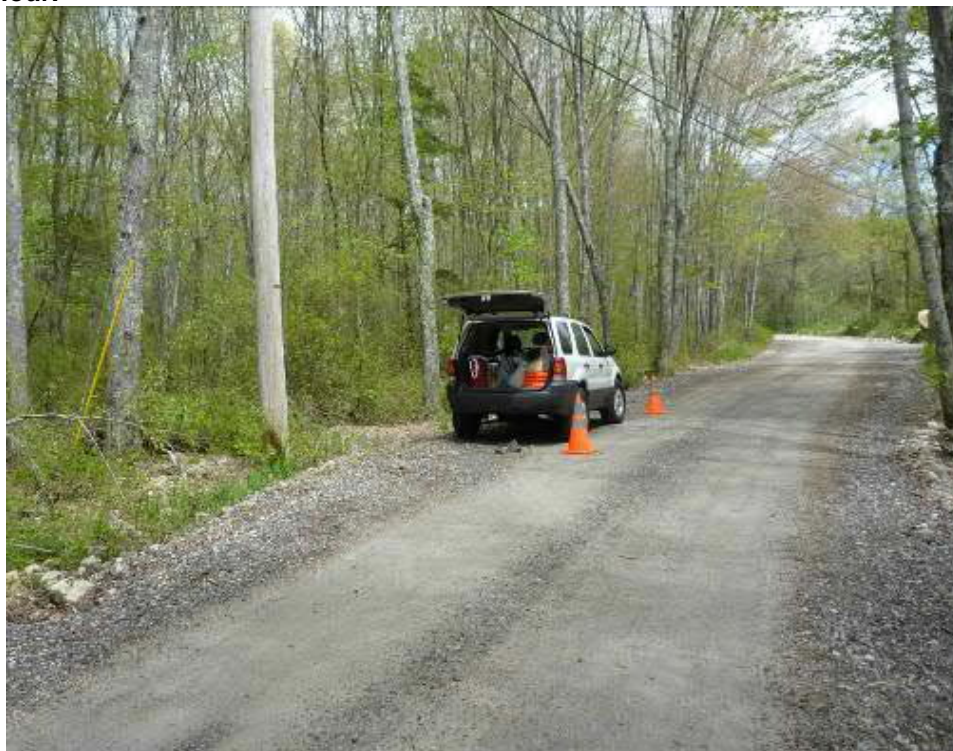
Figure 3. Vehicle parked on low-traffic low-speed road for short-duration work.

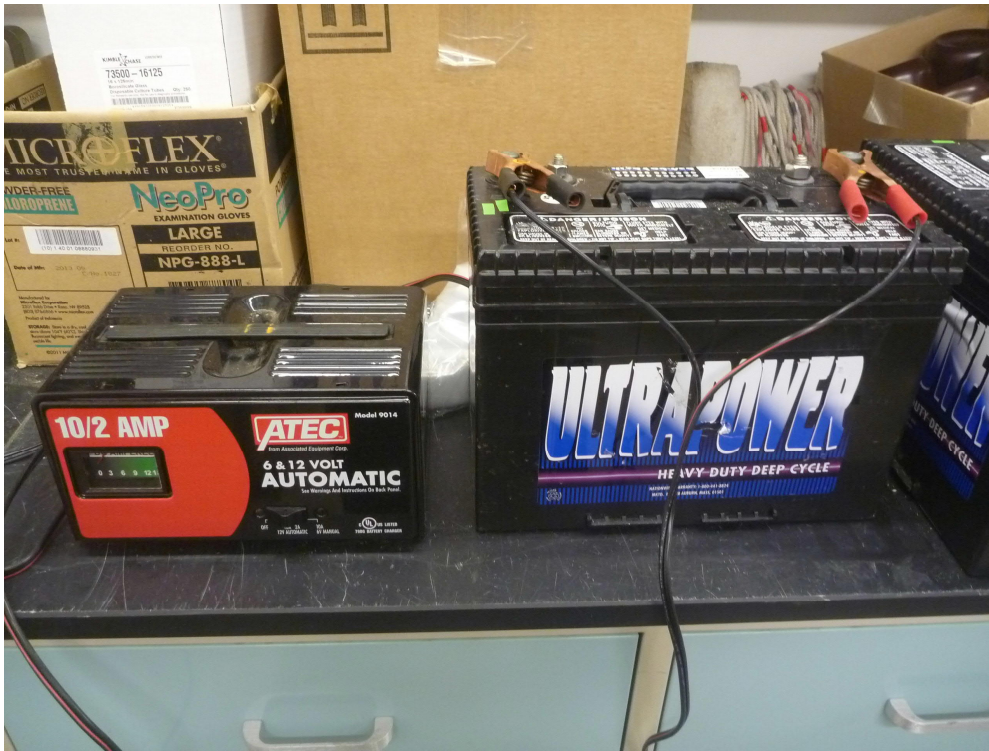
Figure 5. Battery and charger in sampling center.

The department has several battery powered trolling motors that require the use of a heavy-duty deep-cycle battery. These batteries have a handle, but are heavy (40 lbs) so care should be used in lifting and carrying the batteries to vehicles and field sites. These batteries use sulfuric acid as the electrolyte, so extreme caution should be used if batteries become damaged and start to leak. Any leaks should be neutralized with baking soda. Training should be provided for employees who are unfamiliar with charging batteries. General precautions for charging include care in connecting the charger to the battery terminals, with black to negative and red to positive. If clamps touch each other, you can be shocked. Batteries should be charged in a well ventilated area, because the charging procedure can produce hydrogen gas, which can be explosive. Trickle charging is the most effective way to extend the batteries lifespan, so the charger should be set to 2A automatic charge for most applications. Analysts should avoid putting anything on top of the batteries when loading field equipment. Connecting the terminals with a conductive material such as a metal clipboard could result in electrical shock, overheating or fire.

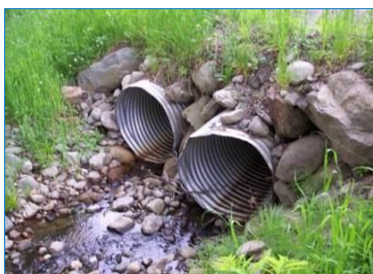
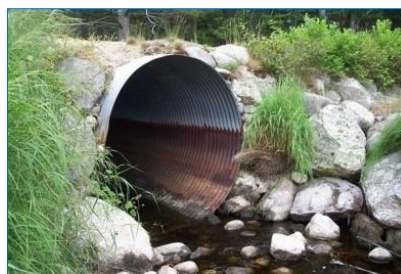
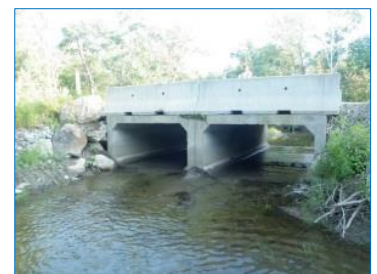
Figure D-1. Examples of good inlet photographs that show the surrounding context of the structure including the structure invert, the fill, and armoring.

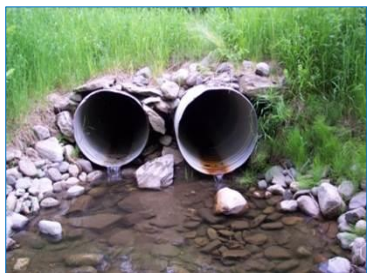
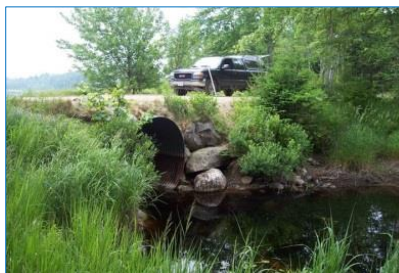
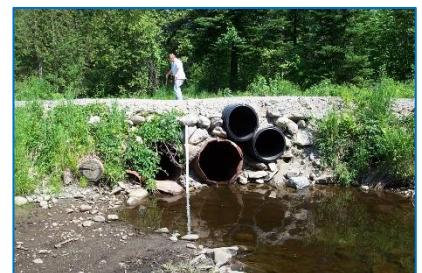
Figure D-2. Examples of good outlet photographs that are taken far enough away from the structure so that the entire structure is visible and the surrounding fill, armoring, and streambanks are captured.

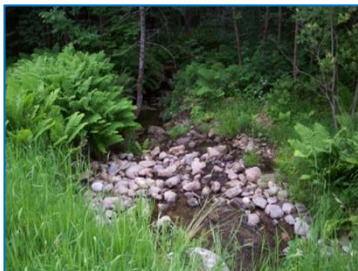
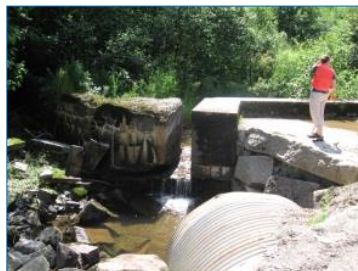
Figure D-3. Examples of good upstream photographs that capture the stream channel as far as the eye can see and include the streambanks on each side. More context can usually be captured by taking the photograph from the roadway or the top of the structure rather than from in the stream.
