Rhode Island Department of Transportation **Road-Stream Crossing Assessment Handbook**

August 2019

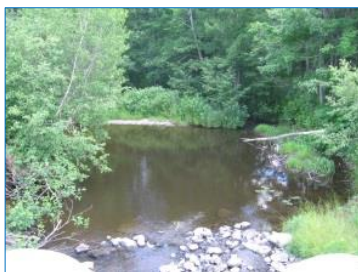
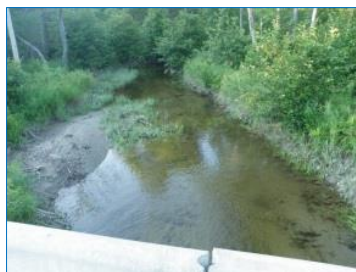
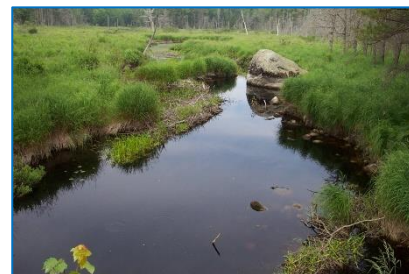
Figure D-4. Examples of good downstream photographs that capture the stream channel as far as the eye can see and include the streambanks on each side. More context can usually be captured by taking the photograph from the roadway or the top of the structure rather than from in the stream.

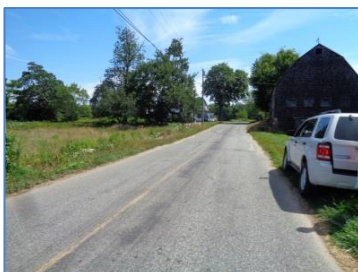
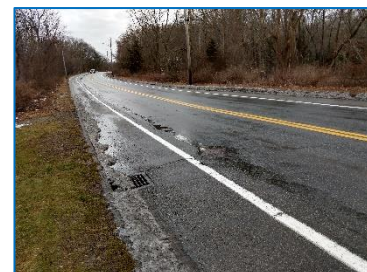
Figure D-5. Examples of good roadway photographs. The roadway photograph should show the condition of the roadway directly over the crossing and include any notable markers that would help locate the crossing in the future.

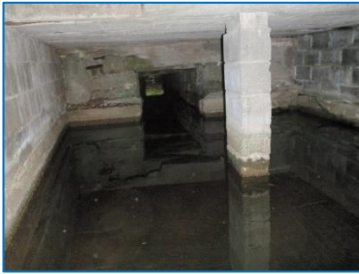
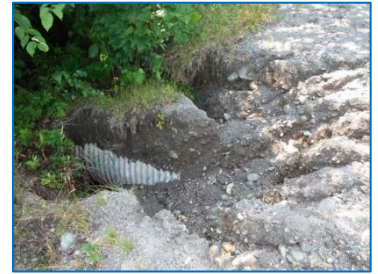
Figure D-6. Examples of additional photographs that may need to be taken if all features of a crossing are not captured in the five standard photographs (upstream, inlet, downstream, outlet, and roadway). These photos may be necessary to show appurtenant structures, damage, or other unique conditions.

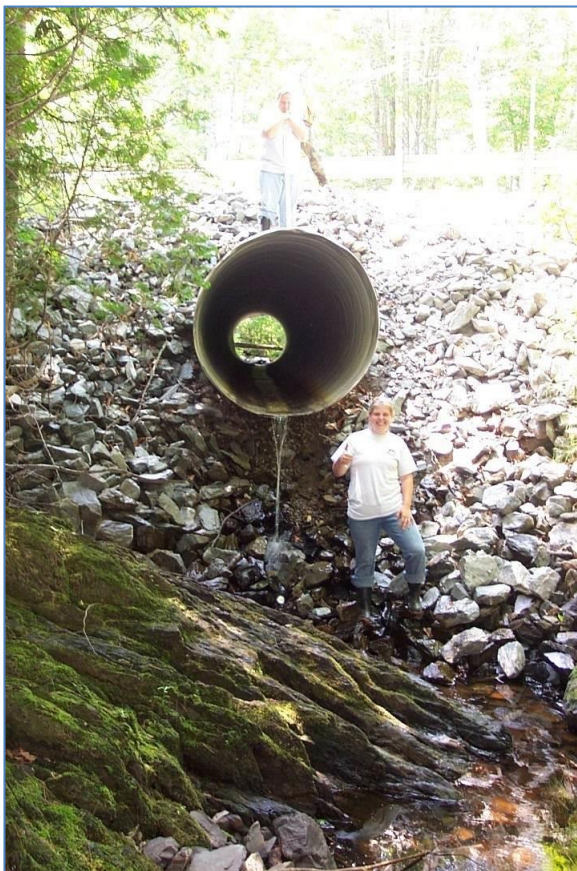
Figure D-7. An additional example of a good photograph. This photo shows adequate context around the structure, including a field data collector in a safe position near the structure for scale, the roadway and bank above the culvert, and the stream downstream of the culvert (including the full width of the culvert). Note that the photograph is overexposed, reducing the available contextual information about the road at the top of the photograph. (Image credit: NAACC)

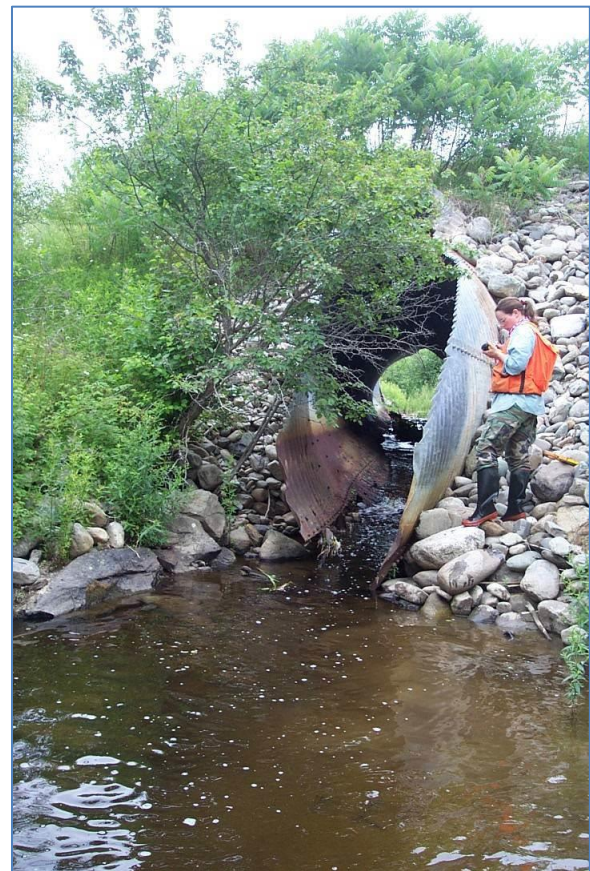
Figure D-8. An additional example of a good photograph. The photo shows the structure opening and surrounding armor, the roadway and bank above, and the stream outside of the structure (including the full width of the stream). The photograph also shows a Field Data Collector standing in a safe position near the structure, which provides a reference for the scale of the objects in the photograph (Image credit: NAACC)

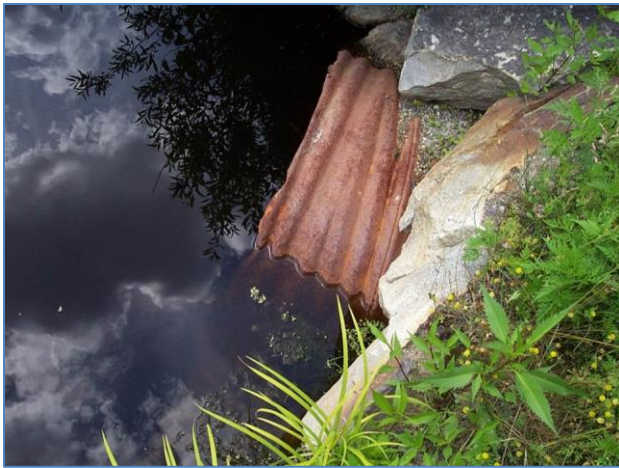
Figure D-9. An example of a photograph of a culvert that shows very little context around the culvert that is the subject of the photograph. The photo could be improved by taking a head-on photograph of the culvert and backing up to capture more context (Image credit: NAACC).

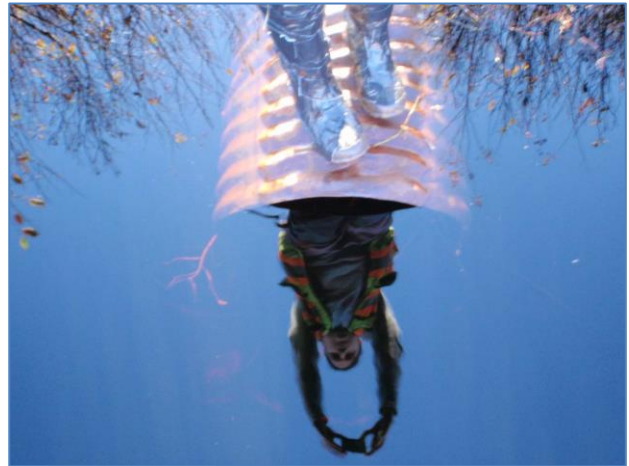
Figure D-10. An example of a photograph of a culvert that shows no context around the culvert that is the subject of the photograph. The photo is also confusing due to the high reflection. This photo could be improved by taking a distant photo of the culvert head-on from the shoreline (you can always zoom in on digital images to better see the structure) (Image credit: NAACC).

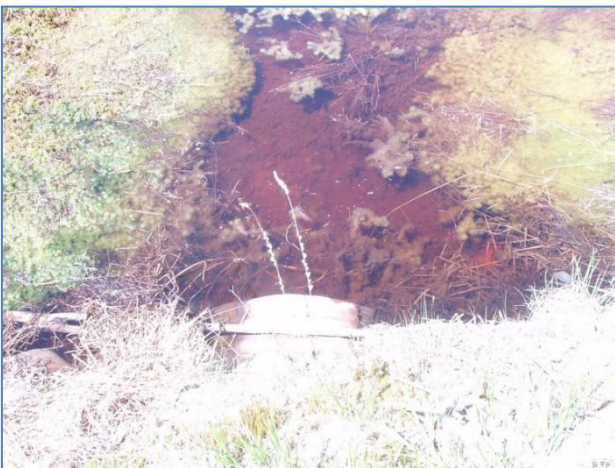
Figure D-11. An example of a downstream photograph that shows very little context of the crossing. Note that the photo is also overexposed, which limits the information available in the photo. This photo could be improved by adjusting the angle of the photo to capture more of the downstream channel and adjusting the settings to avoid overexposure (Image credit: NAACC).

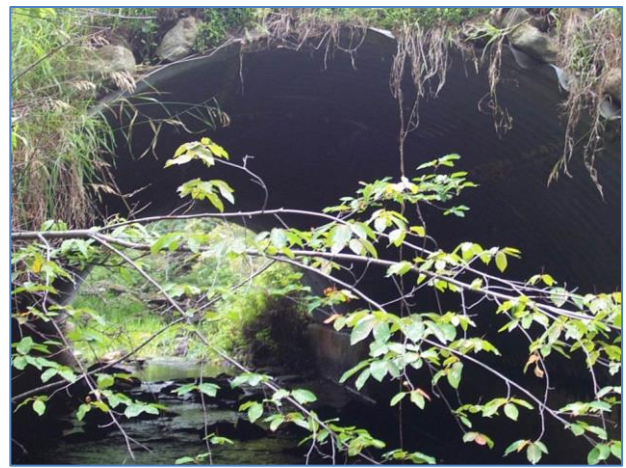
Figure D-12. An example of a photograph of a culvert that shows very little context due to the proximity of the photo to the structure and the tree branch blocking the view. This photo could be improved by stepping back several feet to capture the surrounding context of the culvert and adjusting the location from which the photo is taken to avoid the tree branch (Image credit: NAACC).

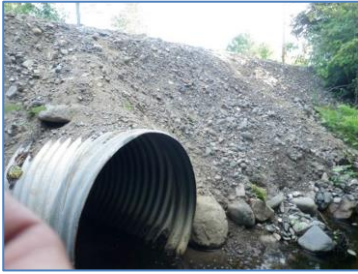
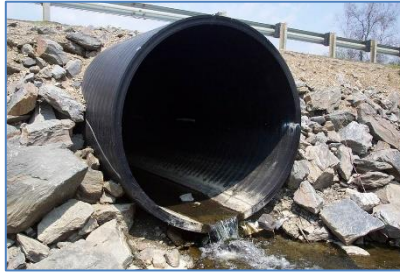
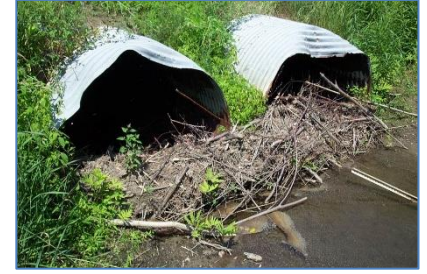
Figure D-13. Examples of photographs of culverts that show too little context. These photos could be improved by stepping back several feet to take the photo (Image credit: NAACC).

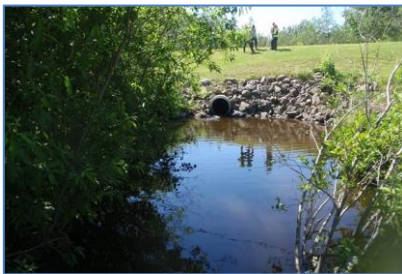
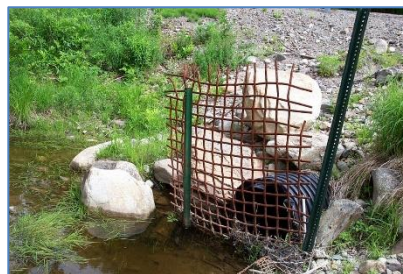
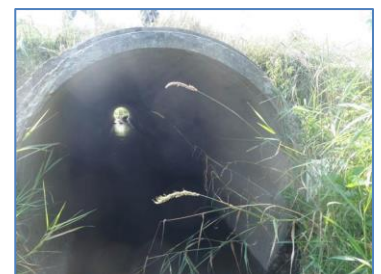
Figure D-14. Additional examples of photographs that contain too little context. These photos could be improved by adjusting the location from which the photo is taken to capture more context, or taking additional photos from different viewpoints to capture the entirety of the crossing.

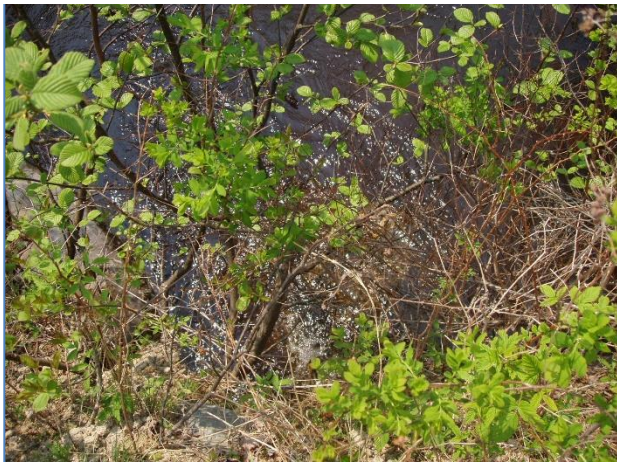
Figure D-15. This photograph is not very useful because the structure and stream channel are hidden behind the dense vegetation. This photo could be improved by taking the photograph from a different location or angle, or taking multiple photographs to adequately capture the crossing.

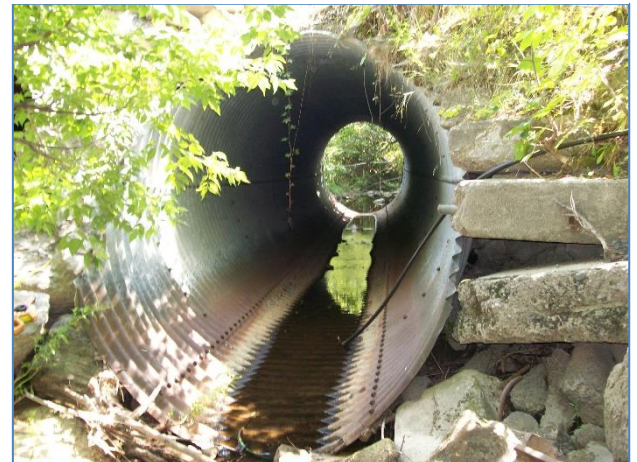
Figure D-16. While this photograph adequately shows the crossing structure, it could be improved by stepping several feet back to capture the surrounding context including the stream, armoring, and fill.

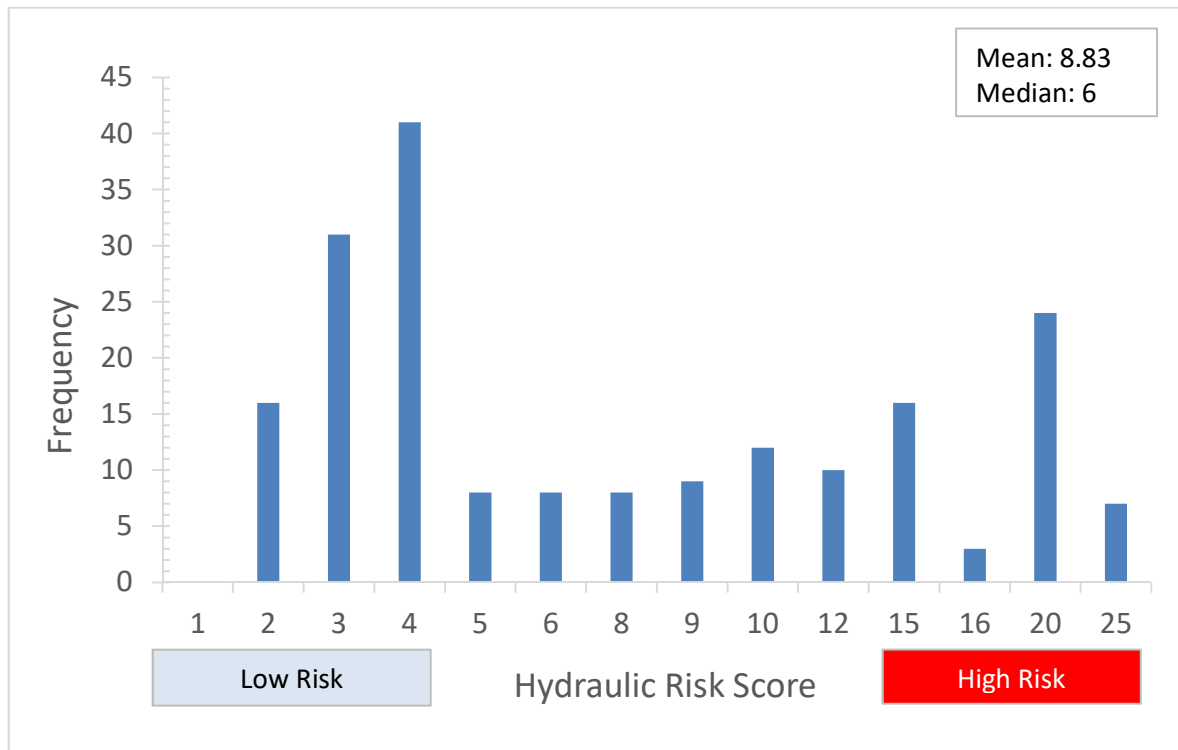
Figure 6. Histogram showing the distribution of Hydraulic Risk Scores for all crossings.

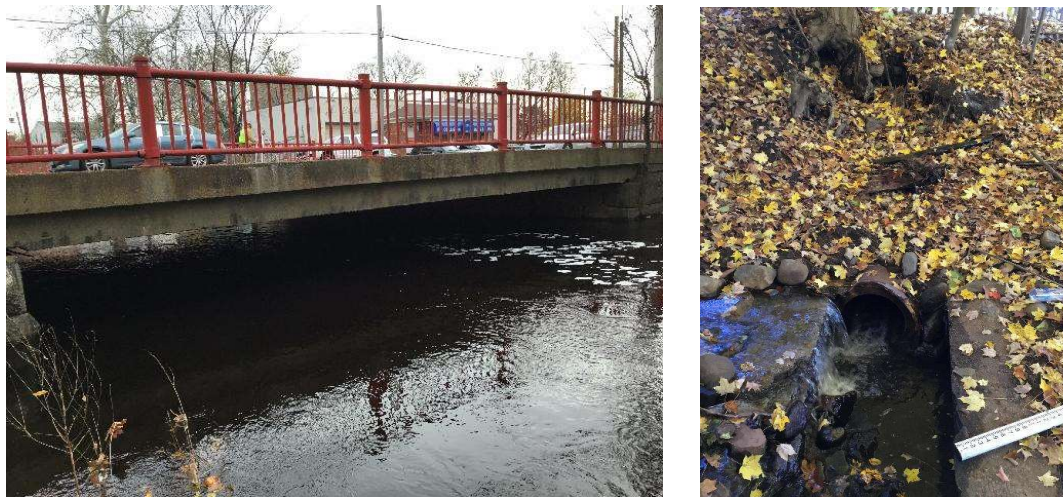
Figure 8. Two of the crossings that received the highest Hydraulic Risk Scores: xy41822527143992 (left) on Valley Street in Providence over the Woonasquatucket River and xy41866427149748 on Dean Street in Johnston at an unnamed tributary to the Woonasquatucket River.

The crossings that received the highest possible *Hydraulic Risk Score* of 25 are listed below in **Table 7**. All of these crossings received a *Binned Hydraulic Capacity Score* of 5 and an *Impact Score* of 5, indicating that they are incapable of passing the 10-year peak flow and have high flood and transportation disruption impact potential in the event of failure. The crossings with the highest *Hydraulic Risk Scores* are located in densely developed areas of Providence, Johnston and Smithfield, with a few others scattered throughout the watershed (**Figure 7**). Photos of the inlets of two of the crossings that received the highest *Hydraulic Risk Scores* (xy41822527143992 and xy41866427149748) are provided in **Figure 8**. These photos demonstrate that both smaller culverts and larger bridges can have high hydraulic risk.

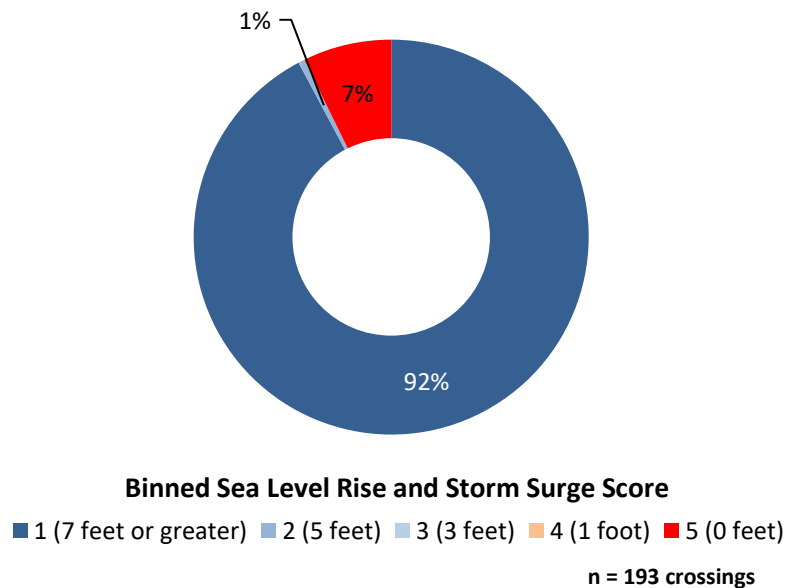
Figure 11. Binned sea level rise and storm surge scores. A score of 1 indicates that the crossing will not be impacted by the 100-year storm plus 7 feet of sea level rise. A score of 5 indicates that the crossing is already impacted by the 100-year storm surge, with no sea level rise.

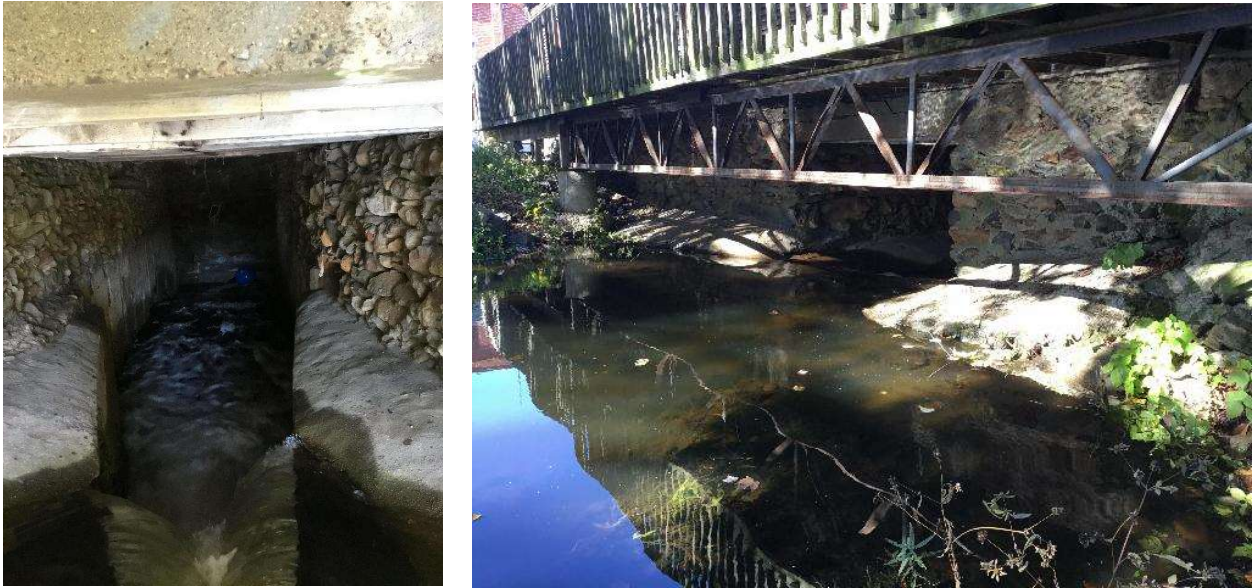
Figure 19. Inlet drop (left) and severe channel constriction (right) associated with xy41871207155179 on Putnam Pike in Smithfield, at the Slack Reservoir outflow.

in Smithfield (Hawkins Brook). The high *Geomorphic Risk Score* for crossing xy41834977144282 is driven by constriction of the stream channel, a perched inlet and small substrate size. Crossing xy41871207155179 has an inlet drop, severe constriction of the channel, and straightening of the stream by channelization which contribute to a high *Geomorphic Risk Score* (**Figure 19**). Extensive outlet armoring, an outlet drop, and misalignment of the crossing with the stream channel contribute to the high *Geomorphic Risk Score* for crossing xy41873187150300 (**Figure 20**).

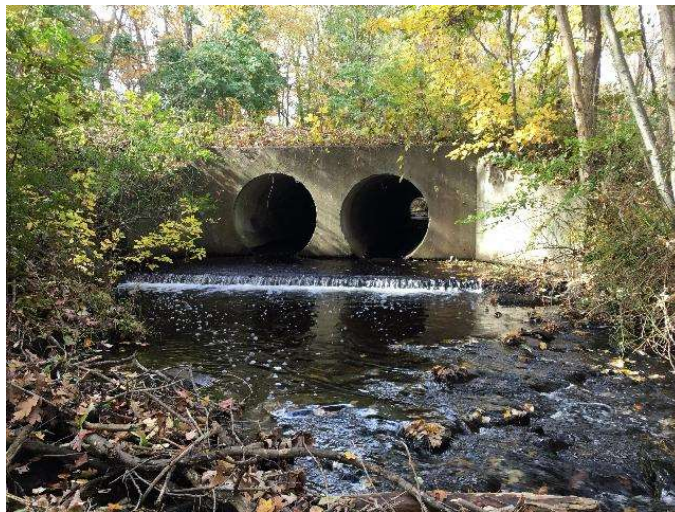
Figure 20. Outlet armoring and outlet drop associated with xy41873187150300 on Dean Street in Smithfield (Hawkins Brook).

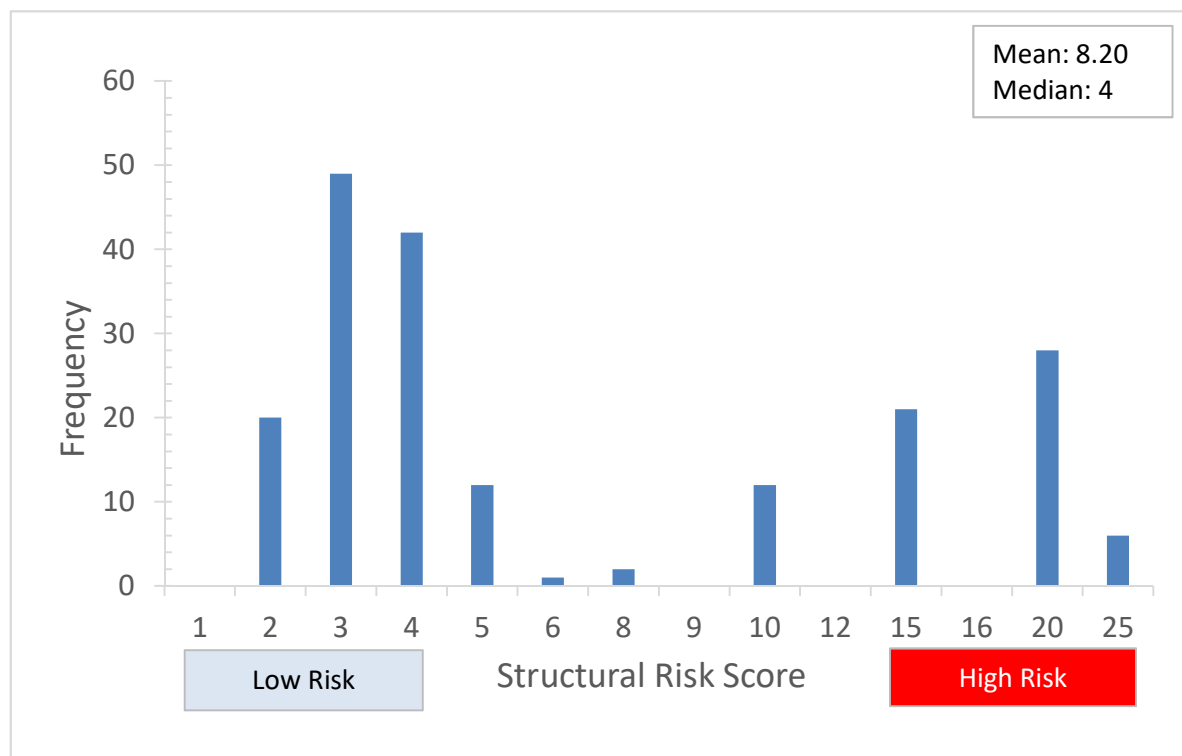
Figure 22. Histogram showing the distribution of Structural Risk Scores for all crossings.

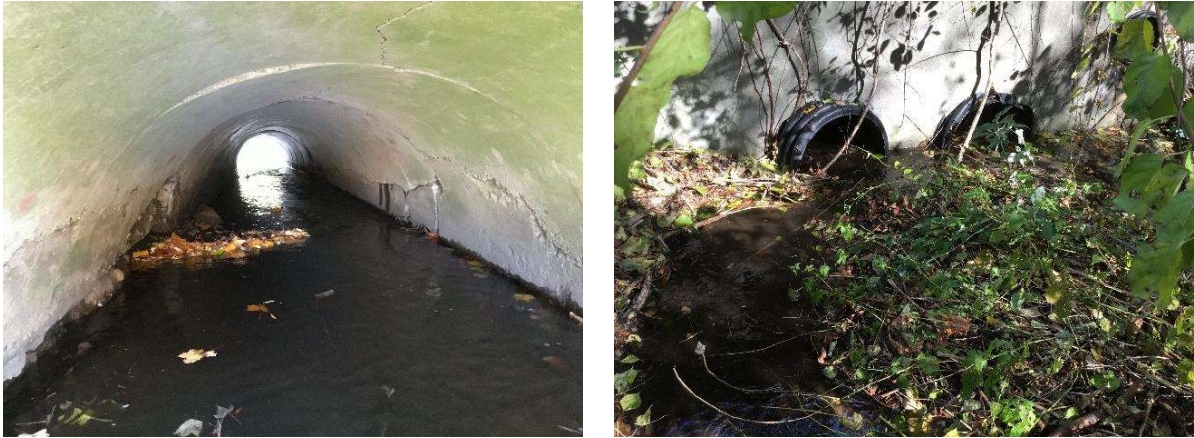
Figure 24. Poor Barrel Condition of xy41834977144282 on Pleasant Valley Parkway in Providence (unnamed tributary to Woonasquatucket River) (left) and level of blockage of xy41888657151262 on Farnum Pike in Smithfield (unnamed tributary to Georgiaville Pond)(right).

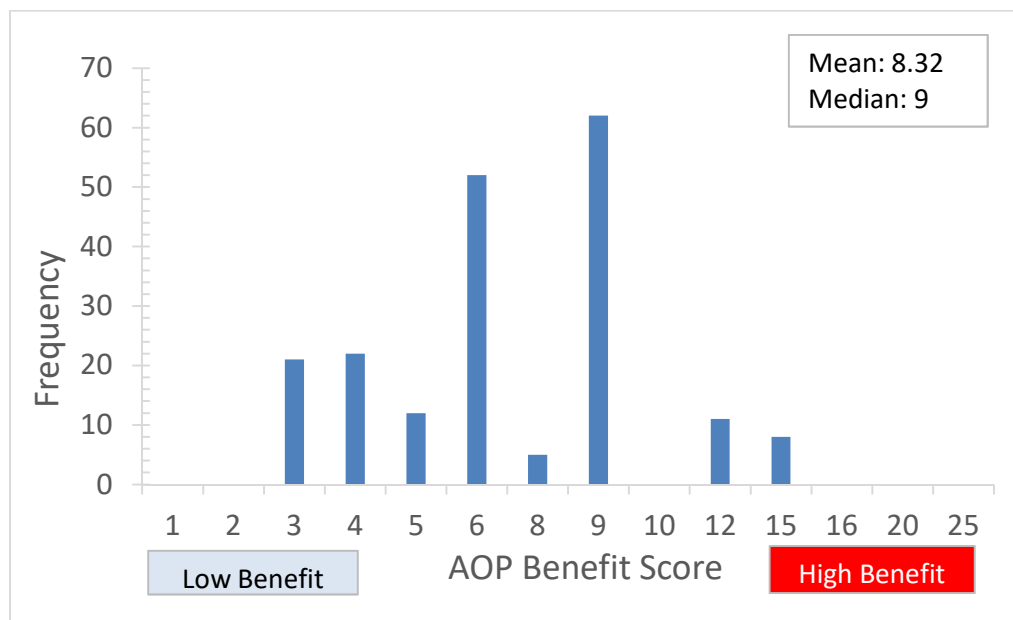
Figure 27. Histogram showing the distribution of AOP Benefit scores for all assessed crossings.

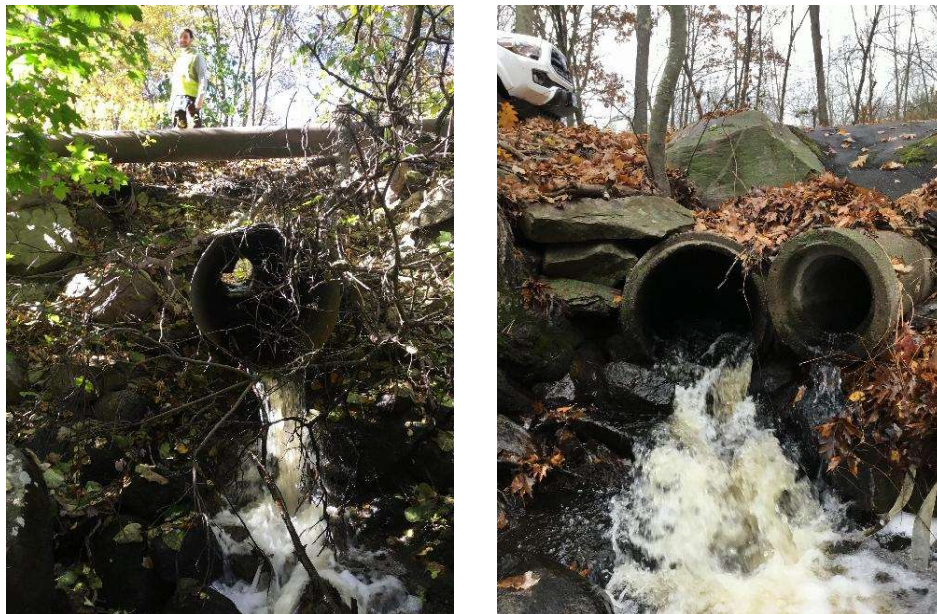
Figure 29. Outlet Drops associated with xy41848877150503 on Pine Hill Avenue in Johnston over Assapumpset Brook (left) and xy41890377149584 on Ridge Road in Smithfield over an unnamed tributary to the Woonasquatucket River (right)

The eight crossings that received the highest *AOP Benefit Scores* are listed in **Table 10**. These eight crossings are all associated with an *Outlet Drop* (**Figure 29**). This is not surprising considering the *Outlet Drop* is given significant weight in the determination of the final *Aquatic Passability Score*, as mentioned above in **Section 2.3.8**. The rationale for this is that although many factors can affect aquatic organism

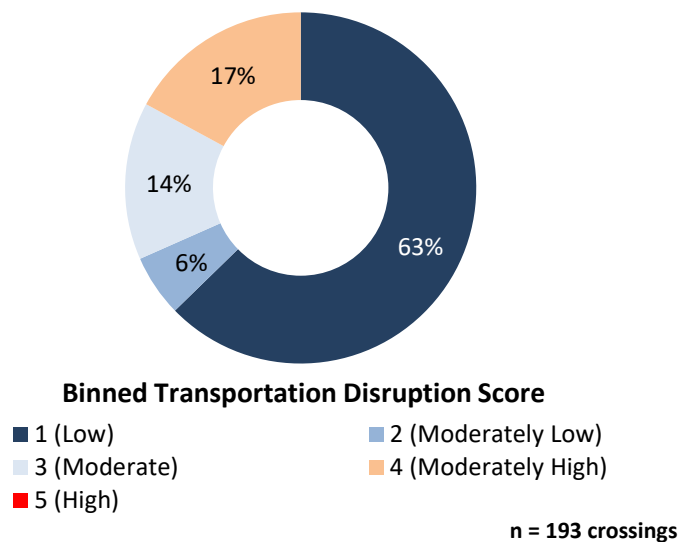
Figure 32. Binned Transportation Disruption Scores for all crossings. A score of 1 indicates the least potential disruption associated with crossing failure while a score of 5 indicates the highest potential disruption.
